ASBESTOS MANAGEMENT PLAN PHASE REPORT

CDB PROJECT NO. 321-055-707

Elgin Mental Health Center
Illinois Department of Mental Health and Developmental Disabilities
Tunnel System
CDB Building No. BR00T
750 South State Street
Elgin, Kane County, Illinois 60123

BY:
BELING CONSULTANTS
Professional Engineers
1001 16TH STREET
MOLINE, ILLINOIS 61265
(309) 757-9800

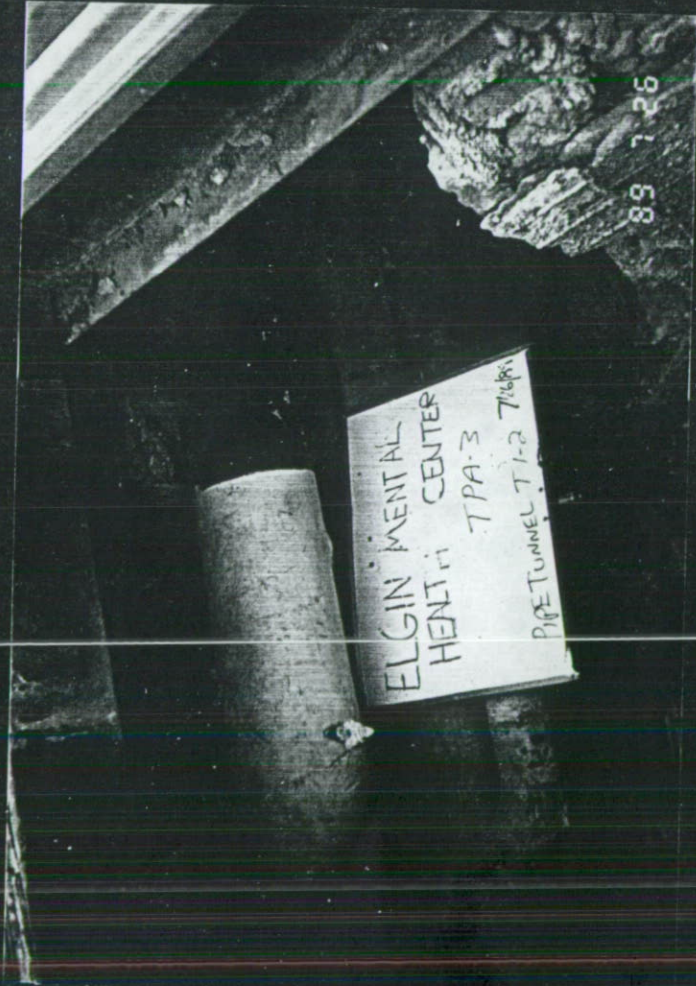
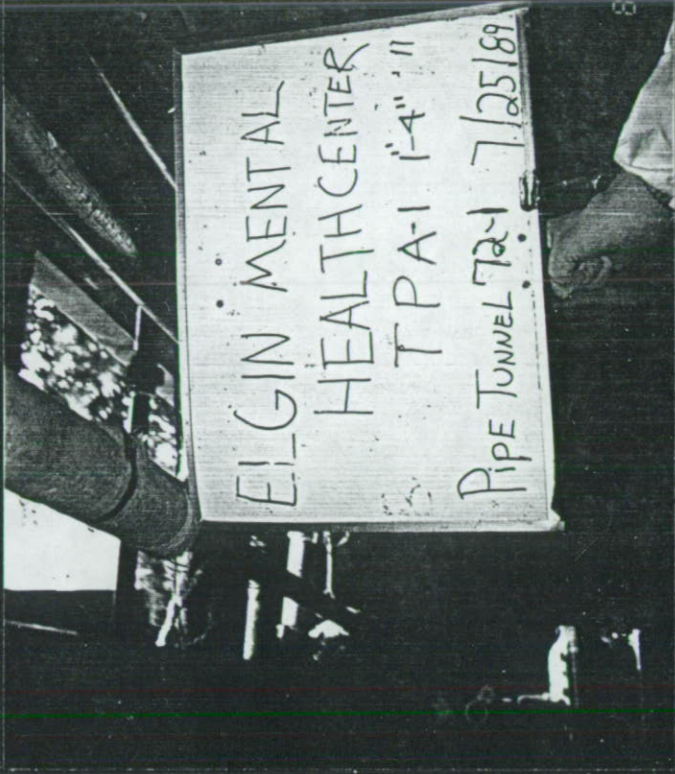
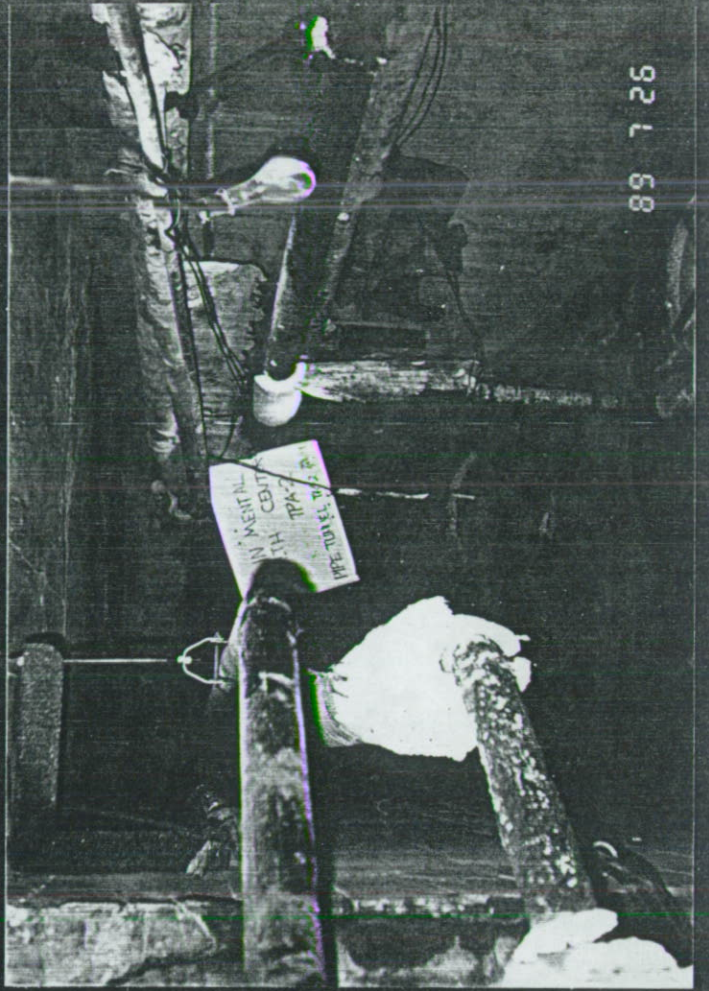
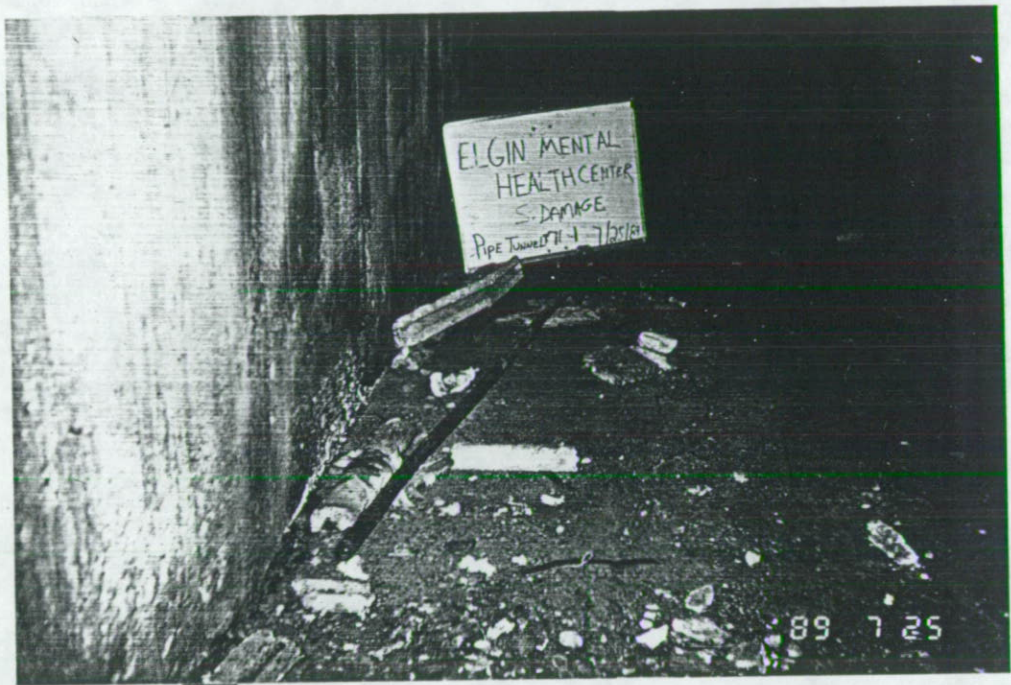
BLDG NAME Pipe Tunnels CDB
BLDG NO. BROOT
HOMO AREA BROOT-TPA DESCRIPT Pipe Insulation 1"-4"
RESPONSE ACTION #3; Continue O & M. Scedule removal when practical
and cost effective, or reduce disturbance.

EXIST. COND. Damaged with localized areas of significant damage.

POT. FOR DAMAGE Yes; May be damaged by piping maintenance. Asbestos
pipe insulation may also be disturbed by physical activity in
areas of the tunnels where insulation has delaminated.

WHY Material is friable with areas of damage and localized
significant damage. Air flow is relatively low in the tunnel
area. Using the flow chart method (Form 5), response action
#3 is recommended.

PREVENTATIVE MEASURES Repair areas of damage. Keep outer covering
intact. Repair tunnel access (manholes) to prevent further damage
from water leakage.

O & M PROCEDURES Conduct periodic surveillance. Repair damaged
coverings with lag cloth and bridging encapsulant. Wear approved
respirator when entering and working in pipe tunnels.

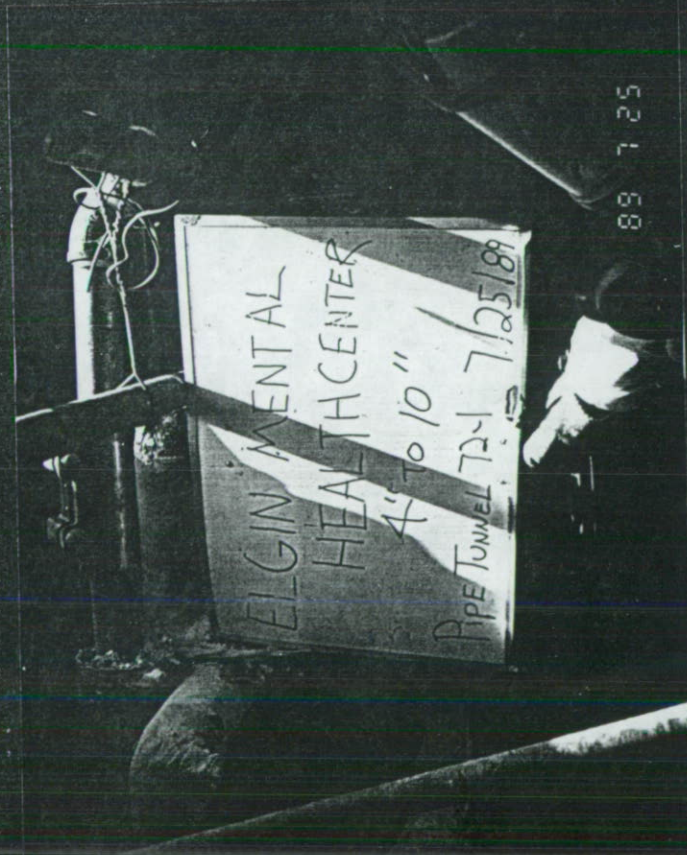
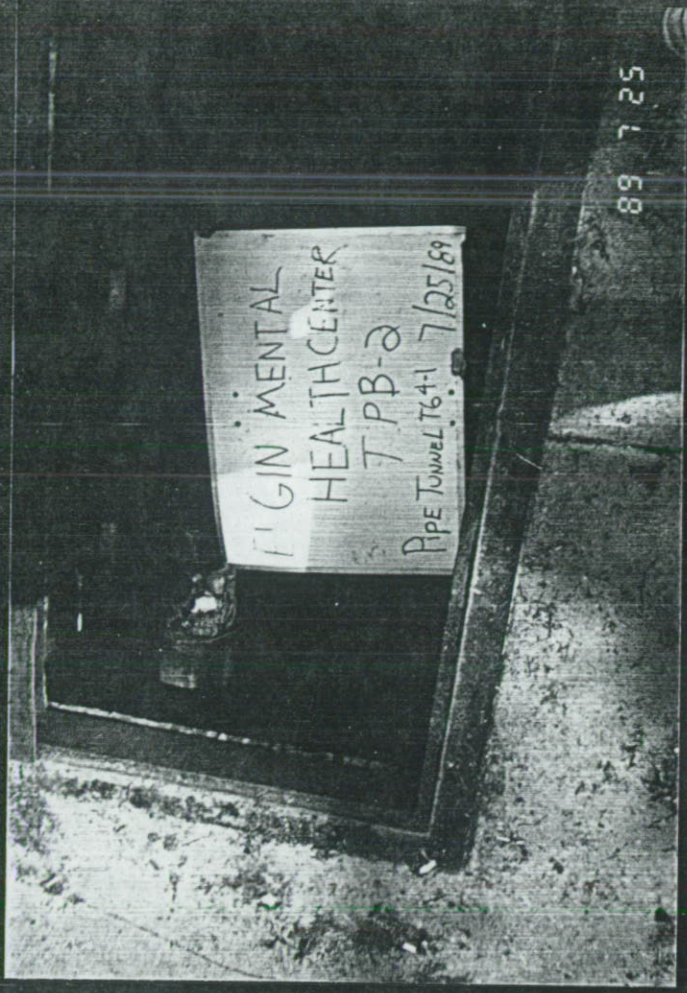
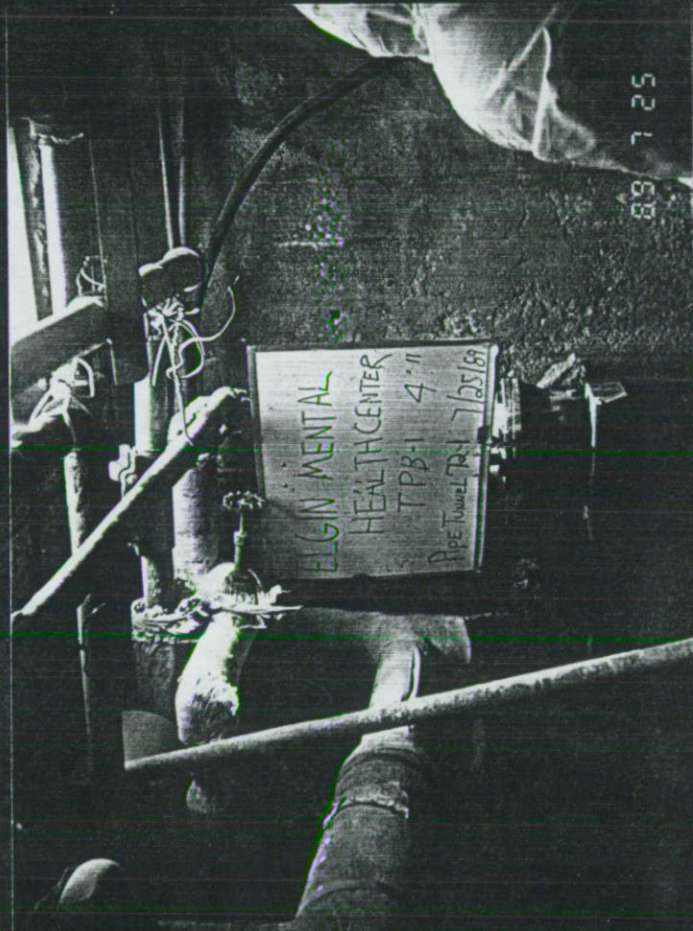
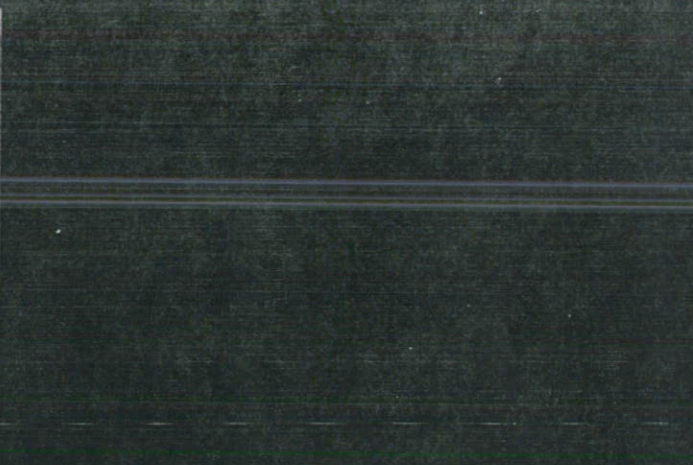
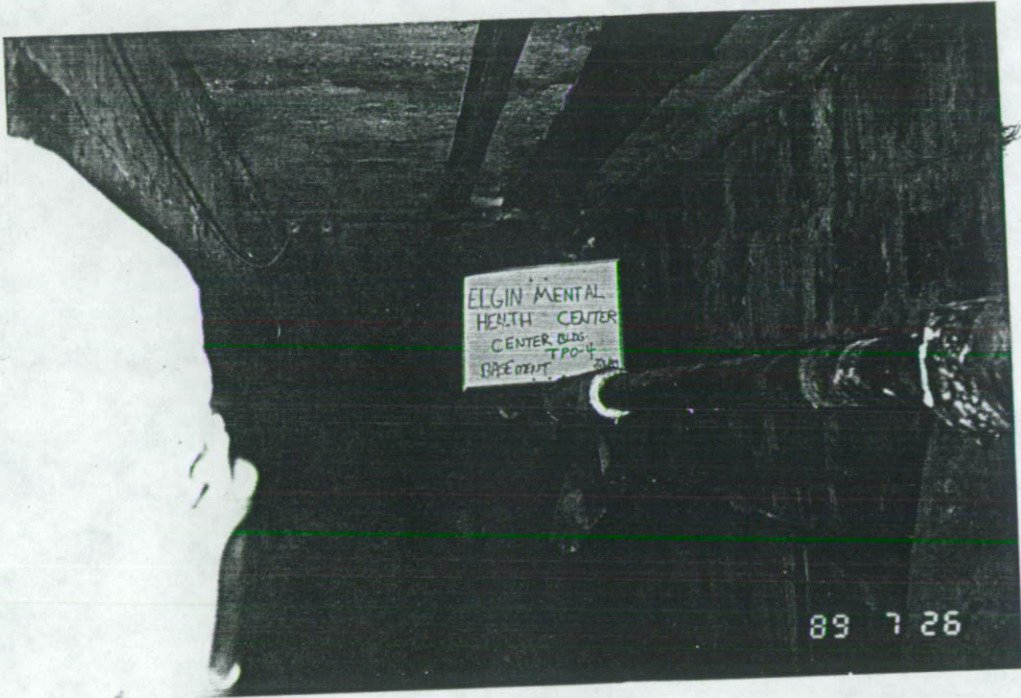
BLDG NAME Pipe Tunnels CDB BLDG NO. BROOT
HOMO AREA BROOT- TPB DESCRIPT Pipe Insulation 5"-10"
RESPONSE ACTION #3; Continue O & M. Schedule removal when practical
and cost effective, or reduce disturbance.

EXIST. COND. Damaged with localized areas of significant damage.

POT. FOR DAMAGE Yes; May be damaged by piping maintenance. Asbestos
pipe insulation may also be disturbed by physical activity in
areas of the tunnels where insulation has delaminated.

WHY Material is friable with areas of damage and localized
significant damage. Air flow is relatively low in the tunnel
area. Using the flow chart method (Form 5), response action
#3 is recommended.

PREVENTATIVE MEASURES Repair areas of damage. Keep outer covering
intact. Repair tunnel access (manholes) to prevent further damage
from water leakage.

O & M PROCEDURES Conduct periodic surveillance. Repair damaged
coverings with lag cloth and bridging encapsulant. Wear approved
respirator when entering and working in pipe tunnels.

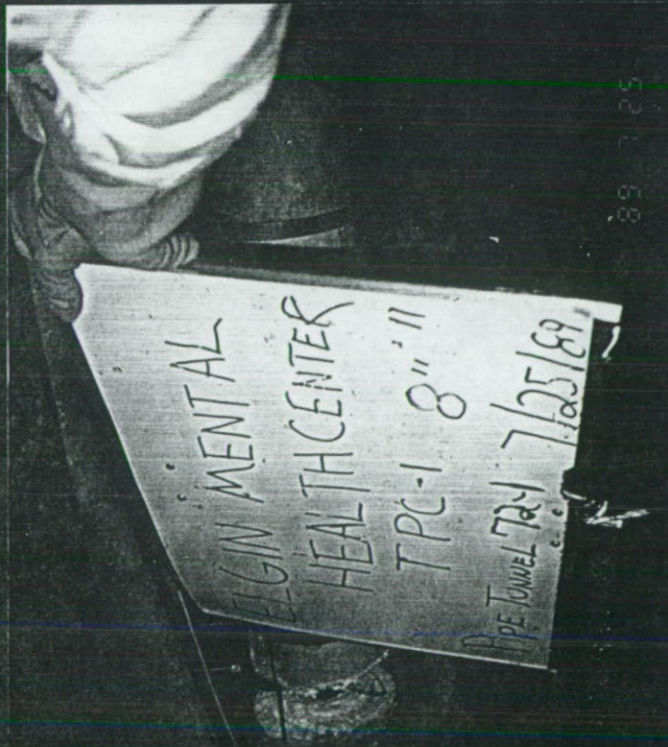
ELGIN MENTAL
HEALTH CENTER
TPC-1 8" II
PIPE TUNNEL 7/25/89

EXIST. COND. Damaged with localized areas of significant damage.

POT. FOR DAMAGE Yes; May be damaged by piping maintenance. Asbestos
pipe insulation may also be disturbed by physical activity in
areas of the tunnels where insulation has delaminated.

PREVENTATIVE MEASURES Keep outer covering
intact. Repair tunnel access (manholes) to prevent further damage
from water leakage.

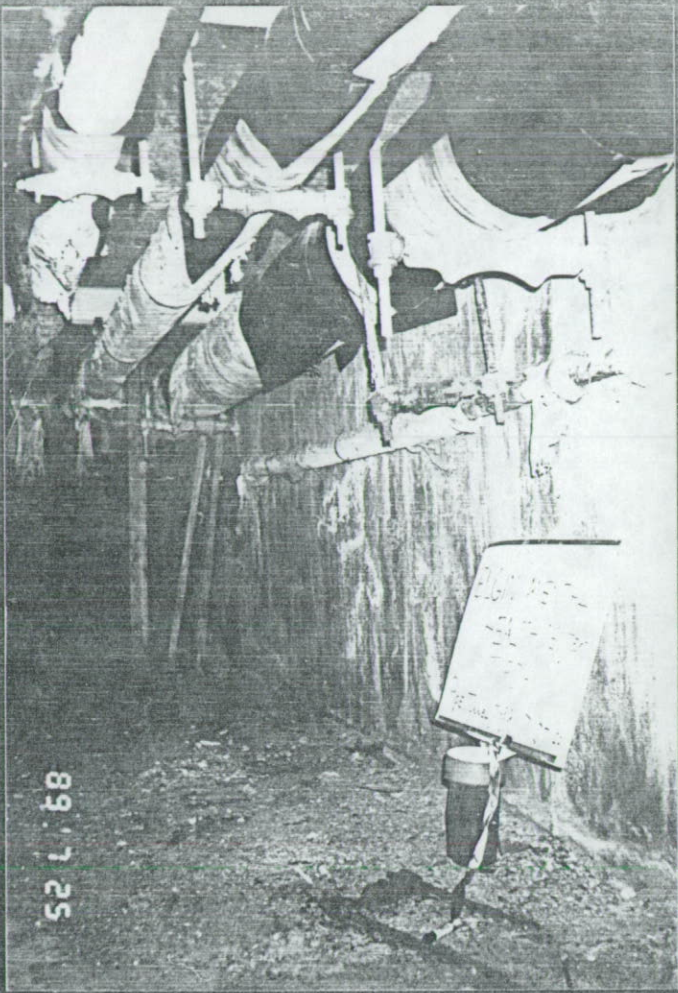
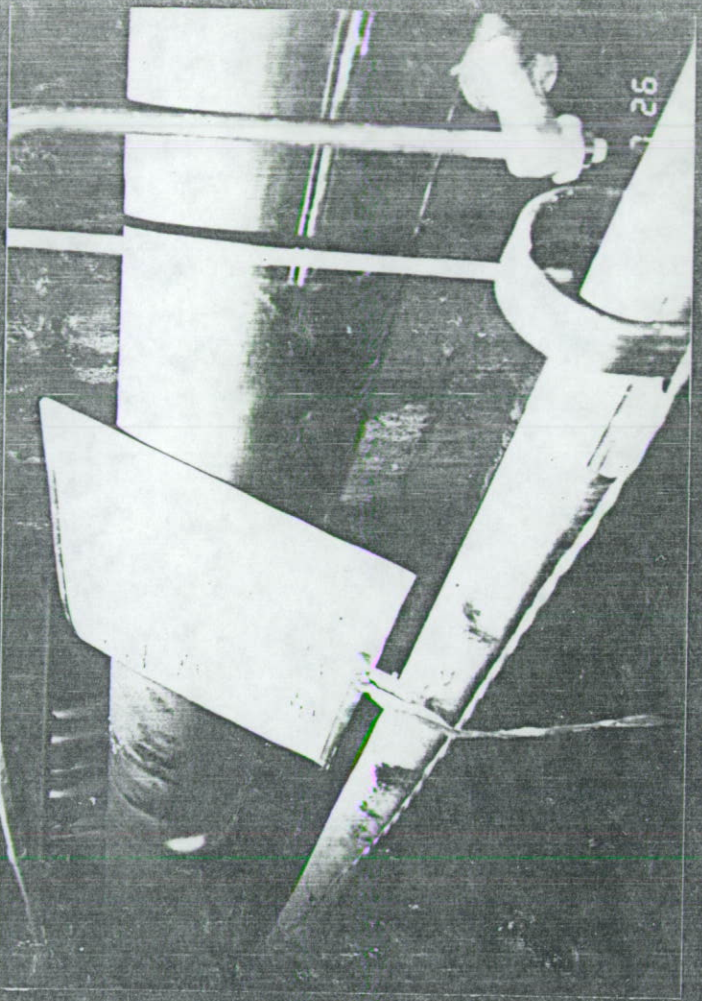
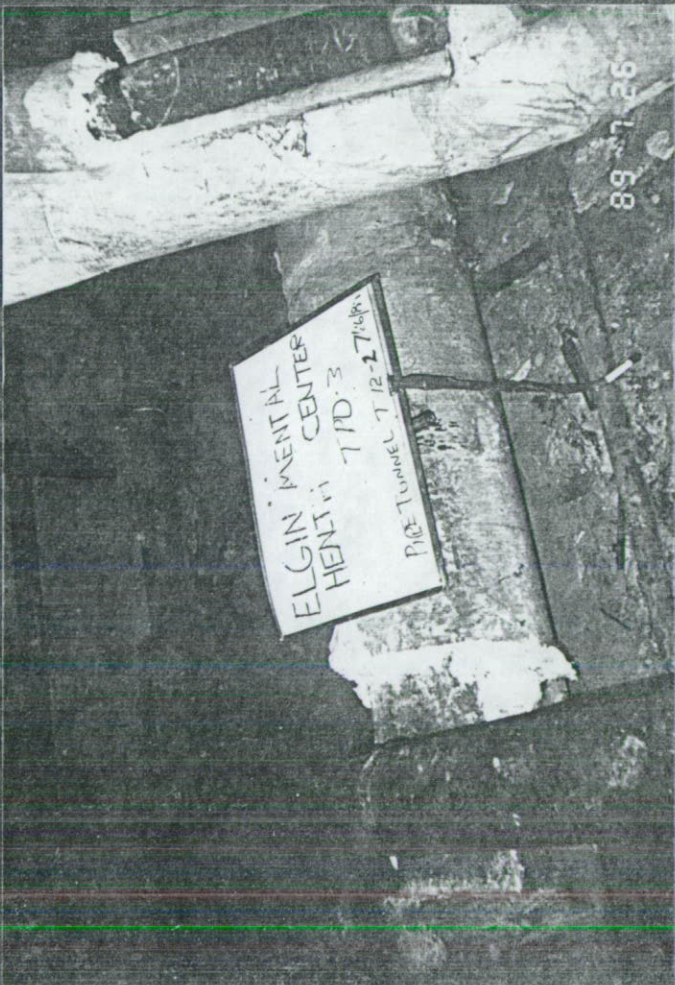
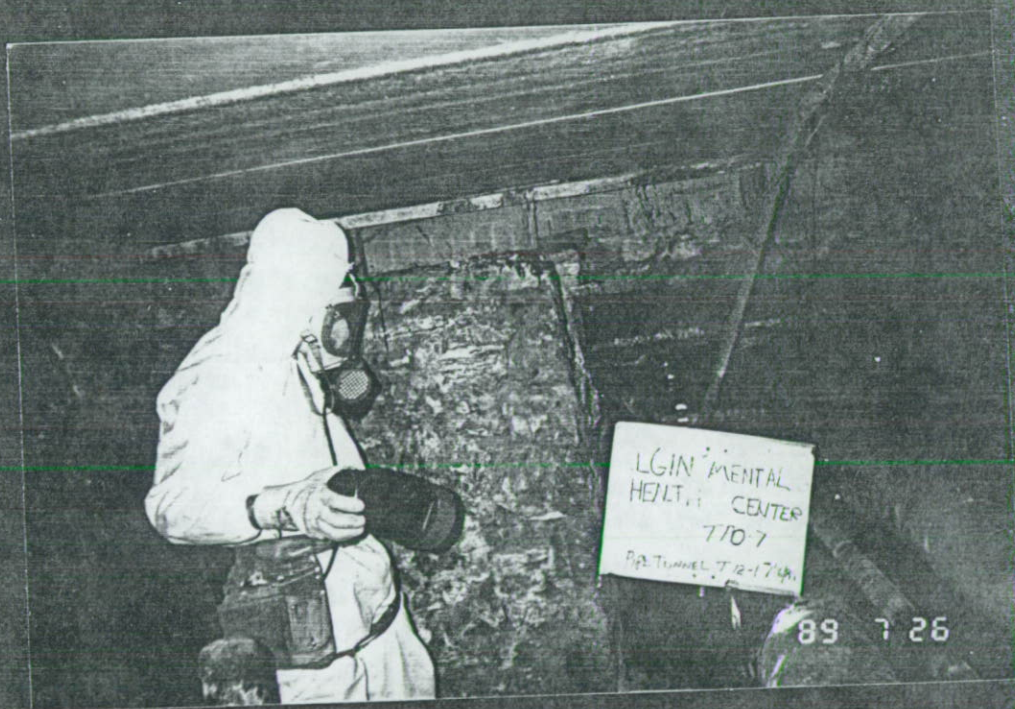
BLDG NAME Pipe Tunnels CDB BLDG NO. BROOT
HOMO AREA BROOT-TPD DESCRIPT Pipe Insulation 16+"
RESPONSE ACTION #3; Continue O & M. Schedule removal when practical
and cost effective, or reduce disturbance.

EXIST. COND. Damaged with localized areas of significant damage.
