## **Asbestos Inspection Report – Campus Boiler Replacement**

**CDB #822-010-127**

**NORTHERN ILLINOIS UNIVERSITY  
EAST HEATING PLANT (U1028)  
Wirtz Drive & Lucinda Ave., Dekalb, IL 60115  
WEST HEATING PLANT (U1110)  
Douglas and Stadium Drive, Dekalb, IL 60115**

NORTHERN ILLINOIS UNIVERSITY  
CAMPUS BOILER REPLACEMENT PROJECT  
BUILDINGS: U1028 AND U1110  
DEKALB, DEKALB COUNTY, ILLINOIS  
CDB PROJECT NO. 822-010-127

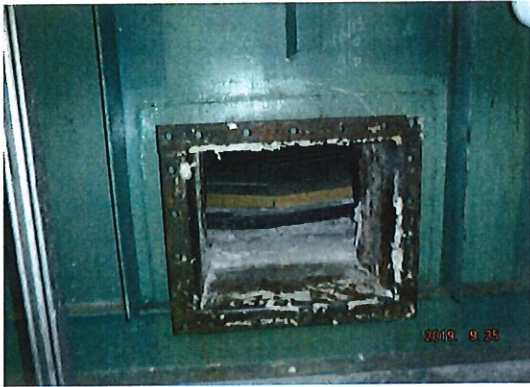
Sample ID : MMA-1/3

ACM : No

Material :  
Boiler Fire Brick

Location :  
Interior of boiler

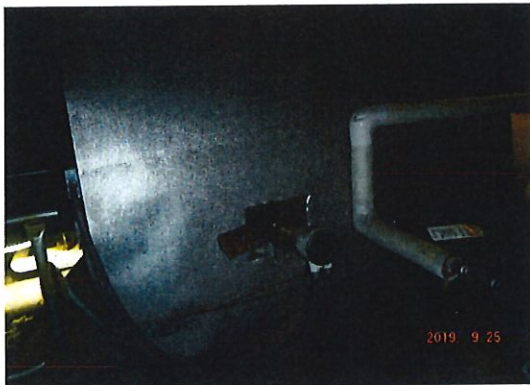
Sample ID : TDA-1/3

ACM : No

Material :  
Boiler Flue Insulation

Location :  
Inside aluminum jacketing on flue duct and air intake duct

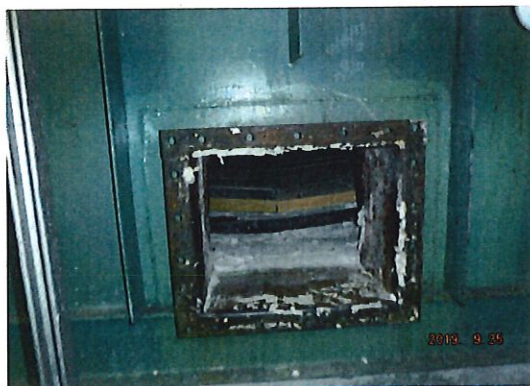
Sample ID : TDB-1/3

ACM : No

Material :  
Boiler Wall Insulation

Location :  
Inside boiler jacketing

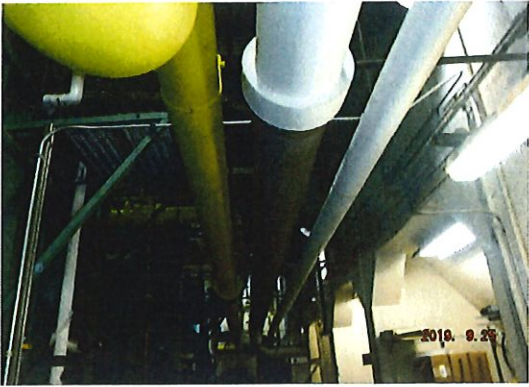
Sample ID : TPA-1/3

ACM : Yes

Material :  
Pipe Insulation Type 1

Location :  
Brown painted Condensate Return Pipe

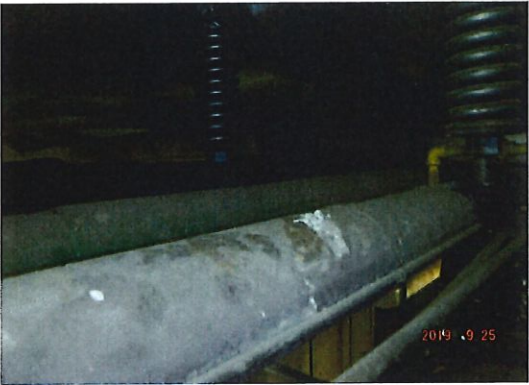
Sample ID : TPB-1/3

ACM : Yes

Material :  
Pipe Insulation Type 2

Location :  
Small Brown pipe

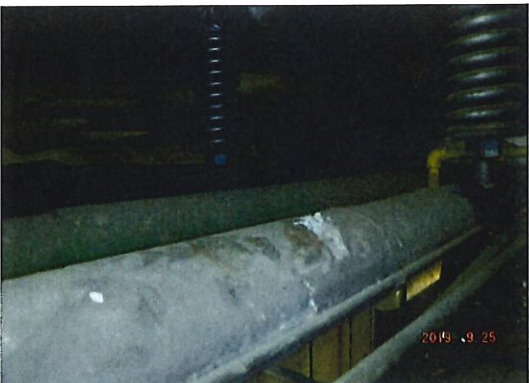
Sample ID : TPC-1/3

ACM : Yes

Material :  
Pipe Insulation Type 3

Location :  
Medium sized Brown pipes

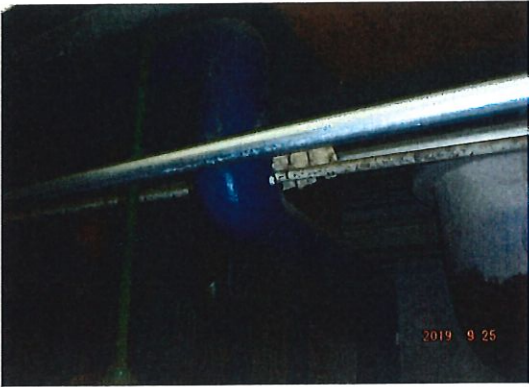
Sample ID : TJD-1/3  
ACM : Yes  
Material :  
Pipe Fitting Insulation (Blue Pipe)  
Location :  
Small Blue pipes  
Comment :

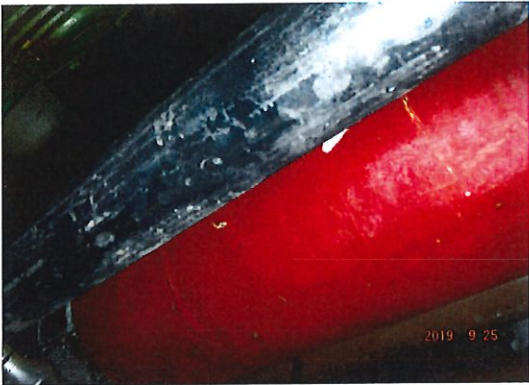
Sample ID : TPE-1/3  
ACM : Yes  
Material :  
Pipe Insulation Type 4  
Location :  
Red painted Steam Header pipe  
Comment :

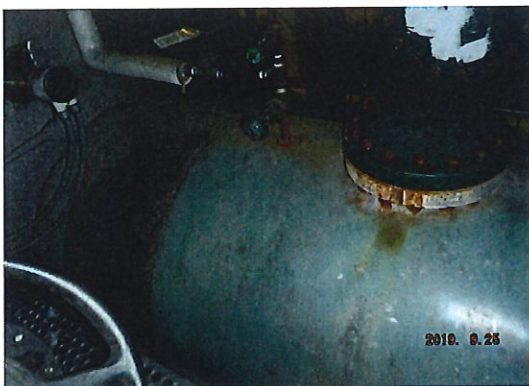
Sample ID : TDC-1/3  
ACM : No  
Material :  
Boiler Top Insulation  
Location :  
Under Metal Jacket Rounded top in center  
Comment :

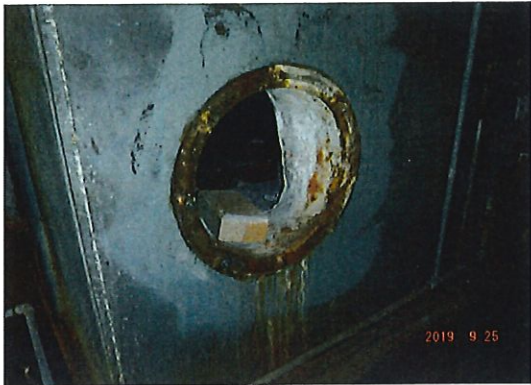
Sample ID : MMA-1/3

ACM : No

Material :  
Boiler Fire Brick

Location :  
Inside Boiler

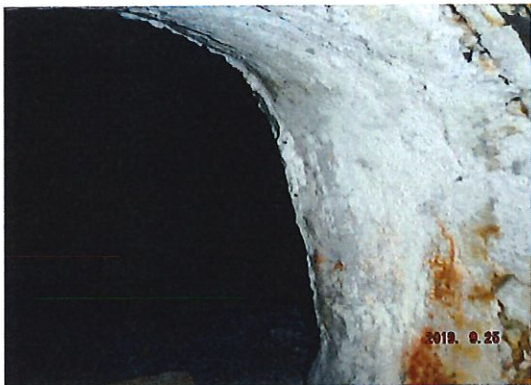
Sample ID : TBA-1/3

ACM : No

Material :  
Boiler Packing Insulation (walls)

Location :  
Inside Boiler

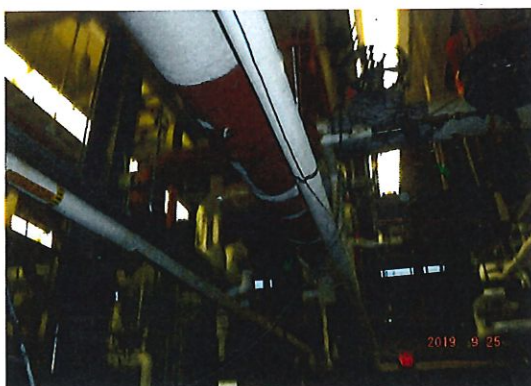
Sample ID : TPA-1/3

ACM : Yes

Material :  
Pipe Insulation Type 1

Location :  
18" Steam Header painted red

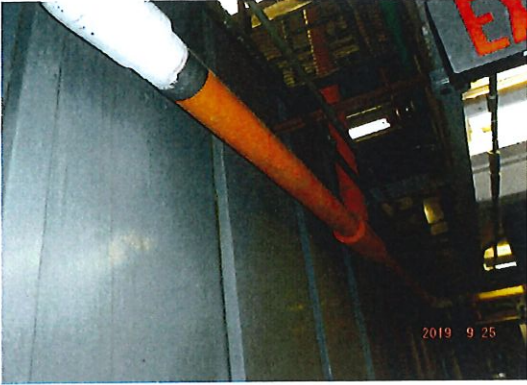
Sample ID : TPB-1/3

ACM : Yes

Material :  
Pipe Insulation Type 2

Location :  
Low Pressure Steam painted orange

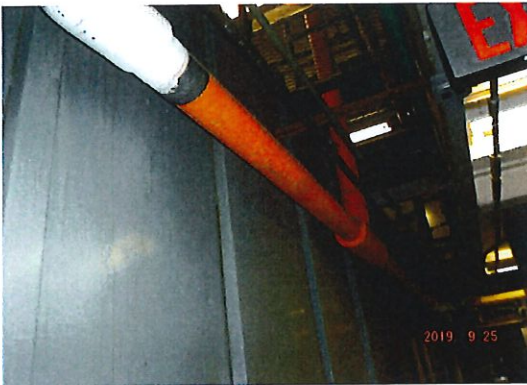
Sample ID : TJB-1

ACM : Yes

Material :  
Pipe Fitting Insulation (LPS)

Location :  
Low Pressure Steam painted orange

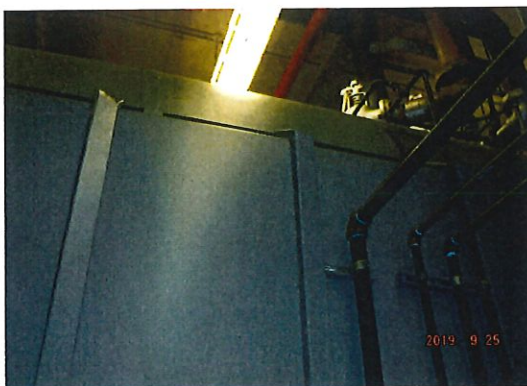
Sample ID : TBB-1/3

ACM : No

Material :  
Boiler Insulation (Top)

Location :  
Top round section

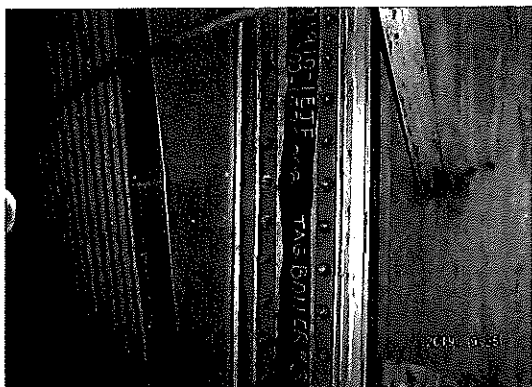
Sample ID : TBC-1/3

ACM : No

Material :  
Rope Gasket

Location :  
Air intake gasket and Firebox door

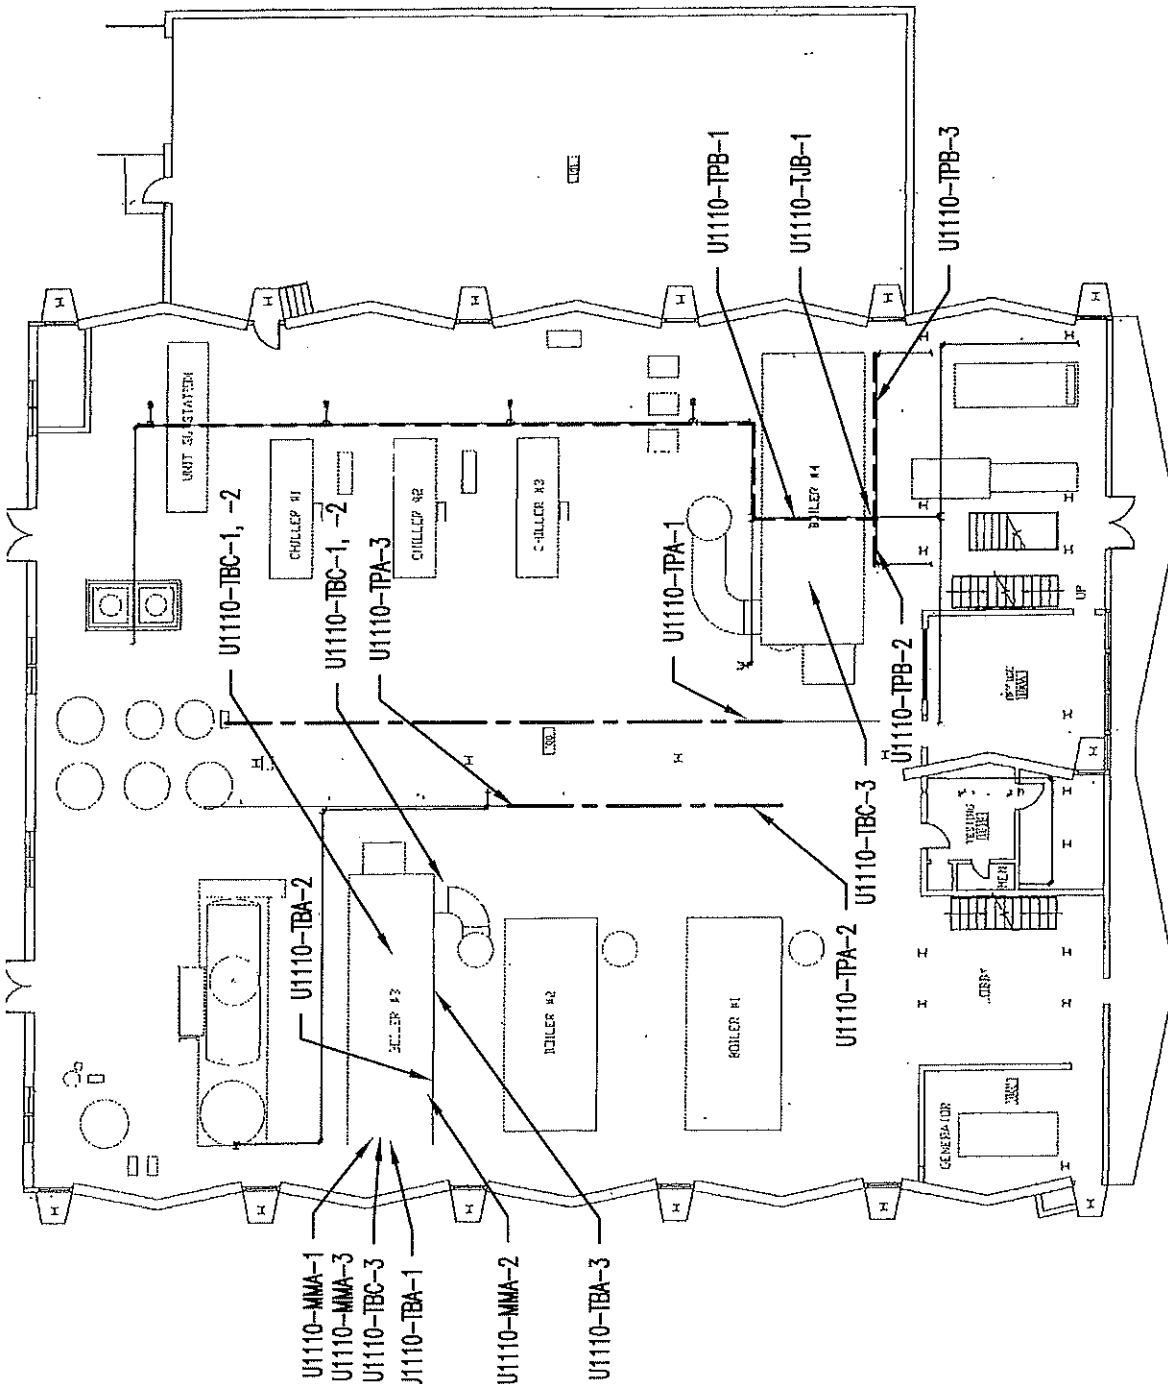
NIU - WEST CAMPUS HEATING PLANT

- ACM PIPE INSULATION
- TPA - PIPE INSULATION TYPE 1 (STEAM HEADER PAINTED RED) APPROX. 60 LIN. FT.
- ACM PIPE & FITTING INSULATION TPB & TUB - PIPE INSULATION TYPE 2 APPROX. 45 LF/2 LF
- NON-ACM FIBERGLASS ADJOINING STEAM HEADER
