# ASBESTOS MANAGEMENT PLAN REPORT

CDB - PROJECT NUMBER -- 910-010-093

NORTHERN ILLINOIS UNIVERSITY  
1425 WEST LINCOLN HIGHWAY  
WEST HEATING PLANT  
C.D.B. BUILDING #U1110  
NORTHERN ILLINOIS UNIVERSITY - DEKALB CAMPUS  
DEKALB, DEKALB COUNTY, ILLINOIS 60115

BY:  
CARNOW, CONIBEAR & ASSOC., LTD.  
333 WEST WACKER DRIVE, SUITE 1400  
CHICAGO, ILLINOIS 60606  
(312)782-4486

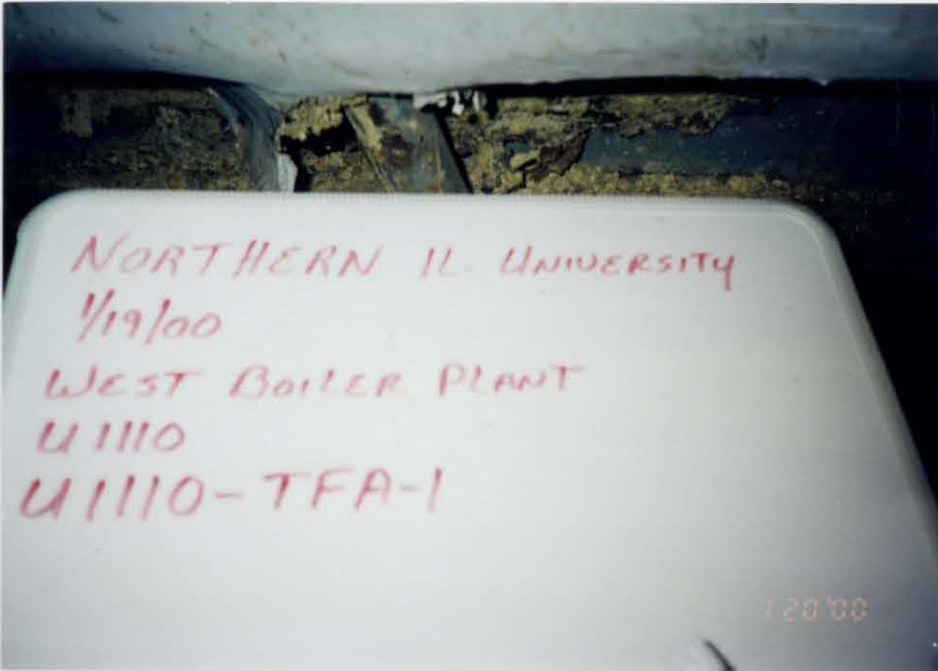
TFA - boiler stack insulation on boiler #1 and #2 (original building - 1962) and TFC - de-aerator stack insulation, are damaged and need to be repaired. There is approximately 10 square feet of debris on the floor around boiler #3 which needs to be cleaned up by an IDPH licensed asbestos worker.

WATER DAMAGE Yes \_\_\_\_\_ No X Description \_\_\_\_\_  
 PHYSICAL DAMAGE Yes X No \_\_\_\_\_ Description THE BOTTOM OF THE STACK ON BOILER #1 NEEDS TO BE REPAIRED  
 AGE DETERIORATION Yes \_\_\_\_\_ No X Description \_\_\_\_\_

U1110 - TFA - 1  
BOILER STACK  
INSULATION ON  
BOILER #1 AND #2  
(ORIGINAL  
BUILDING - 1962)

DAMAGE PREVENTION MEASURES REPAIR BOILER STACKS #1 AND #2. MAINTAIN THIS STACK IN GOOD CONDITION. IF THEY BECOME DAMAGED, REPAIR THEM IMMEDIATELY.

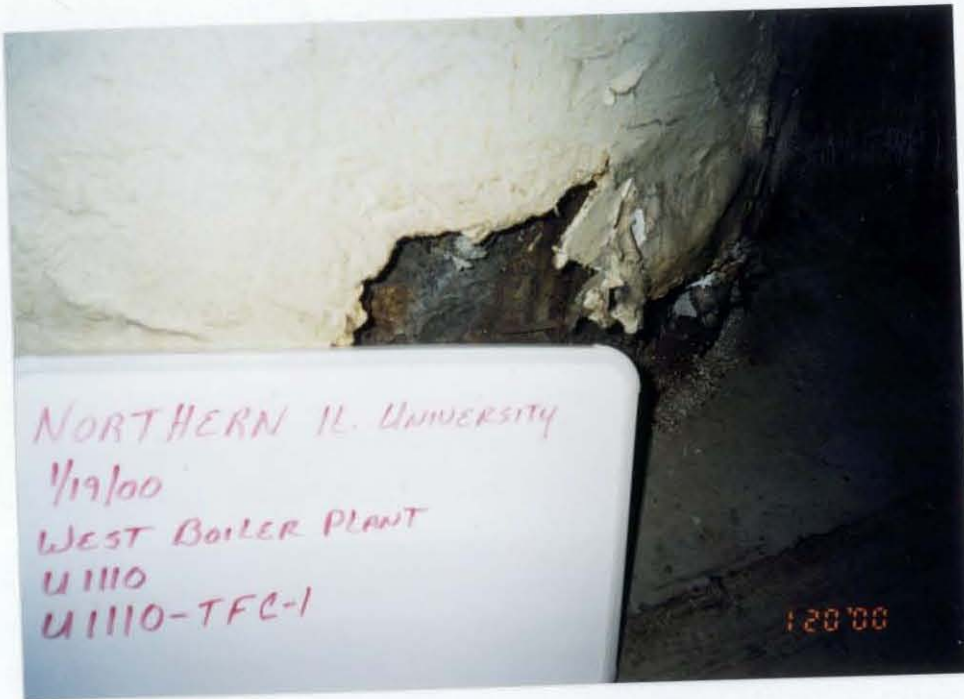
U1110 - TFB - 1  
BOILER STACK  
INSULATION ON  
BOILER #3  
(ADDITION #1 -  
1964)  
(Picture is incorrect.  
Material designation  
was changed to  
TFB.)

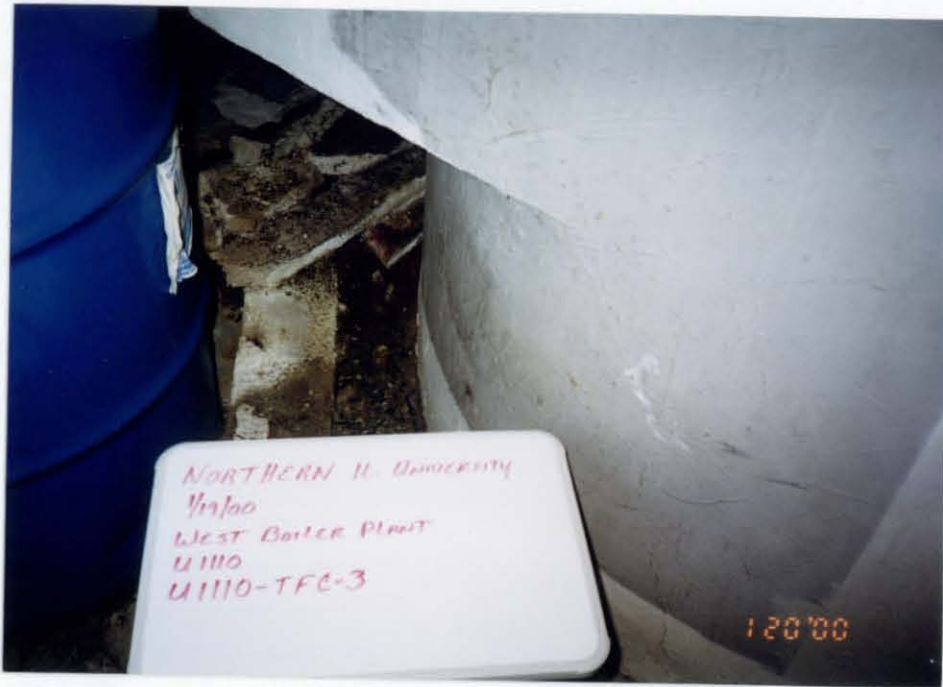
U1110 - TFB - 3  
BOILER STACK  
INSULATION ON  
BOILER #3  
(ADDITION #1 -  
1964)  
(Picture is incorrect.  
Material designation  
was changed to  
TFB.)

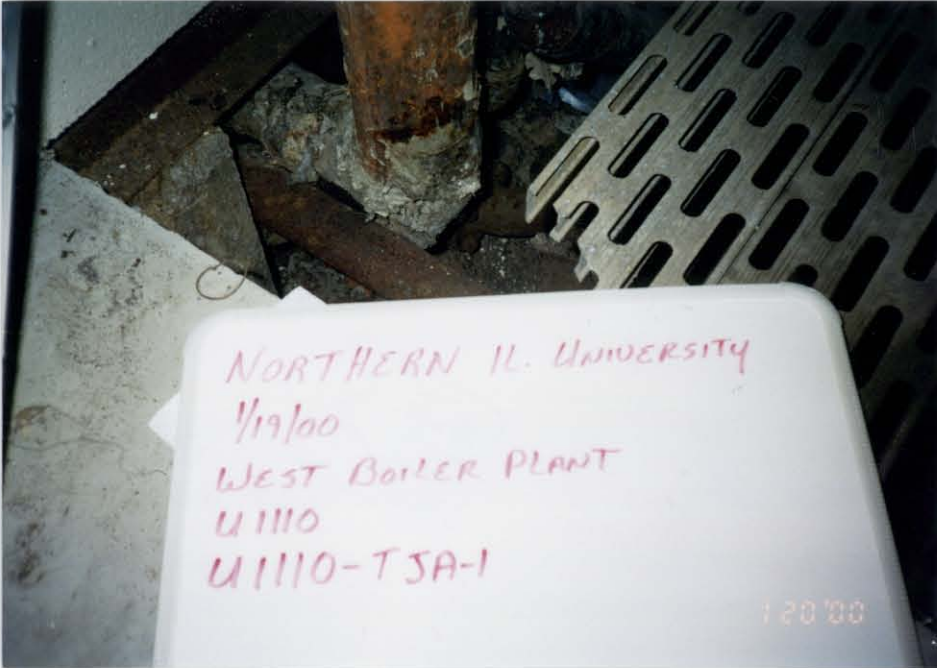
U1110 - TJA - 1  
FITTINGS ON  
FIBERGLASS PIPE  
INSULATION  
(ORIGINAL  
BUILDING - 1962)

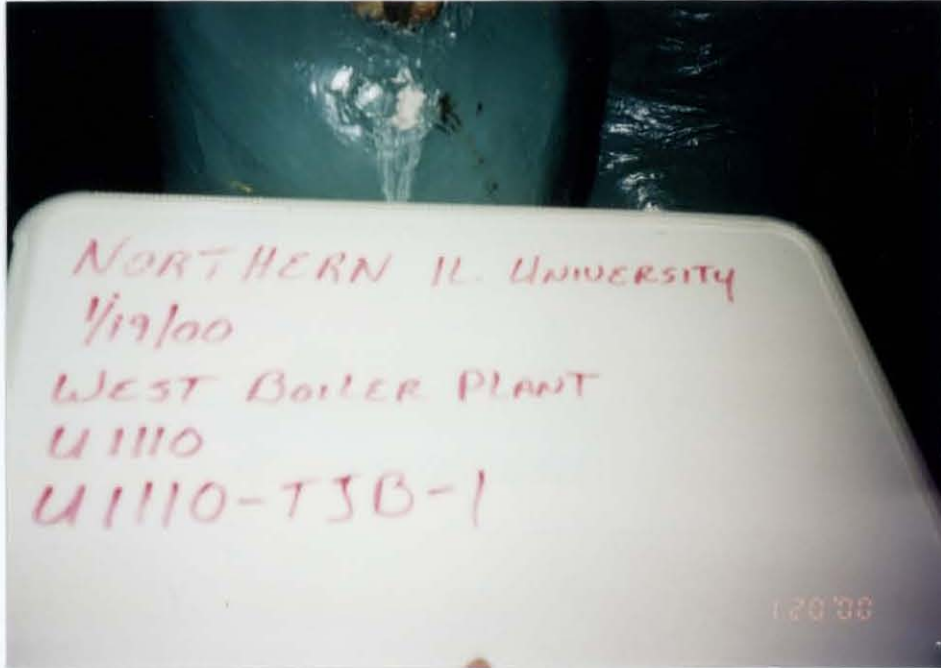
U1110 - TJB - 1  
FITTINGS ON  
FIBERGLASS PIPE  
INSULATION  
(ADDITION #1 -  
1964)

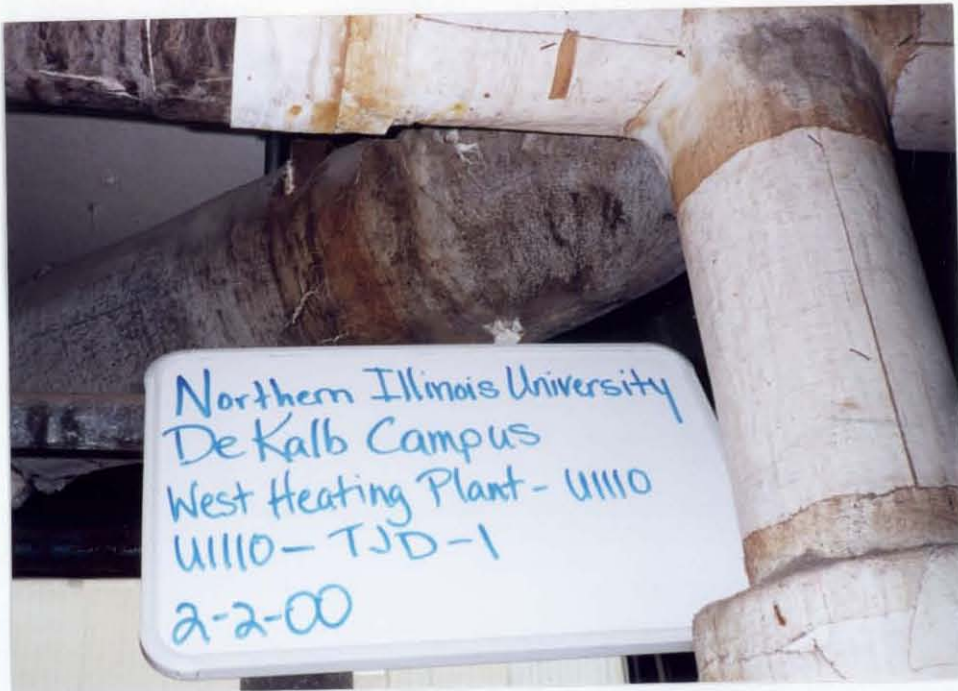
U1110 - TJD - 1  
FITTINGS ON  
MAG-BLOCK PIPE  
INSULATION  
(ORIGINAL  
BUILDING - 1962)

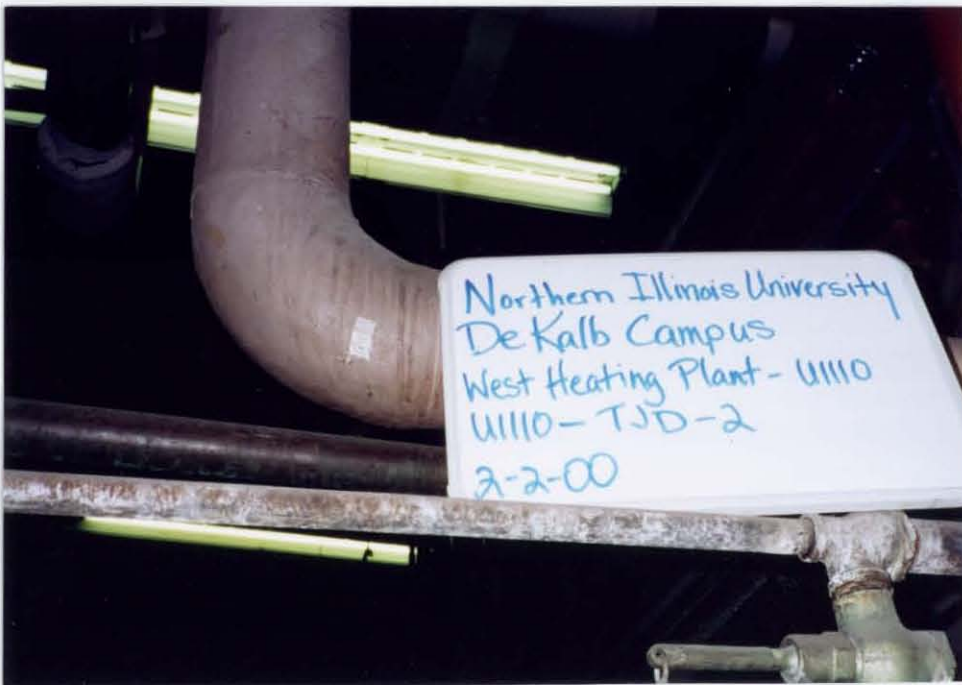
U1110 - TJD - 2  
FITTINGS ON  
MAG-BLOCK PIPE  
INSULATION  
(ORIGINAL  
BUILDING - 1962)

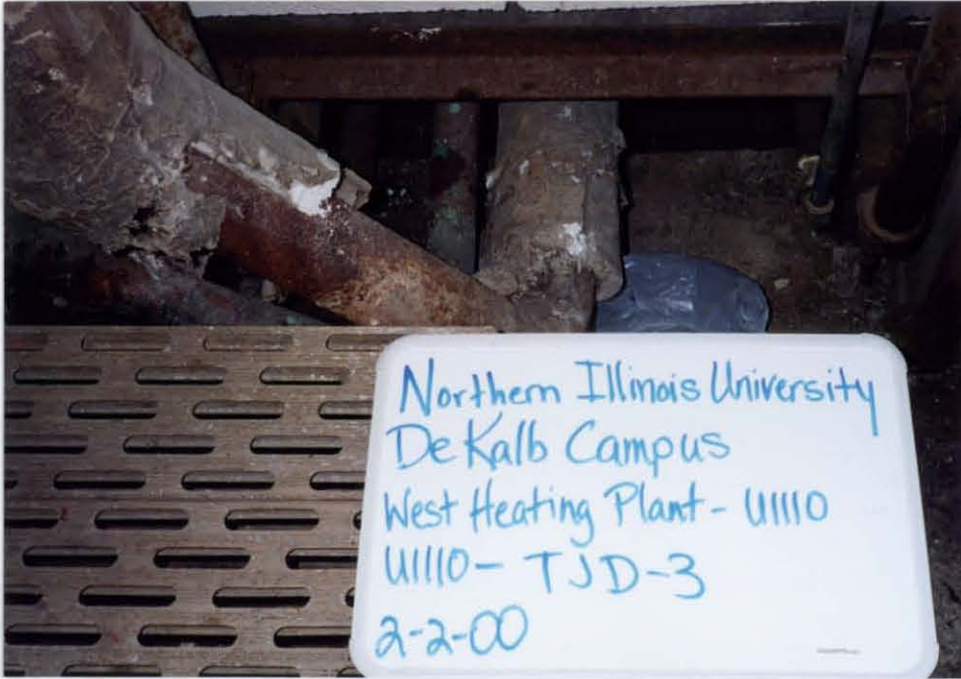
U1110 - TJD - 3  
FITTINGS ON  
MAG-BLOCK PIPE  
INSULATION  
(ORIGINAL  
BUILDING - 1962)

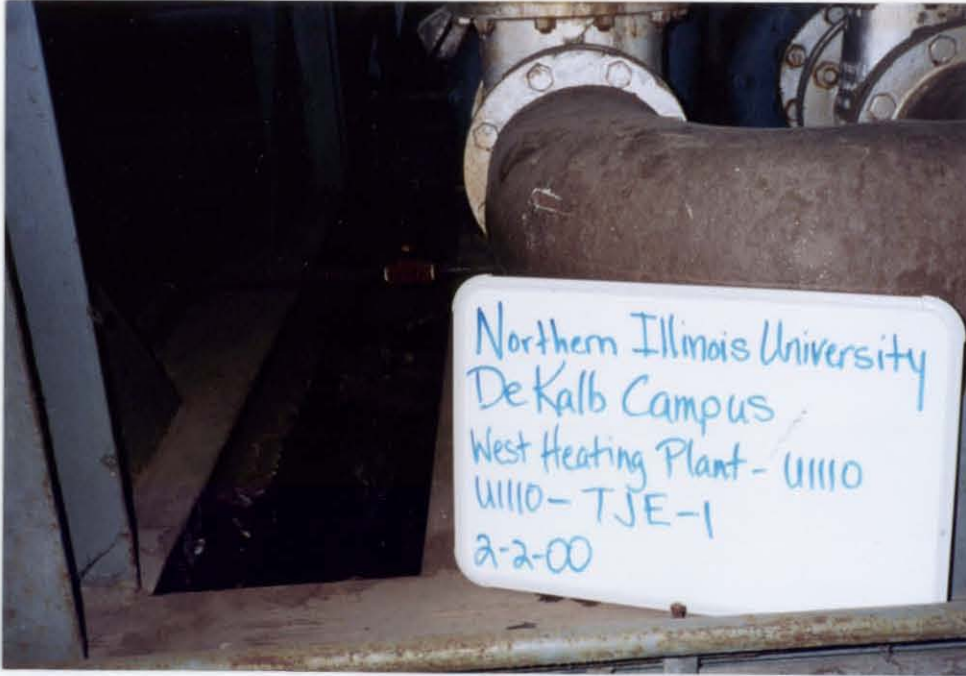
U1110 - TJE - 1  
FITTINGS ON  
MAG-BLOCK PIPE  
INSULATION  
(ADDITION #1 -  
1964)

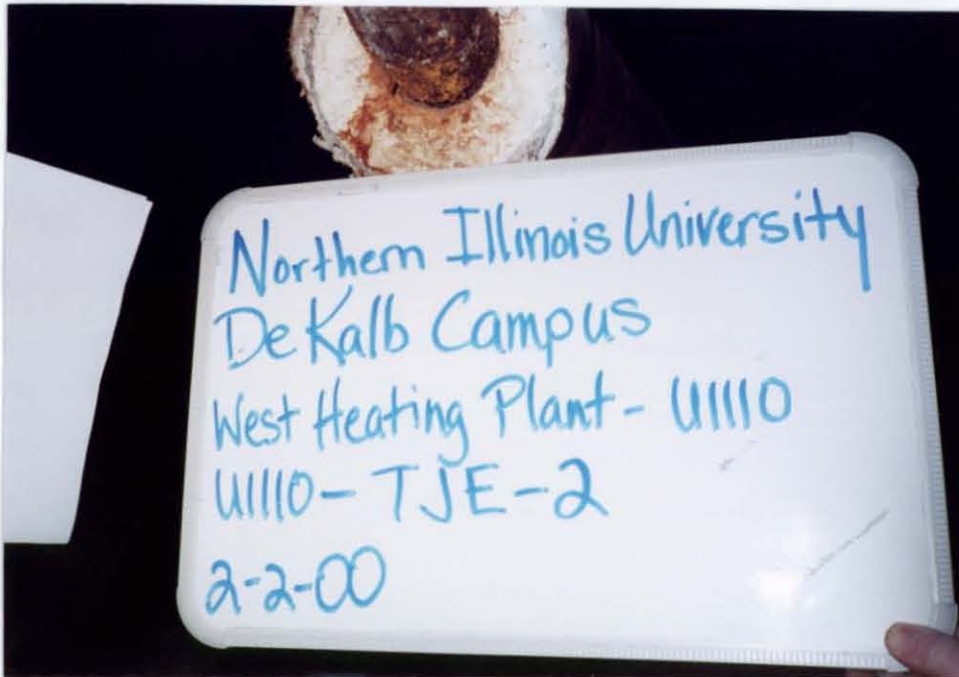
U1110 - TJE - 2  
FITTINGS ON  
MAG-BLOCK PIPE  
INSULATION  
(ADDITION #1 -  
1964)

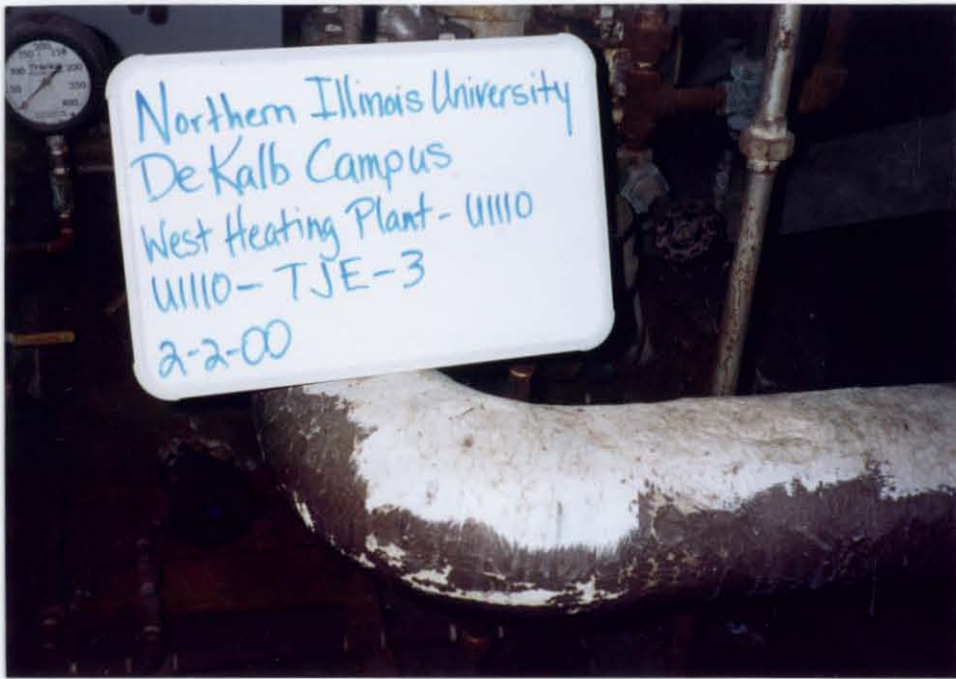
U1110 - TJE - 3  
FITTINGS ON  
MAG-BLOCK PIPE  
INSULATION  
(ADDITION #1 -  
1964)

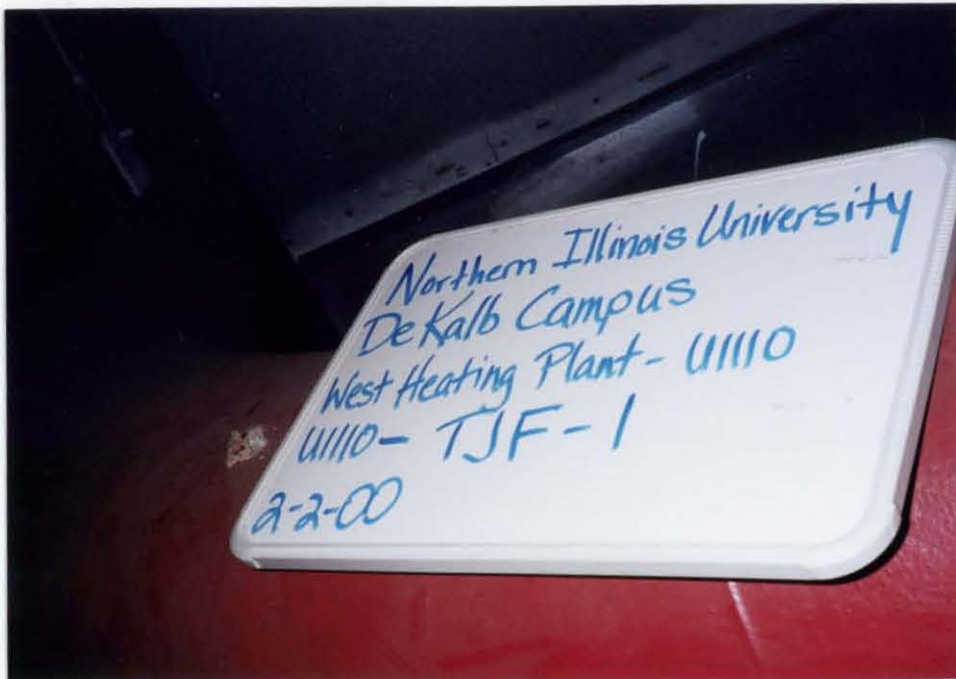
U1110 - TJF - 1  
FITTINGS ON  
MAG-BLOCK PIPE  
INSULATION  
(ADDITION #2 -  
1966)

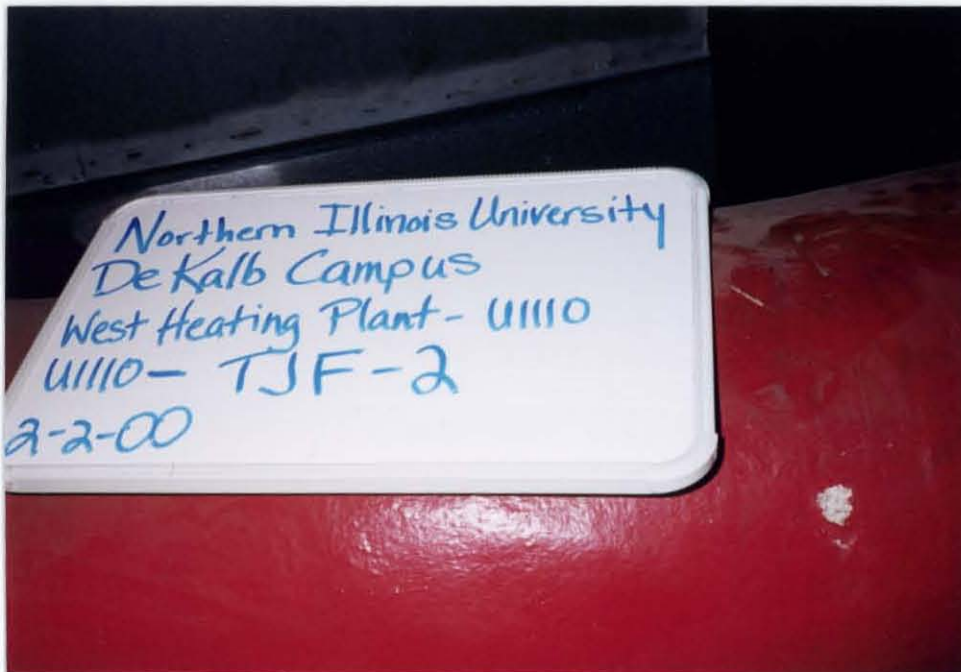
U1110 - TJF - 2  
FITTINGS ON  
MAG-BLOCK PIPE  
INSULATION  
(ADDITION #2 -  
1966)

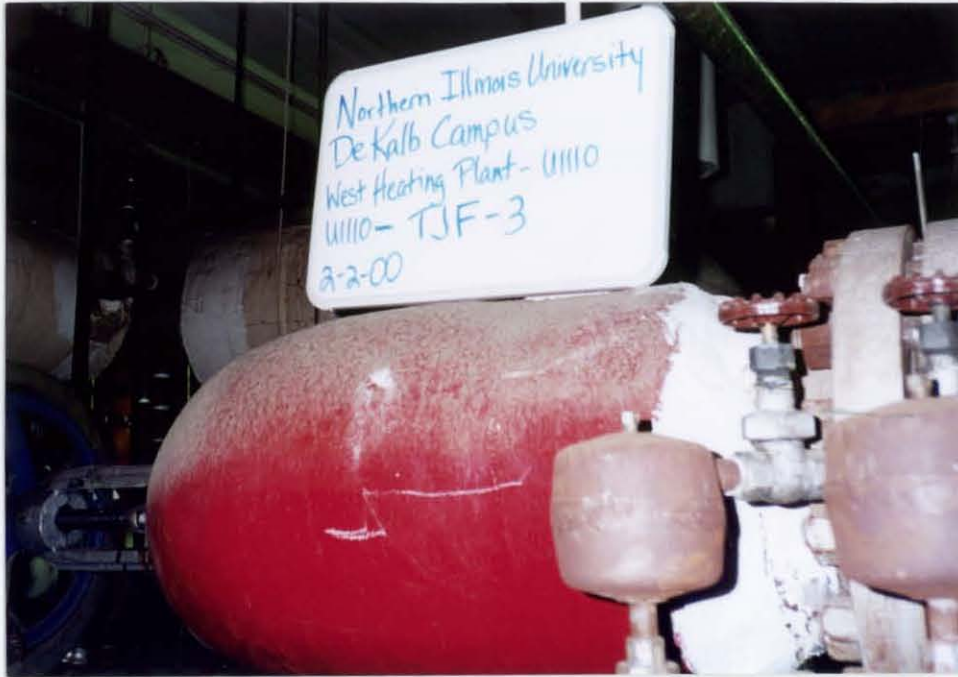
U1110 - T.J.F. - 3  
FITTINGS ON  
MAG-BLOCK PIPE  
INSULATION  
(ADDITION #2 -  
1966)

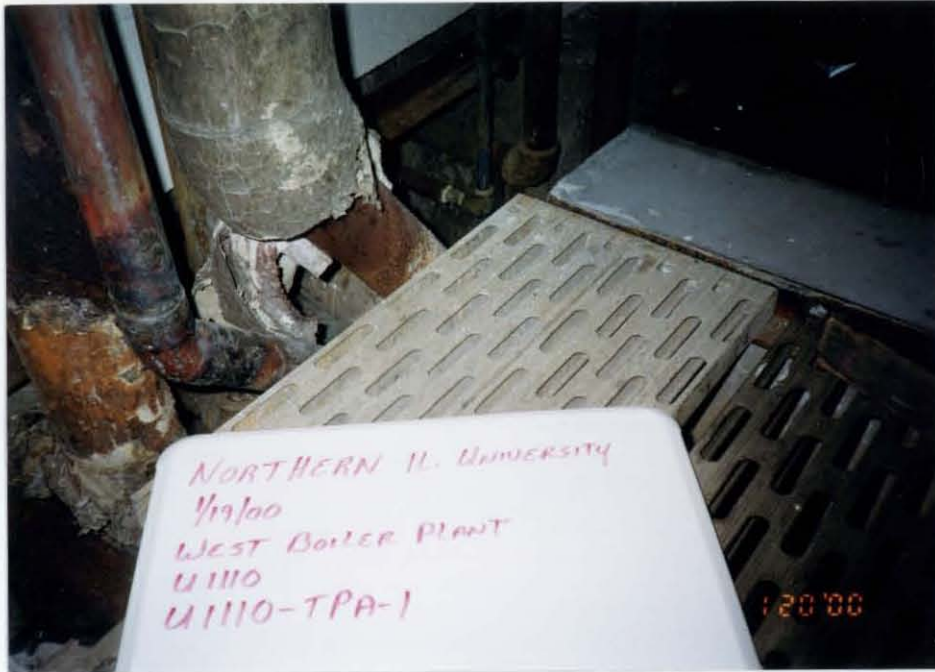
U1110 - TPA - 1  
MAG-BLOCK PIPE  
INSULATION  
(ORIGINAL  
BUILDING - 1962)

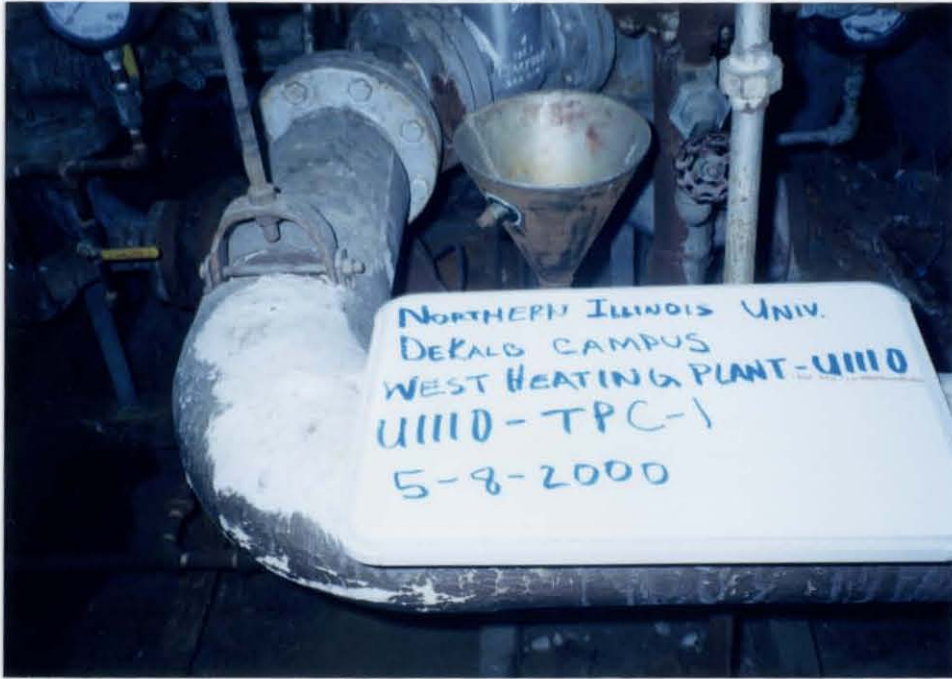
U1110 - TPC - 1  
MAG-BLOCK PIPE  
INSULATION  
(ADDITION #2 -  
1966)

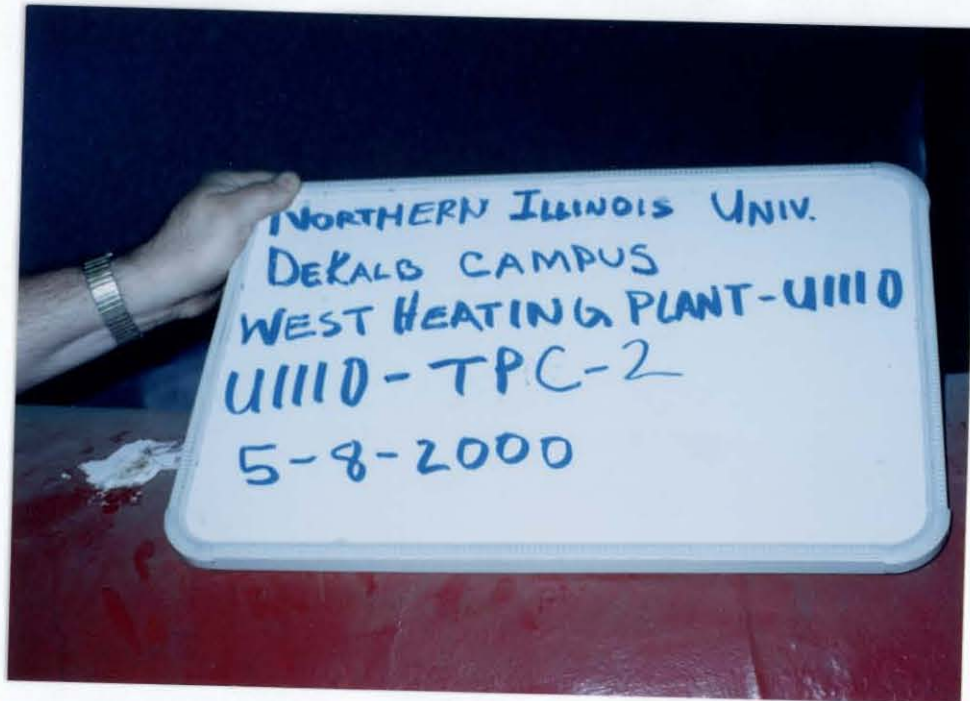
U1110 - TPC - 2  
MAG-BLOCK PIPE  
INSULATION  
(ADDITION #2 -  
1966)

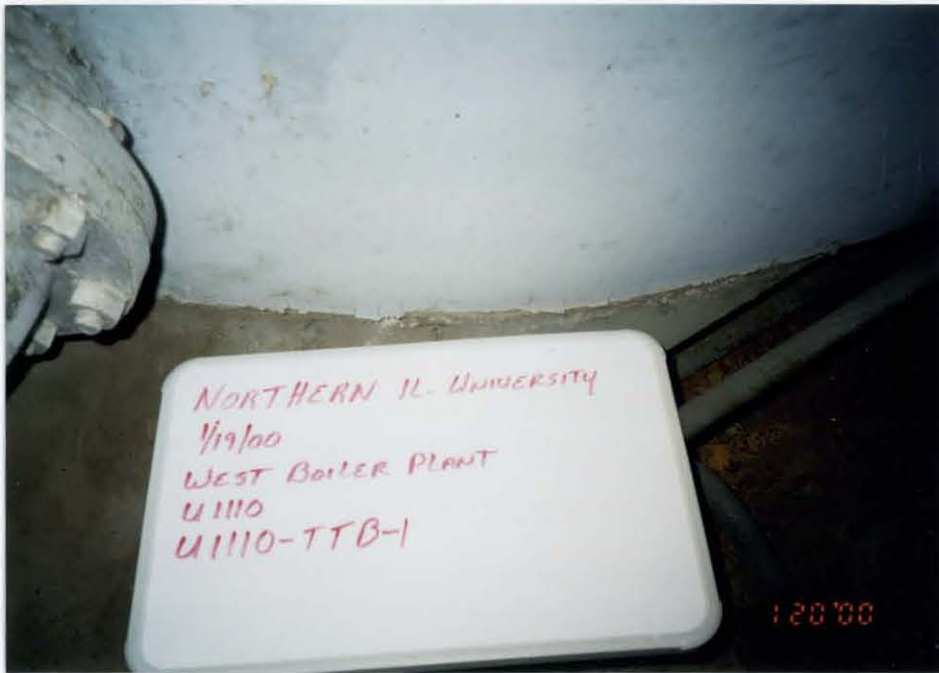
There is approximately 4 sq. ft. of TTB - receiver tank insulation (addition #1 - 1964) where the covering has come off. The insulation is currently in good shape but it should be repaired.

U1110 - TTB - 1  
RECEIVER TANK  
INSULATION  
(ADDITION #1 -  
1964)

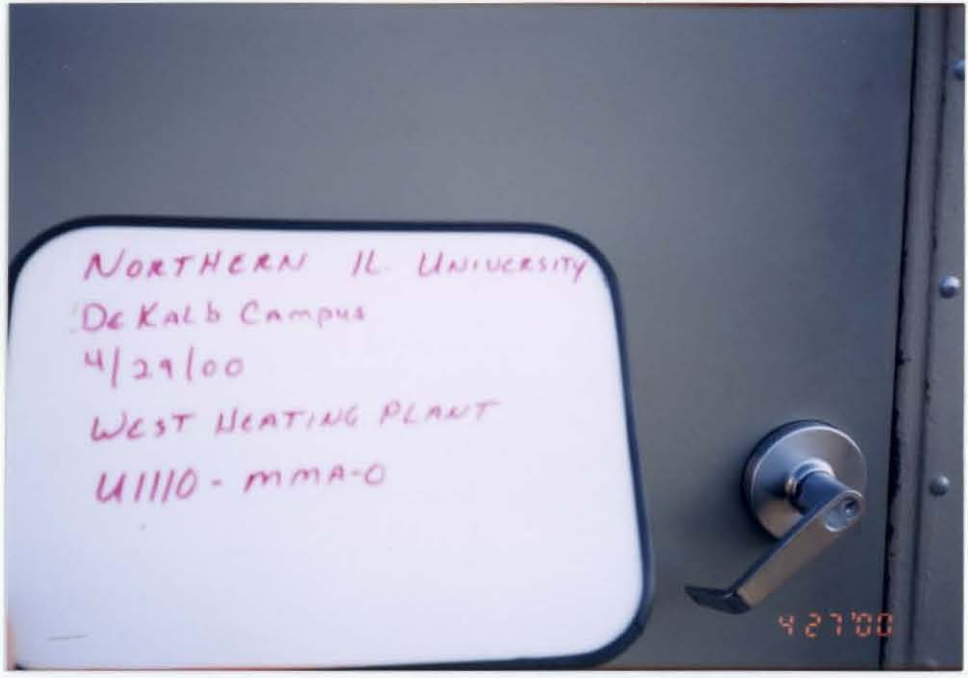
U1110 - MMA - 0  
FIRE DOOR  
INSULATION

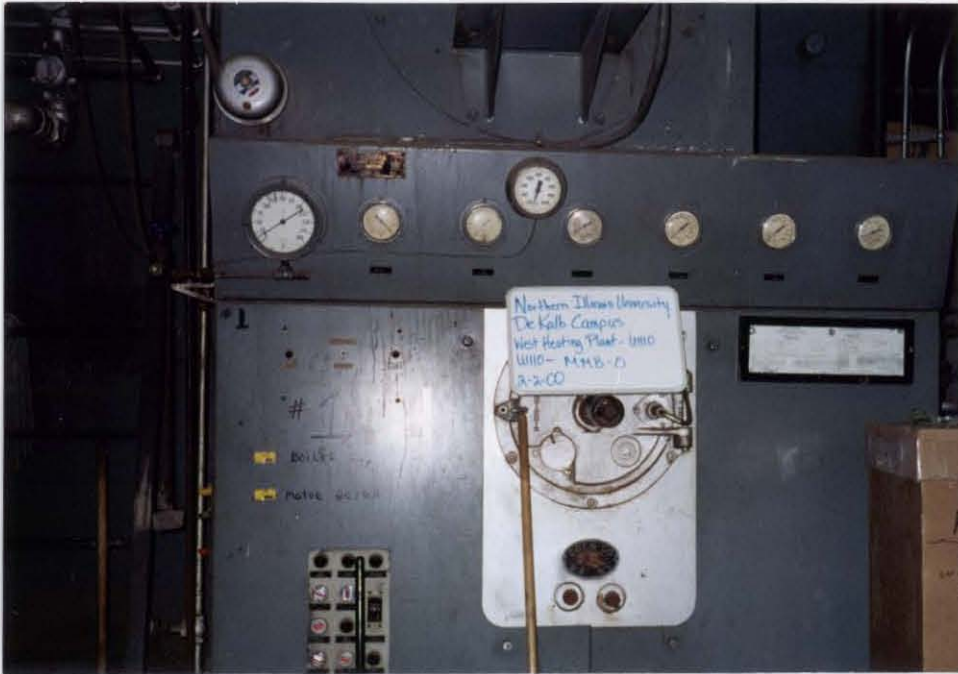
U1110 - MMB - 0  
GASKETS ON  
BOILERS #1 AND #2  
(ORIGINAL  
BUILDING - 1962)

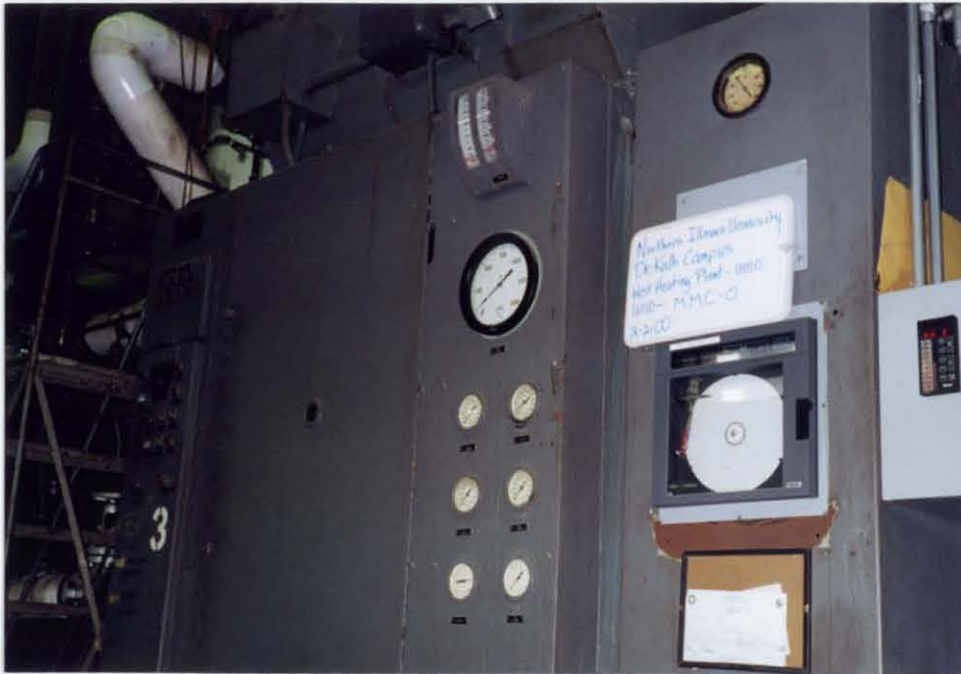
U1110 - MMC - 0  
GASKETS ON  
BOILER #3  
(ADDITION #1 -  
1964)

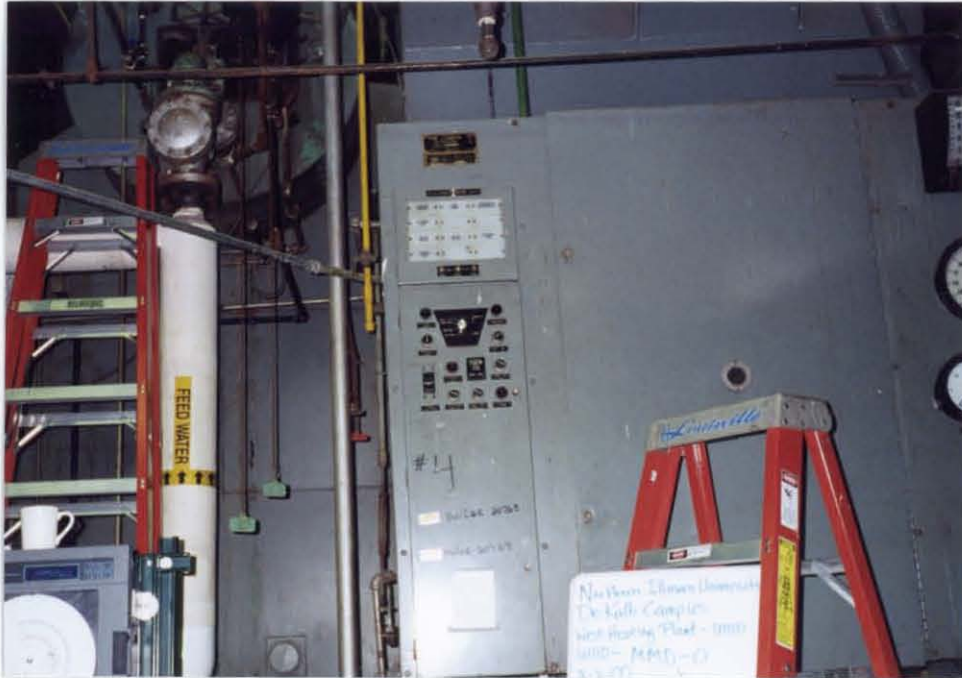
U1110 - MMD - 0  
GASKETS ON  
BOILER #4  
(ADDITION #2 -  
1966)

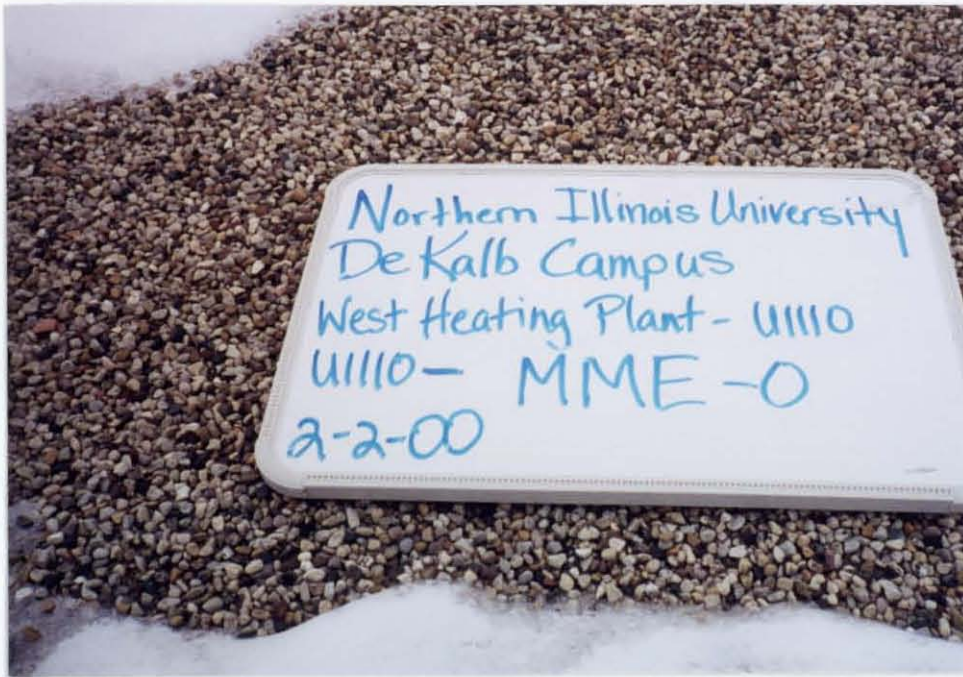
U1110 - MME - 0  
BUILT-UP ROOF  
(Original Building -  
1962)

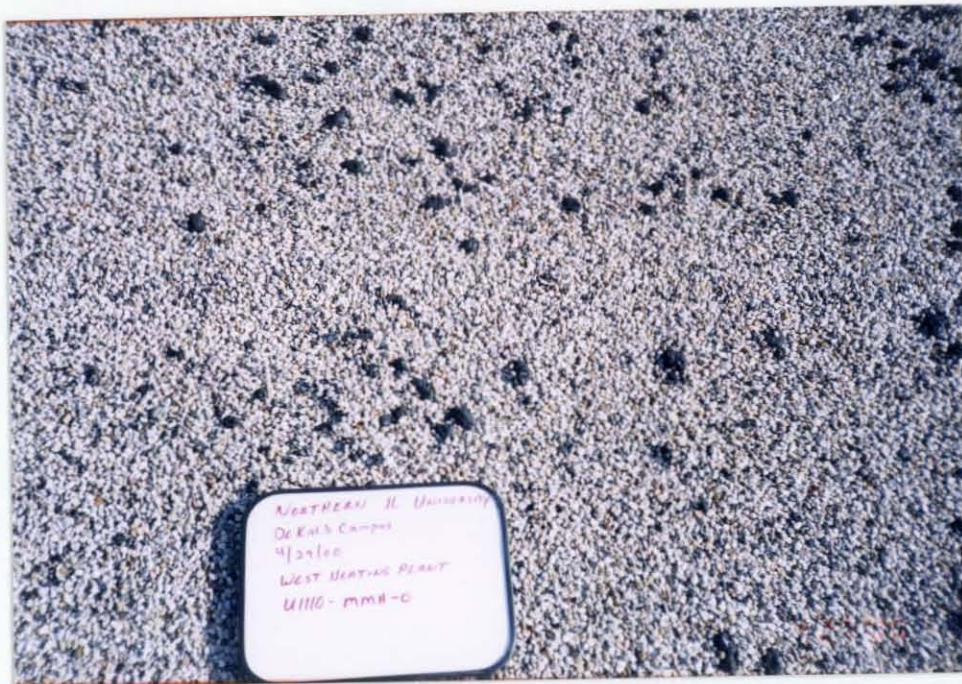
U1110 - MMH - 0  
BUILT-UP ROOF  
(Addition #3 - 1979)

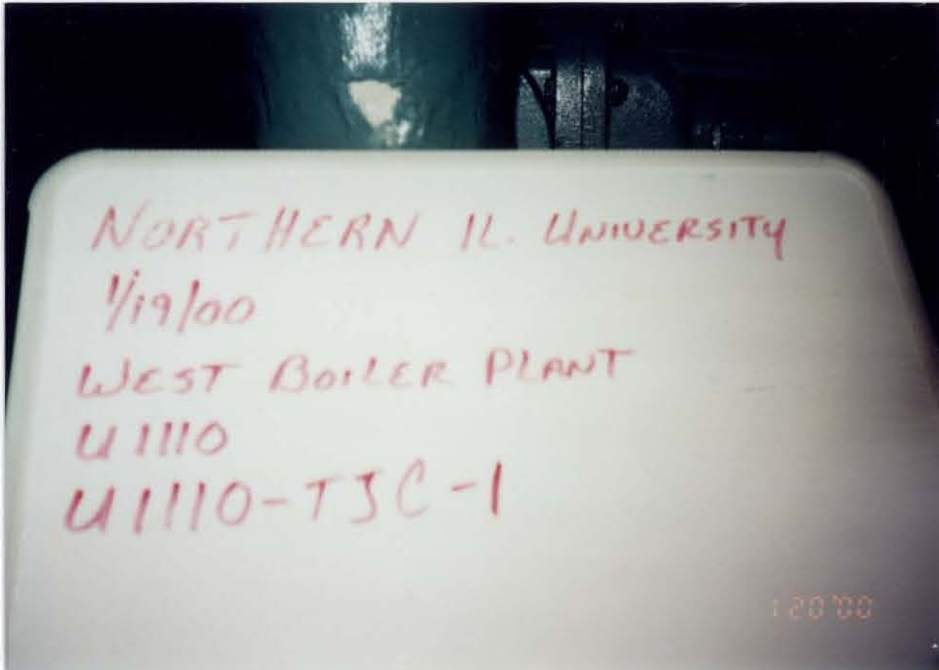
U1110 - TJC - 1  
FITTINGS ON  
FIBERGLASS PIPE  
INSULATION  
(ADDITION #2 -  
1966)

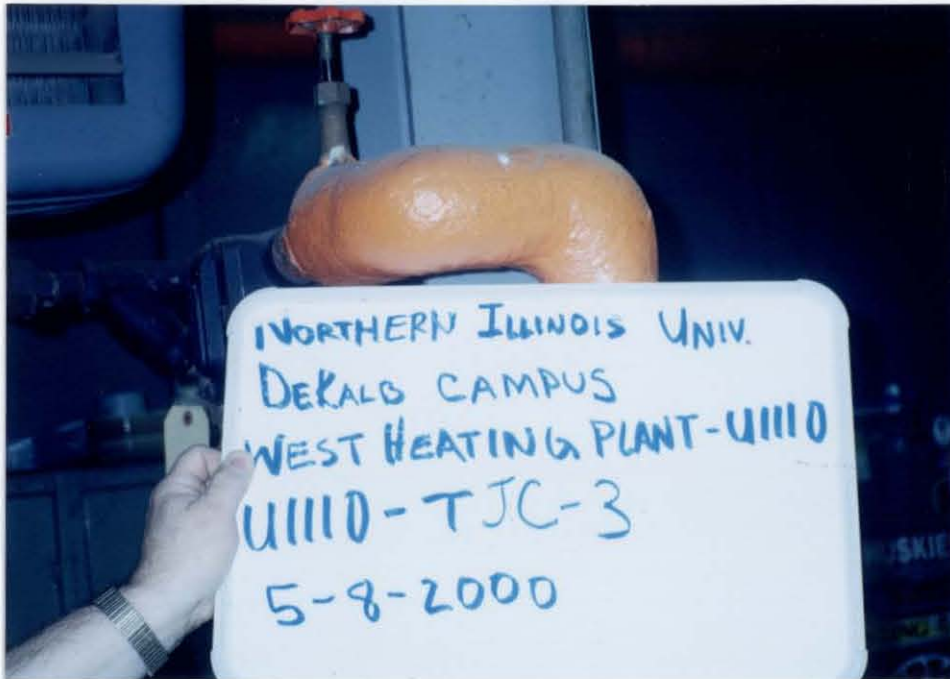
U1110 - TJC - 3  
FITTINGS ON  
FIBERGLASS PIPE  
INSULATION  
(ADDITION #2 -  
1966)

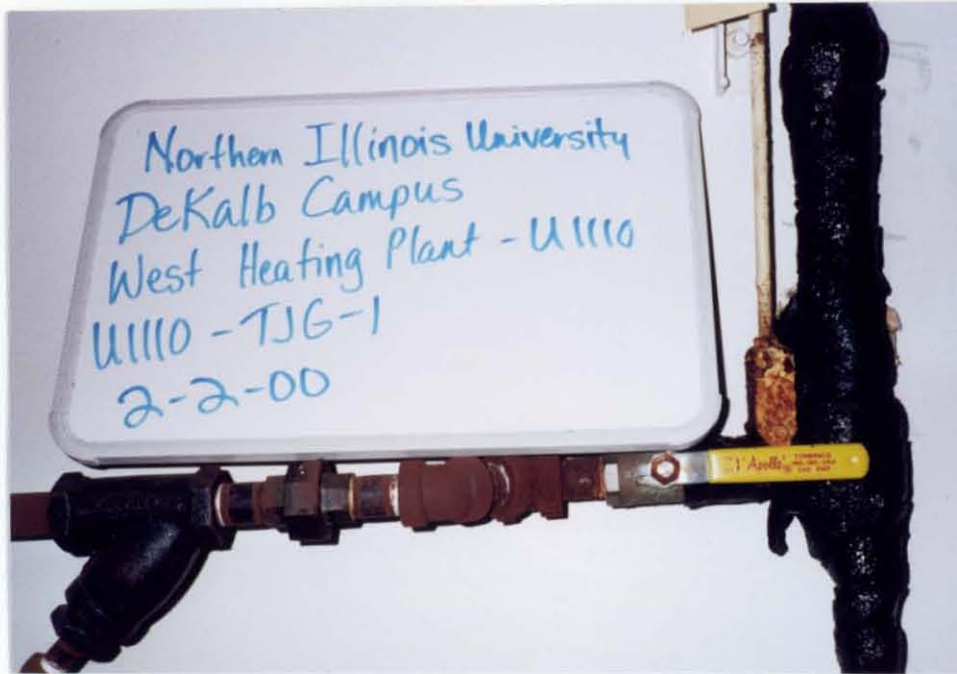
U1110 - TJG - 1  
BLACK PIPE  
FITTING (PATCH)

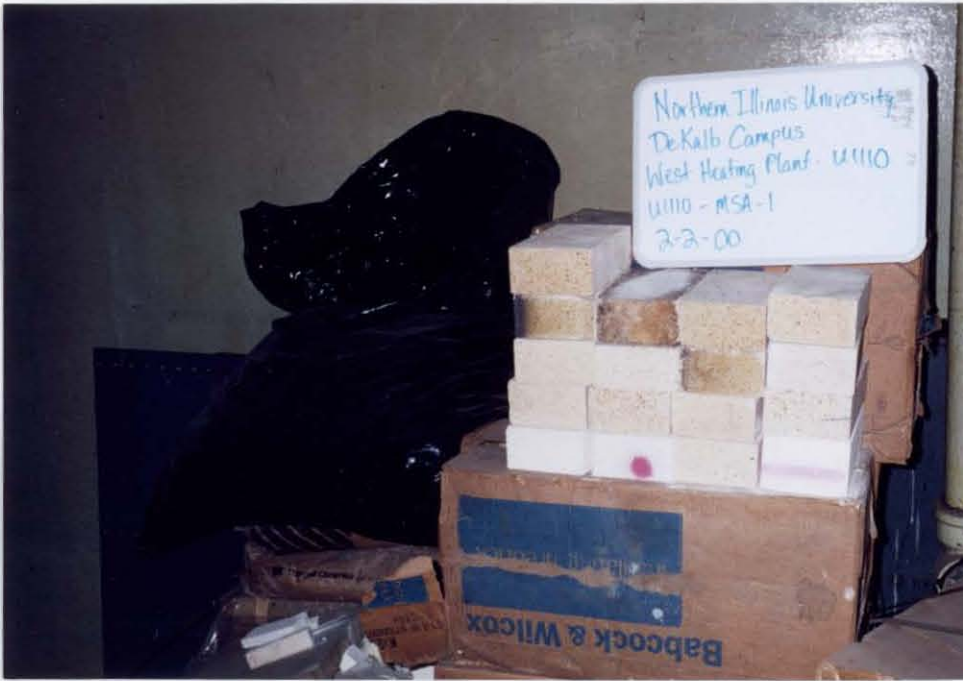
U1110 - MSA - 1  
4" X 7" FIRE BRICK

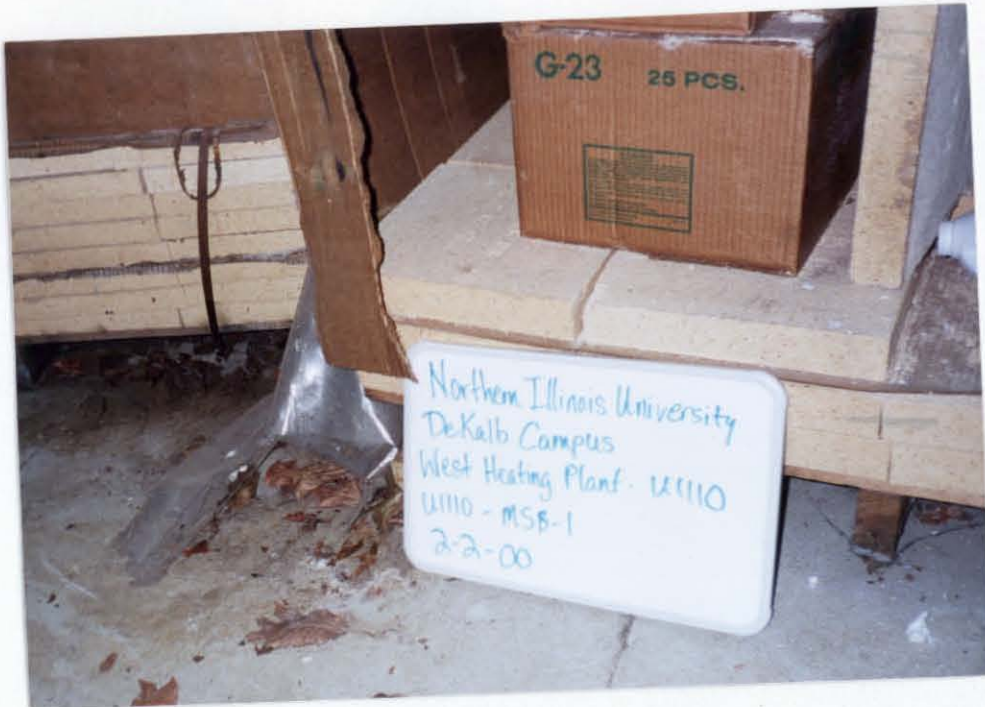
U1110 - MSB - 1  
12" X 12" FIRE  
BRICK
