Asbestos Survey and Lead-Based Paint Sampling Report

SIUE Health Sciences Building 220

September 1, 2021

Terracon Project No. 15217051

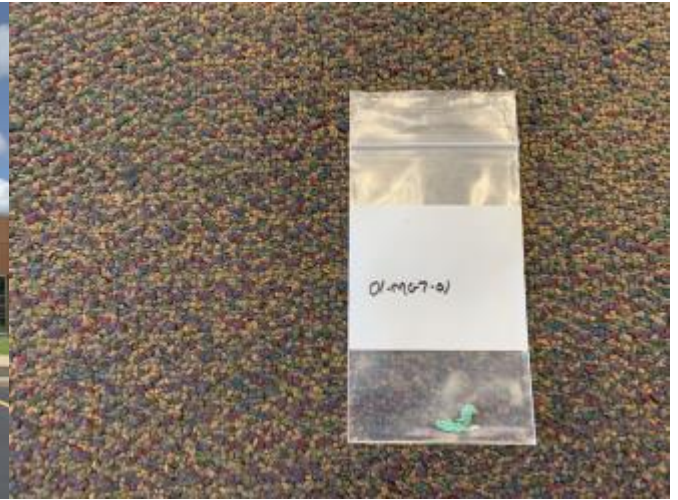
Photo 2: HA 01, green carpet adhesive located in study room, pharmacy lab, room 1027, and offices.

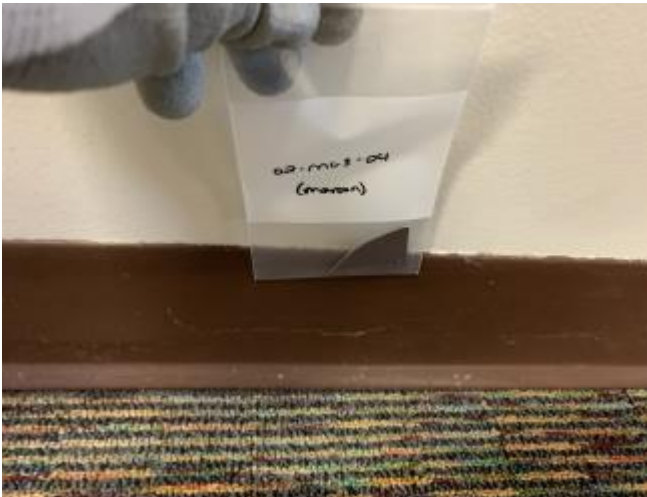
Photo 3: HA 02, 4" maroon cove base and mastic located in the study room.

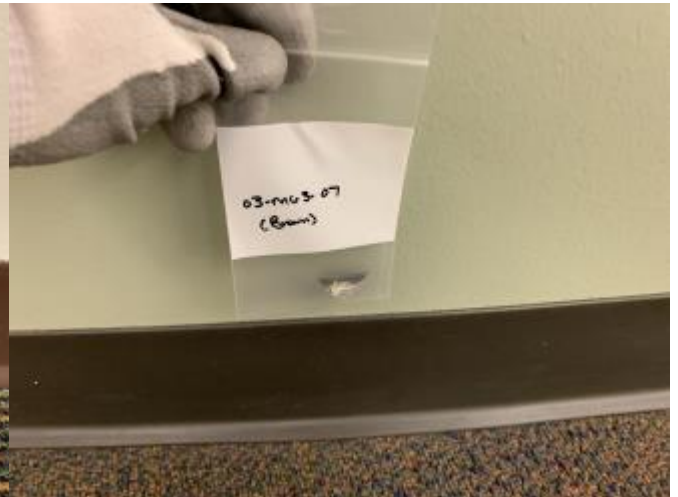
Photo 4: HA 03, 4" brown cove base and mastic located in the pharmacy lab, offices, rooms 1027, 1028, 1039, and labs 1040-1046.

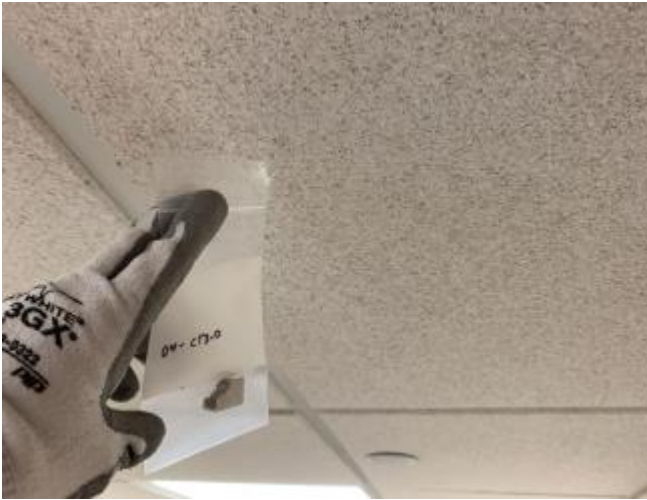
Photo 5: HA 04, 2' x 2' rough textured ceiling tiles located in the office areas.

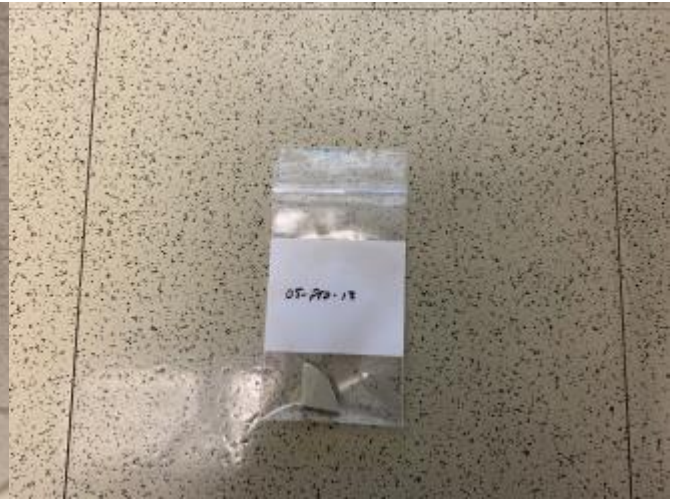
Photo 6: HA 05, 12" x 12" white w/ black dots floor tile located in rooms 1038, 1039, 1009 breakroom, and labs 1040-1046.

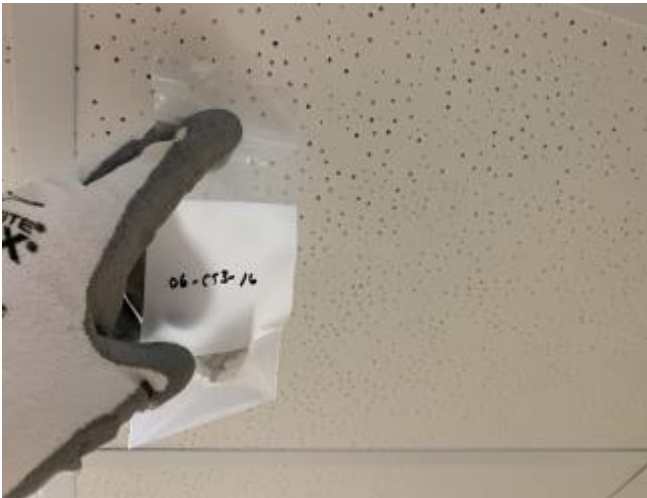
Photo 7: HA 06, 2' x 2' pinhole ceiling tiles located in rooms 1038, 1039, and labs 10040-1046.

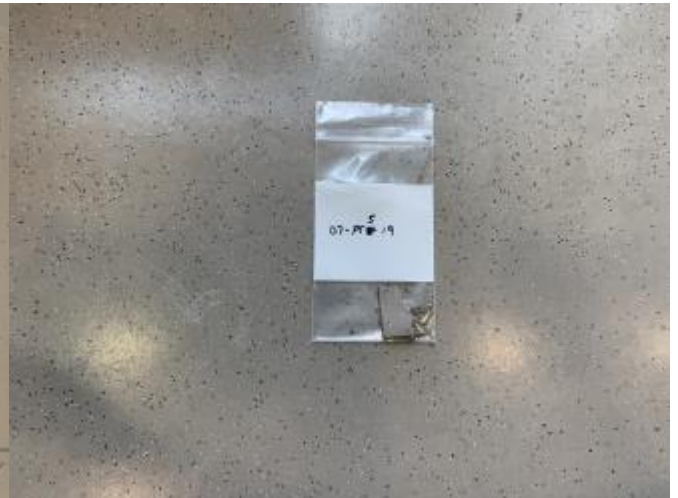
Photo 8: HA 07, grey w/ specks floor tile located in the hallways and room 1051.

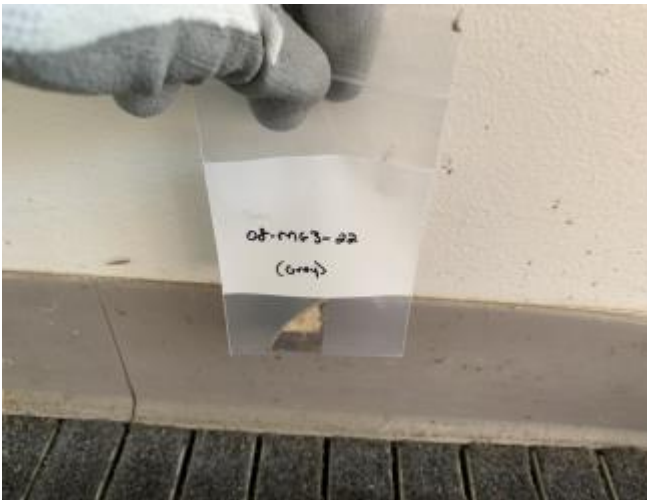
Photo 9: HA 08, 4" grey cove base and mastic located in the entries, hallways, and room 1051.

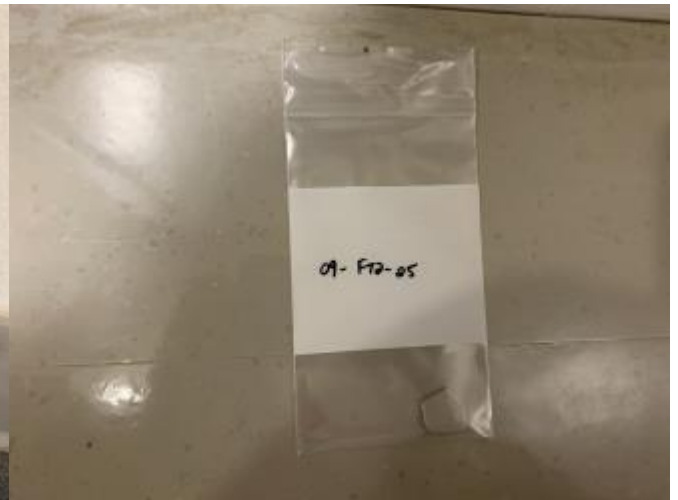
Photo 10: HA 09, 12" x 12" light grey w/ specks floor tile located by the restrooms.

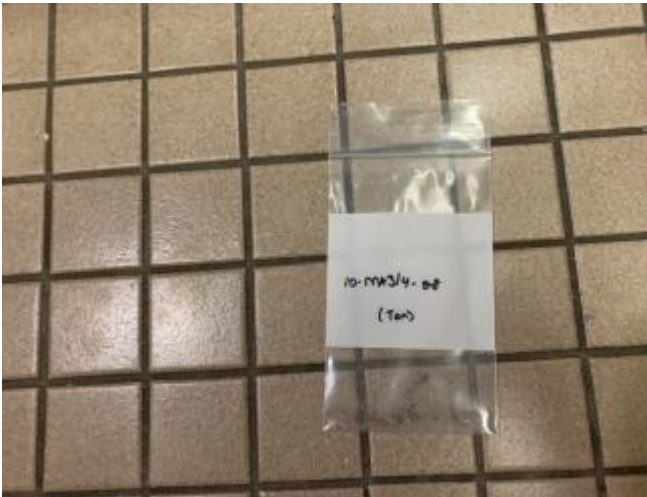
Photo 11: HA 10, 2" x 2" tan ceramic floor tile located in the restrooms.

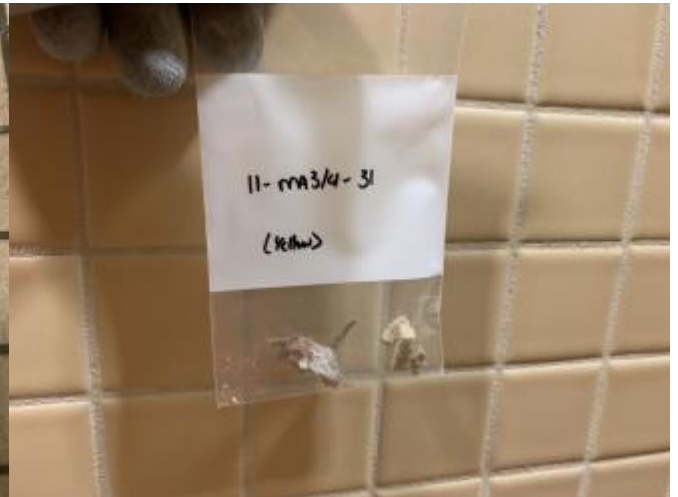
Photo 12: HA 11, 2" x 2" yellow ceramic wall tile located in the restrooms.

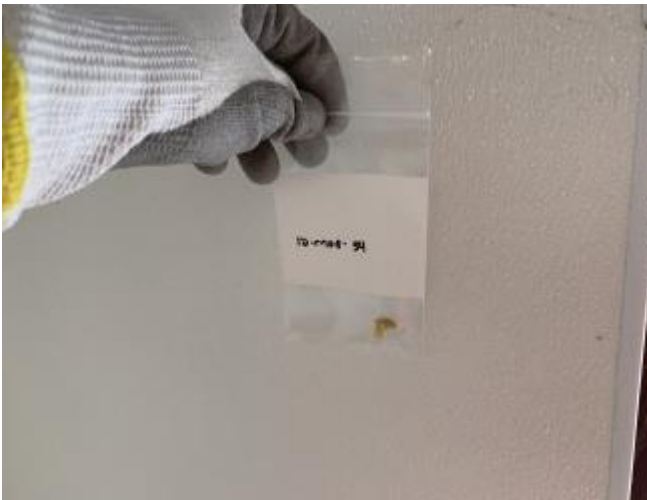
Photo 13: HA 12, fiber reinforced panel adhesive located in the exterior chemical storage room.

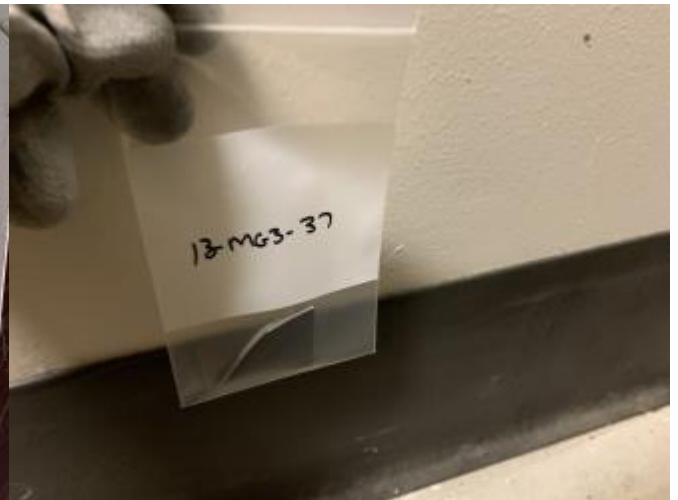
Photo 14: HA 13, 6" black cove base and mastic located in rooms 1052, 1019, and the mechanical room.

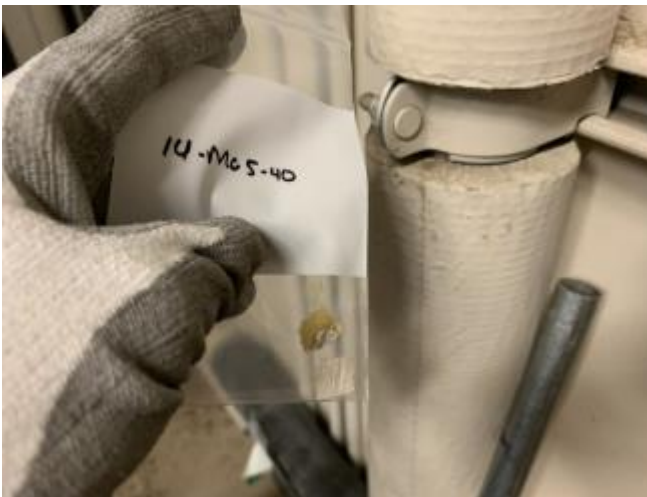
Photo 15: HA 14, white pipe end mastic located in the mechanical room and hallways.

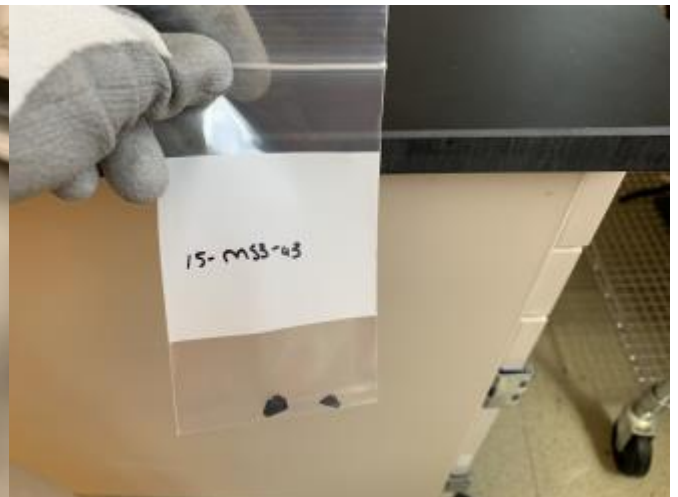
Photo 16: HA 15, black lab tabletops located in labs 1040-1046.

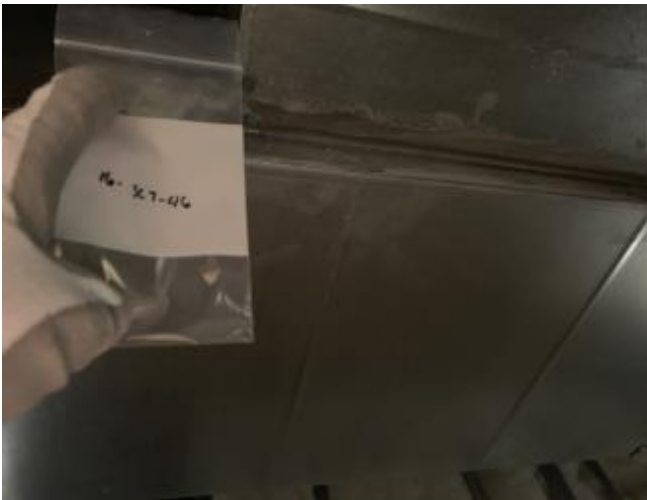
Photo 17: HA 16, grey duct sealant on the HVAC seams.

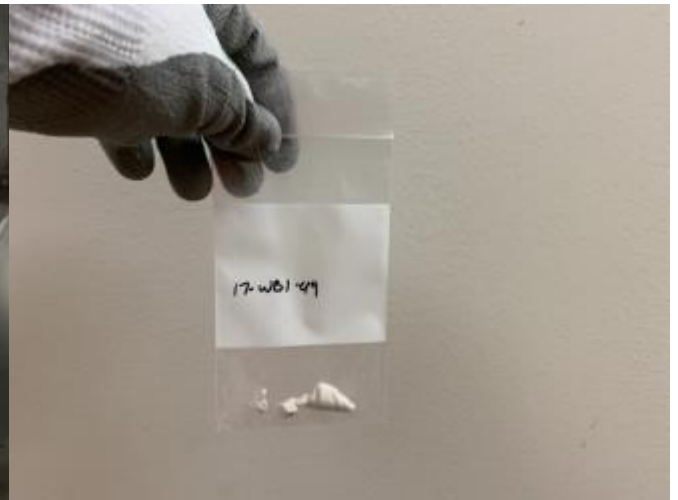
Photo 18: HA 17, drywall and joint compound located throughout the main part of the building.

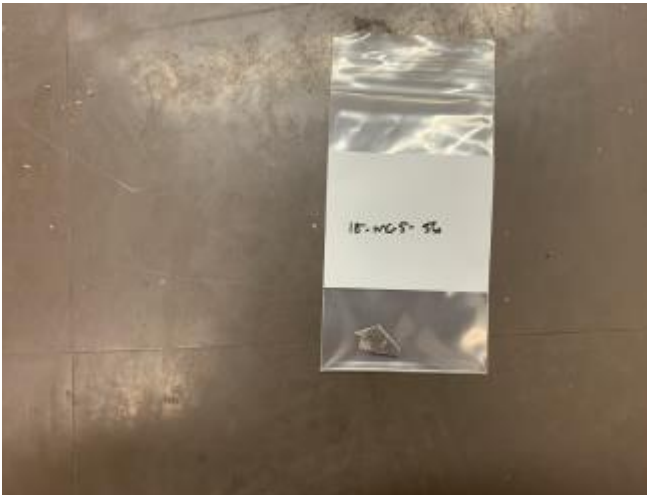
Photo 19: HA 18, mastic under rubber floor located in the storage room in the study room.

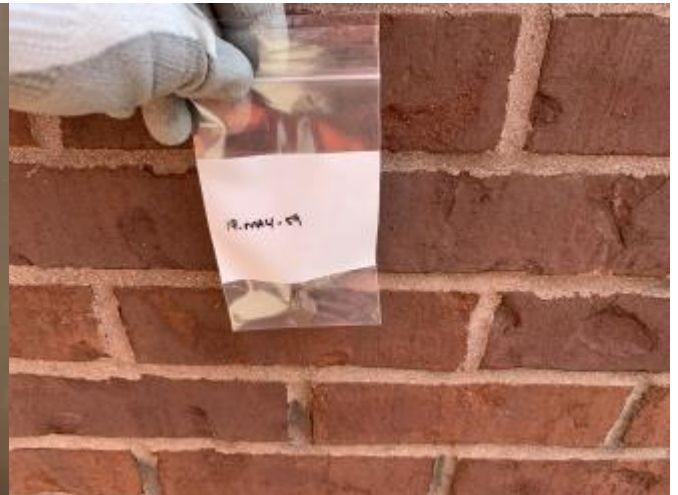
Photo 20: HA 19, brick grout located on the exterior.

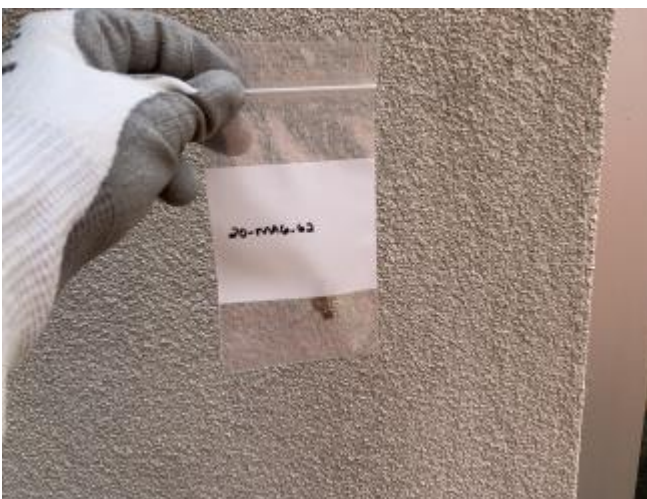
Photo 21: HA 20, stucco located on the exterior back entrance wall and overhang.

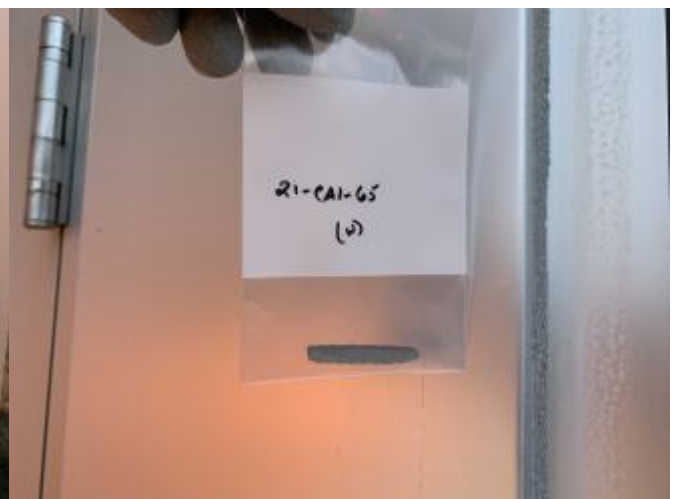
Photo 22: HA 21, white window caulk located on the exterior windows.

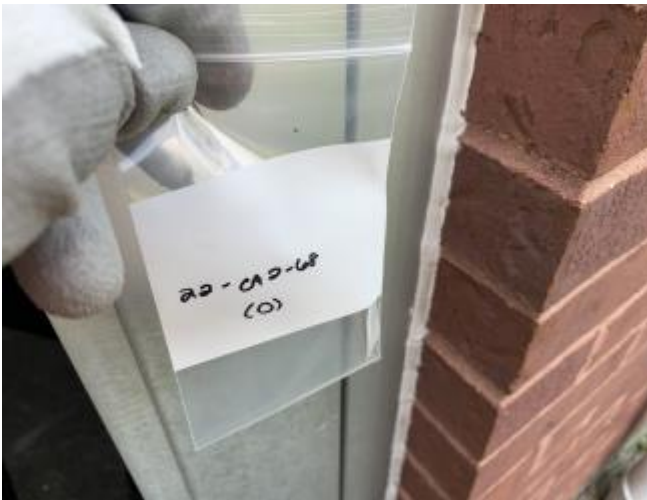
Photo 23: HA 22, white door caulk located on the exterior doors.

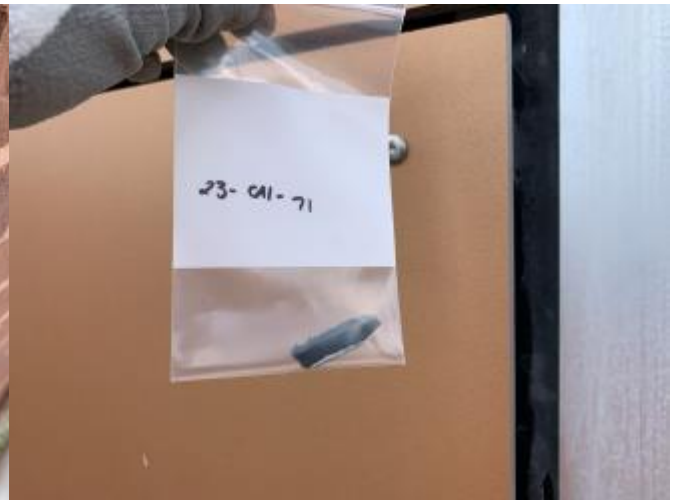
Photo 24: HA 23, black window caulk located on the front exterior windows.

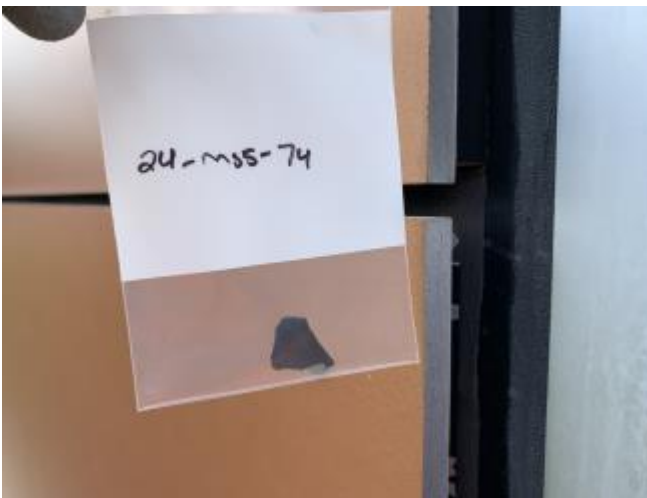
Photo 25: HA 24, black vapor barrier located behind the exterior wall panels.

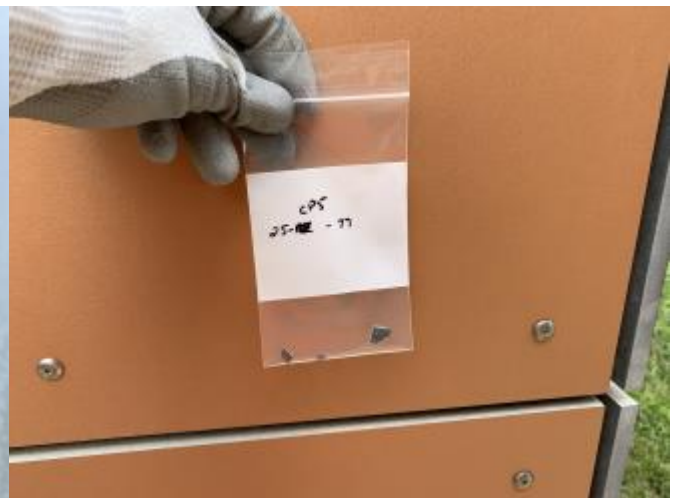
Photo 26: HA 25, cement board panels located on the front exterior.

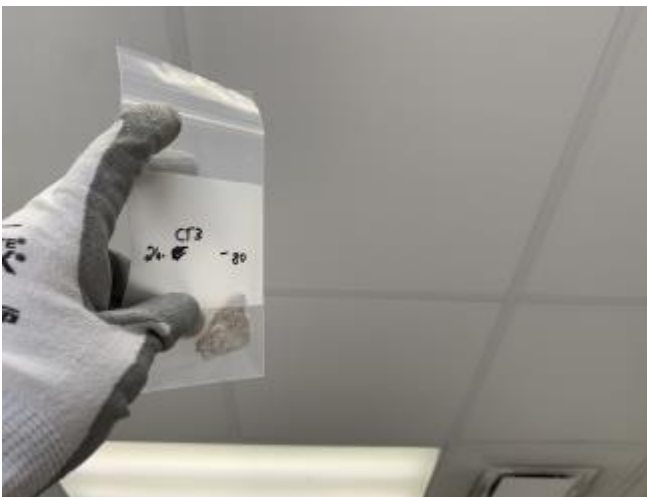
Photo 27: HA 26, 2' x 2' white ceiling tiles located in the exterior chemical storage room.

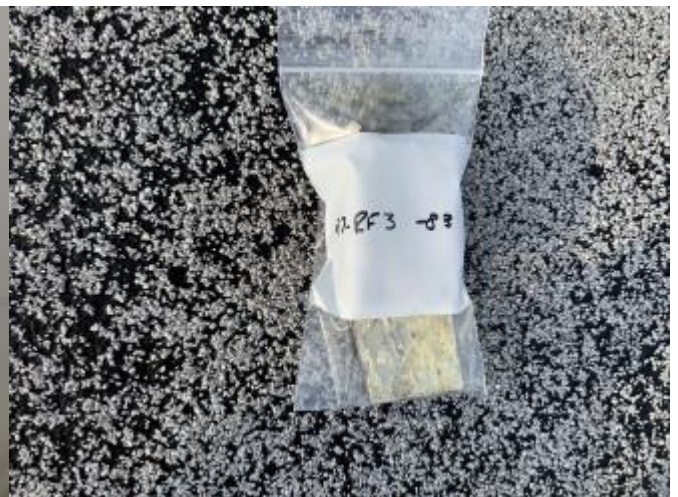
Photo 28: HA 27, rolled shingles located on the roof of the main building.

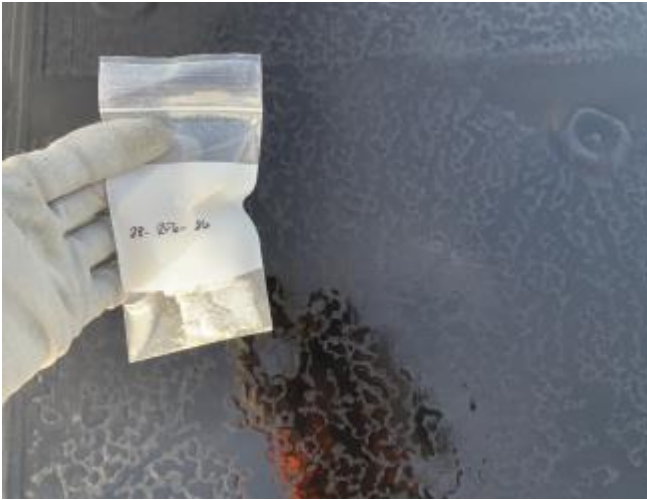
Photo 29: HA 28, black membrane located on the study room roof.

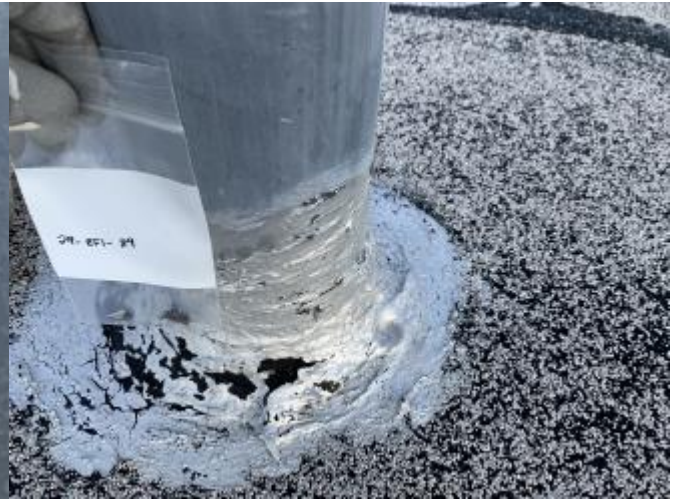
Photo 30: HA 29, black tar with silver paint located around the base of vents and HVAC on the main roof.

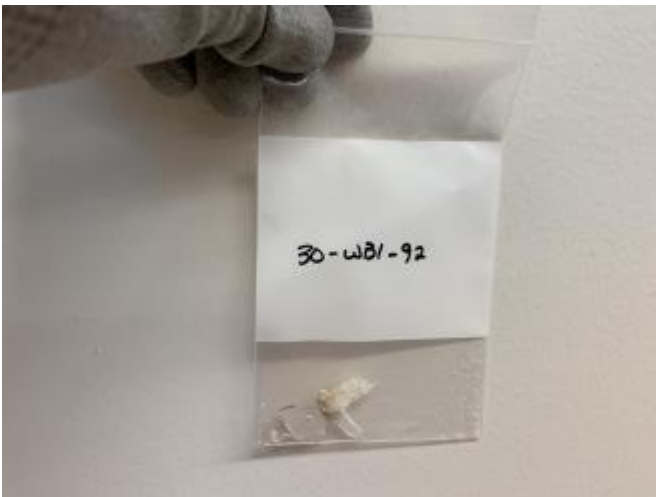
Photo 31: HA 30, drywall and joint compound located in the study room.

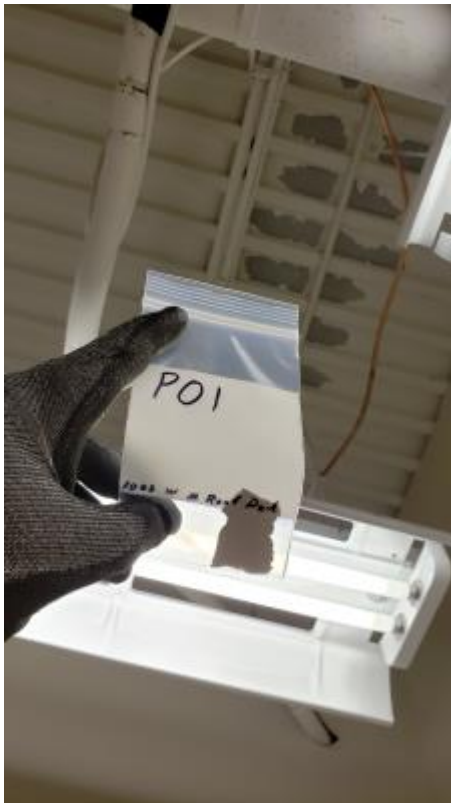
Photo 1: P01, white paint on metal roof deck.

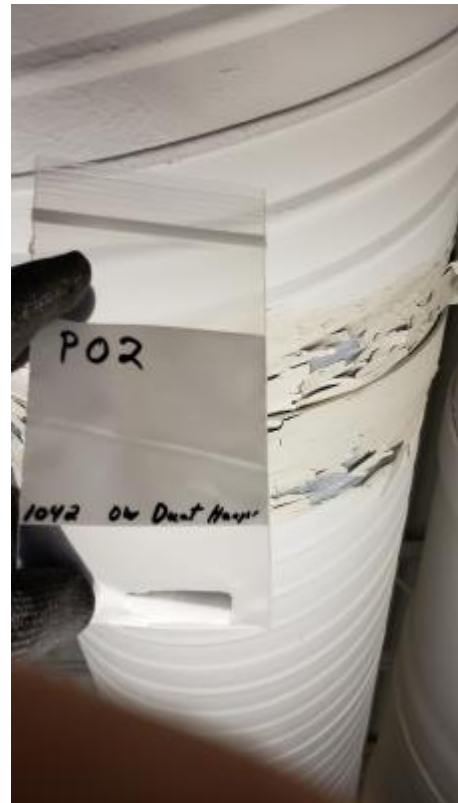
Photo 2: P02, off-white paint on duct hanger metal.

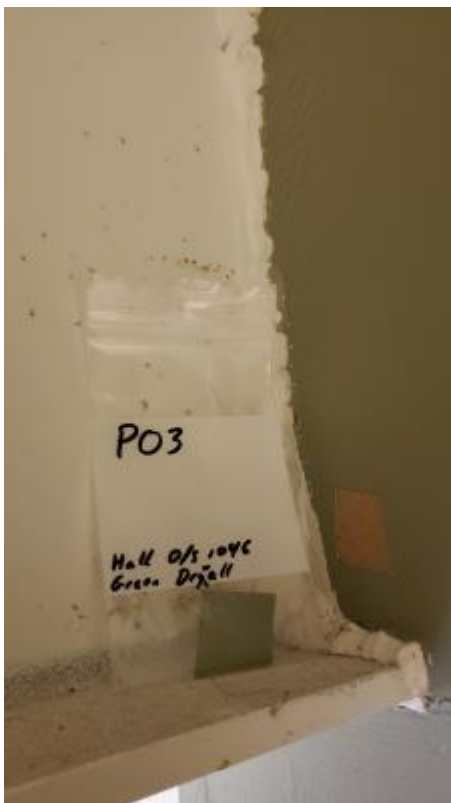
Photo 3: p03, green paint on drywall.

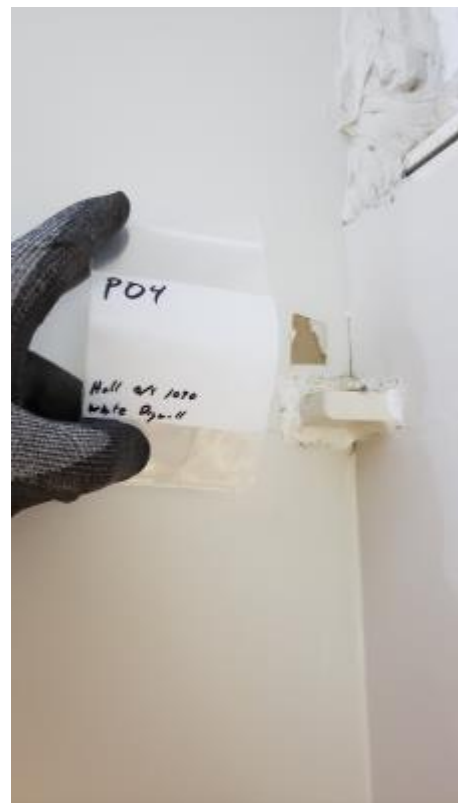
Photo 4: P04, white paint on drywall.

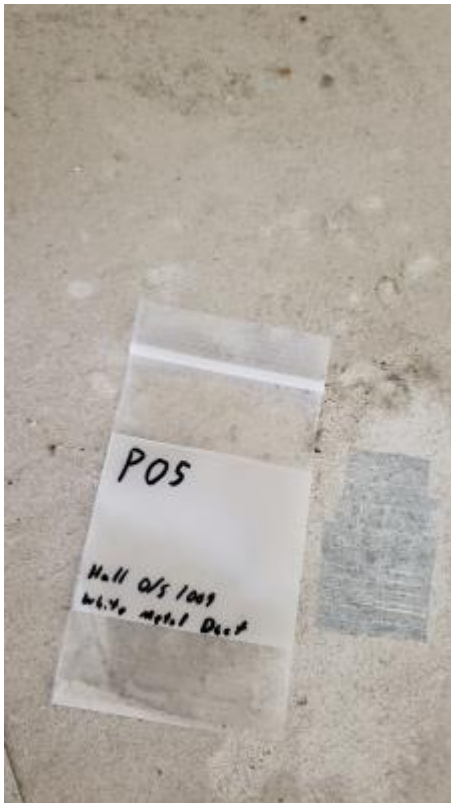
Photo 5: p05, white paint on duct work.

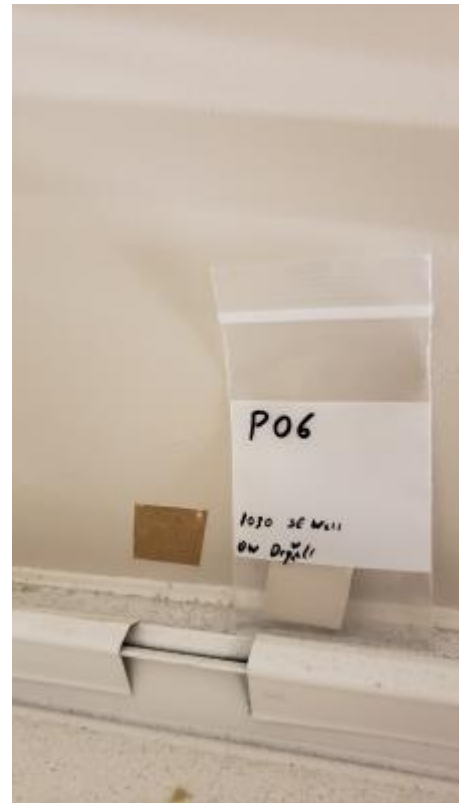
Photo 6: P06, off-white paint on drywall.

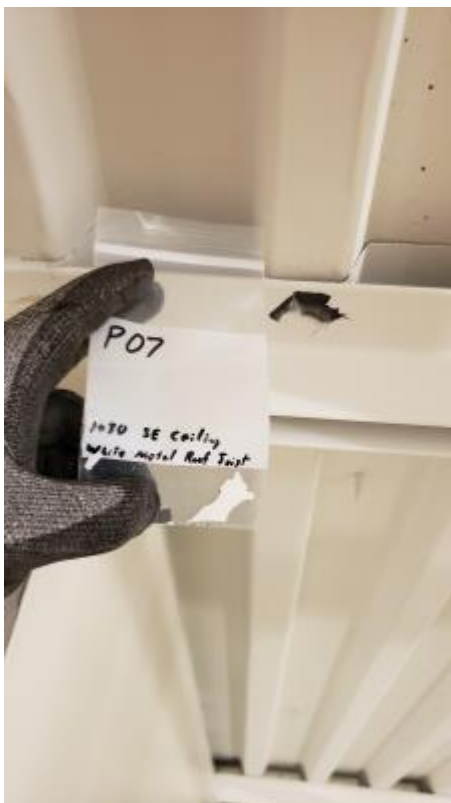
Photo 7: P07, white paint on metal roof joint.

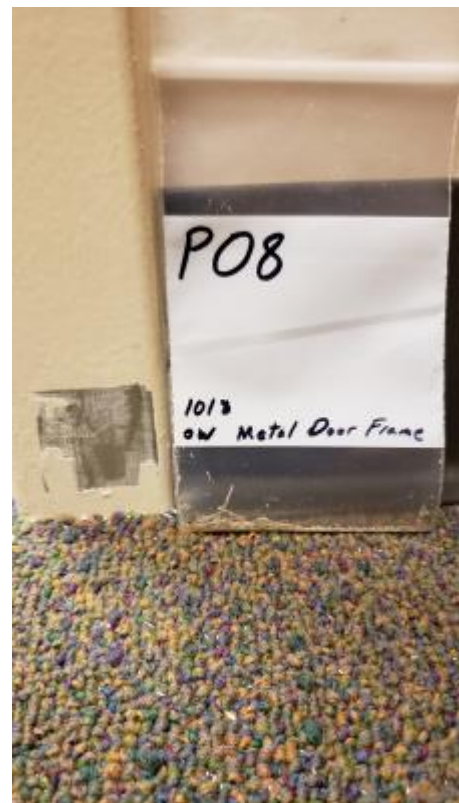
Photo 8: P08, off-white paint on metal door frame.

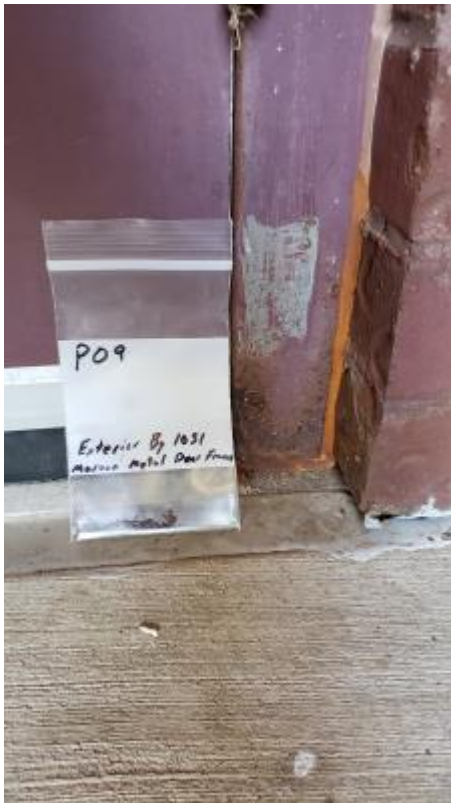
Photo 9: P09, maroon paint on metal door frame.

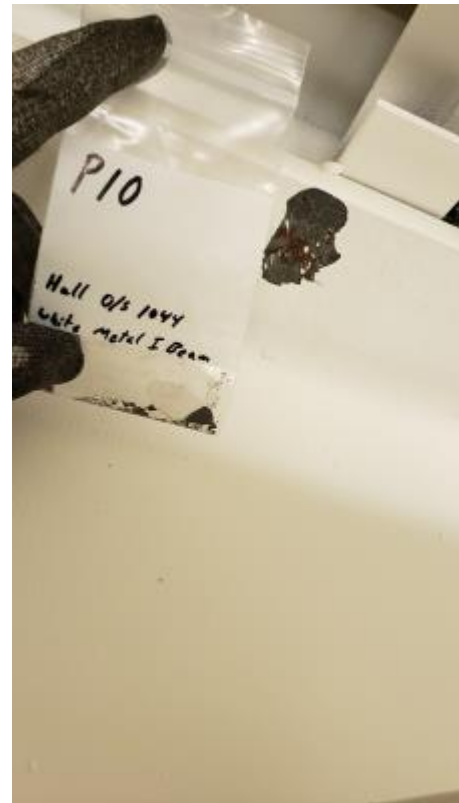
Photo 10: P10, white paint on metal I-beam.

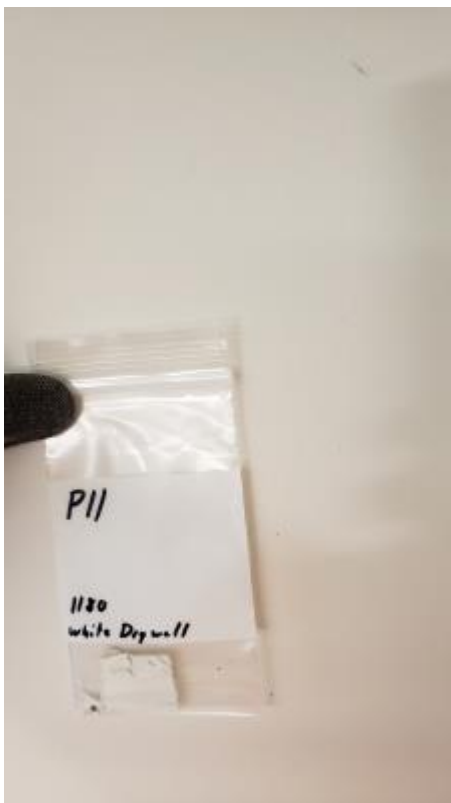
Photo 11: P11, white paint on drywall.

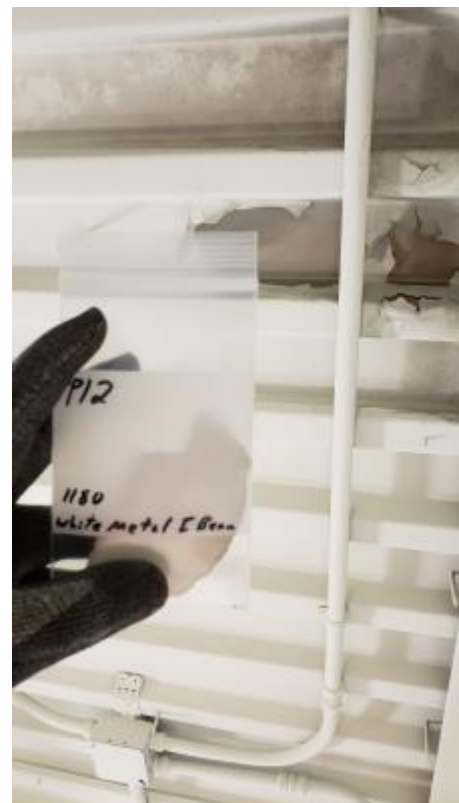
Photo 12: P12, white paint on metal I-beam.
