4.01 EXISTING CONDITIONS REPORTS

This Southern Illinois University Edwardsville (SIUE) Health Sciences Assessment Report considers the landscape within the property boundaries of SIUE Building 200 and Building 220, located on University Drive in Edwardsville, Madison County, IL. This assessment also takes into consideration provided campus standards and connections to the rest of the SIUE campus

This assessment addresses the exterior and interior architectural components of two existing buildings on the SIUE campus, known as Building 200 and Building 220. This report is based solely on visual observation of the buildings and does not involve any testing, removal or demolition of existing components, or other invasive methods to determine existing conditions.

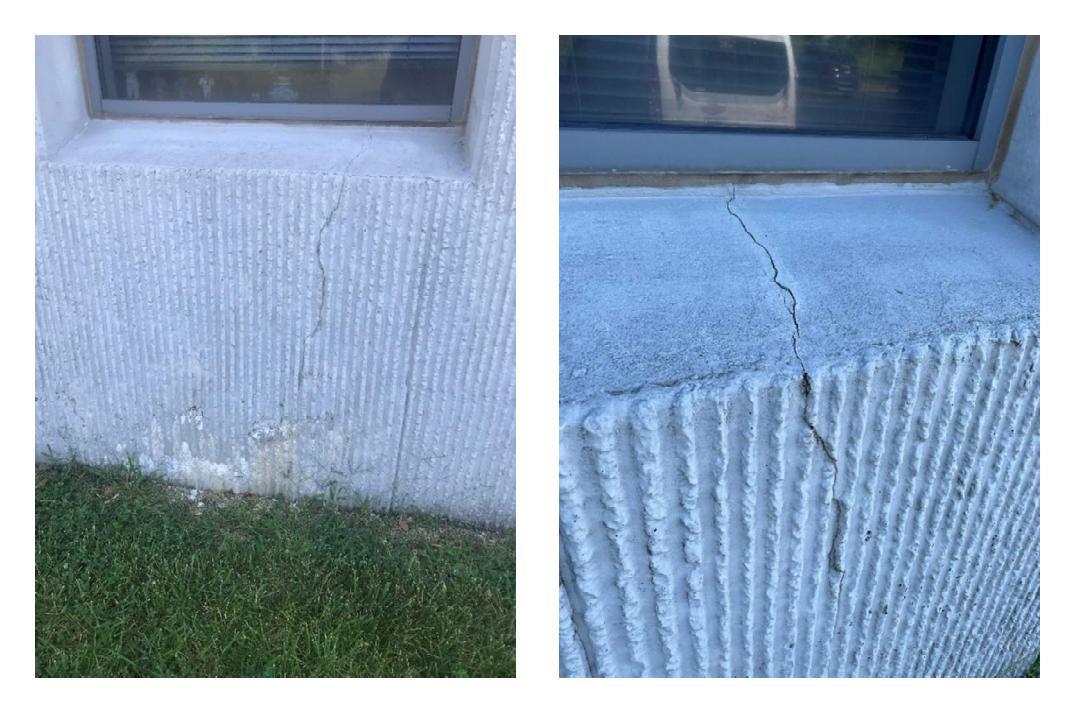
2.1.03.2.1 Figure 1: Examples of cracking, spalling, and failing finishes

The lower level walls of building 200 are primarily cast in place concrete, sloped outward from the vertical plane, with a vertical ribbed, bush-hammered finish. Where lower level walls are not aligned with upper level walls they extend vertically to create parapet guards/fall protection at the upper level terraces. These walls appear to be in fair condition with some cracking, spalling, and peeling paint finishes. Raw concrete is exposed in several areas. Some cracks are significant and may indicate water penetration into the wall assemblies. Refer to the structural assessment for specific observations of concrete walls. Where grass lawn is adjacent to the building there is residual discoloration and finish failures resulting from lawn maintenance. There are some areas, particularly on the north end of the building, where walls are showing signs of mold growth and discoloration from contact with the trees and plantings touching the building.

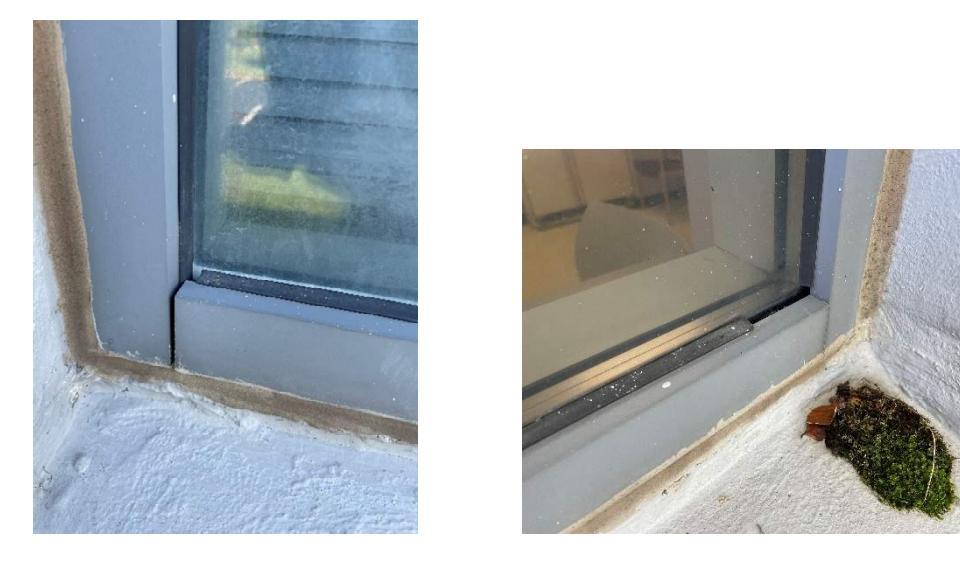
2.1.03.2.1 Figure 2: Window Frames at Lower Level

Openings at the lower level consist of punched window assemblies built in cast wall openings, storefront vestibules and entrance doors at the primary entrances, and hollow metal doors at secondary entrances. Punched windows are metal framed double pane assemblies. Heavy perimeter sealant is aged and displays cracking, shrinking, discoloration, and is missing in some areas. Some joints at metal frames have significant gaps. Gasketing at these windows is partially missing at several instances. Air can be felt passing through the window assemblies where gasketing is compromised. These areas are also susceptible to water penetration into the wall assembly.

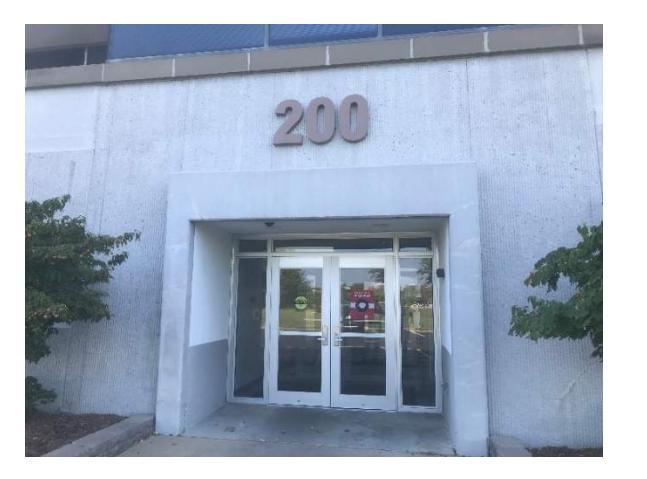
2.1.03.2.1 Figure 3: Lower Level Entrance

Two entrances to the lower level are similar installations of storefront framing, glazing, and doors creating vestibules set back from the face of the wall in concrete and stucco finished insets. Doors, landings, and thresholds are displaying signs of age but are in good condition. Some components such as door bottom rails and hardware may not be considered in compliance with current accessibility codes and standards. Some retro fitting such as door actuators are installed in some locations which may address door hardware and function concerns. Hollow metal doors servicing the south wall of the building are in good condition. Door leaf and hardware finishes show signs of age such as chalking and pickling, and normal wear and tear for a shipping and receiving area. Concrete walks and landings at the lower level are in fair condition with some sinking and heaving displayed, and missing sealant at areas such as where the walk is adjacent to the building.

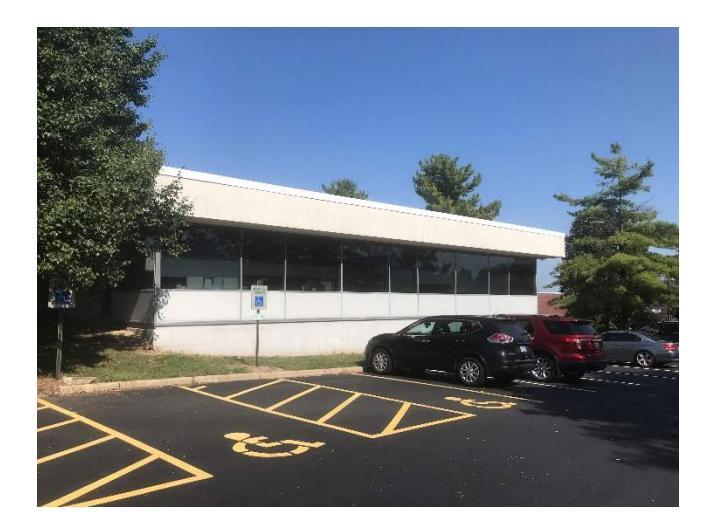
2.1.03.2.1 Figure 4: Partial East Elevation

Metal panel and glazed wall assemblies are in fair condition. Glazing gaskets are aged but complete and no indications of cracking or seal failure were observed. Metal panel finishes are aged and finishes are oxidized showing chalking, fading, and discoloration. Some minor damage to the metal panels has resulted in dents and rust in several locations.

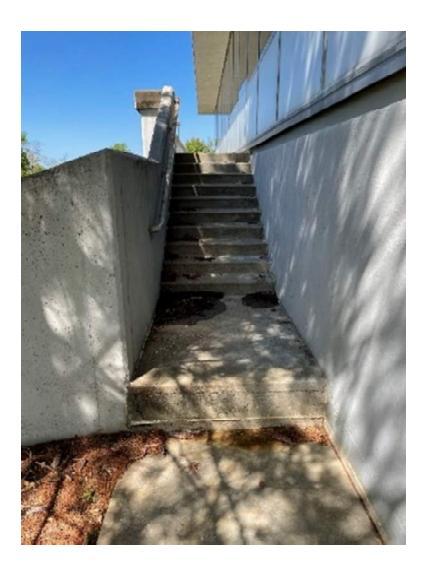
2.1.03.2.1 Figure 6: South Stair to Exterior Terrace Level

Exterior concrete stairs provide access to the upper level terraces at both the north and south ends of the building. At the south stair the concrete stair run is in good condition, however, the lower level landing has sunk far below its original elevation creating a very tall first riser. There are metal handrails at one side at each stair, each with deteriorated finishes. Handrails are approximately 32 inches above stair nosings and landings. The parapets of the lower level walls act as fall protection guards at the terraces. These walls are approximately 36-40 inches above the terrace walking surfaces. Finishes on the parapet walls are failing, displaying significant peeling and cracking, with several areas of exposed raw concrete. Precast concrete caps at terrace parapet walls are in good condition showing discoloration from age, joints appear to be maintained but in need of new sealant.

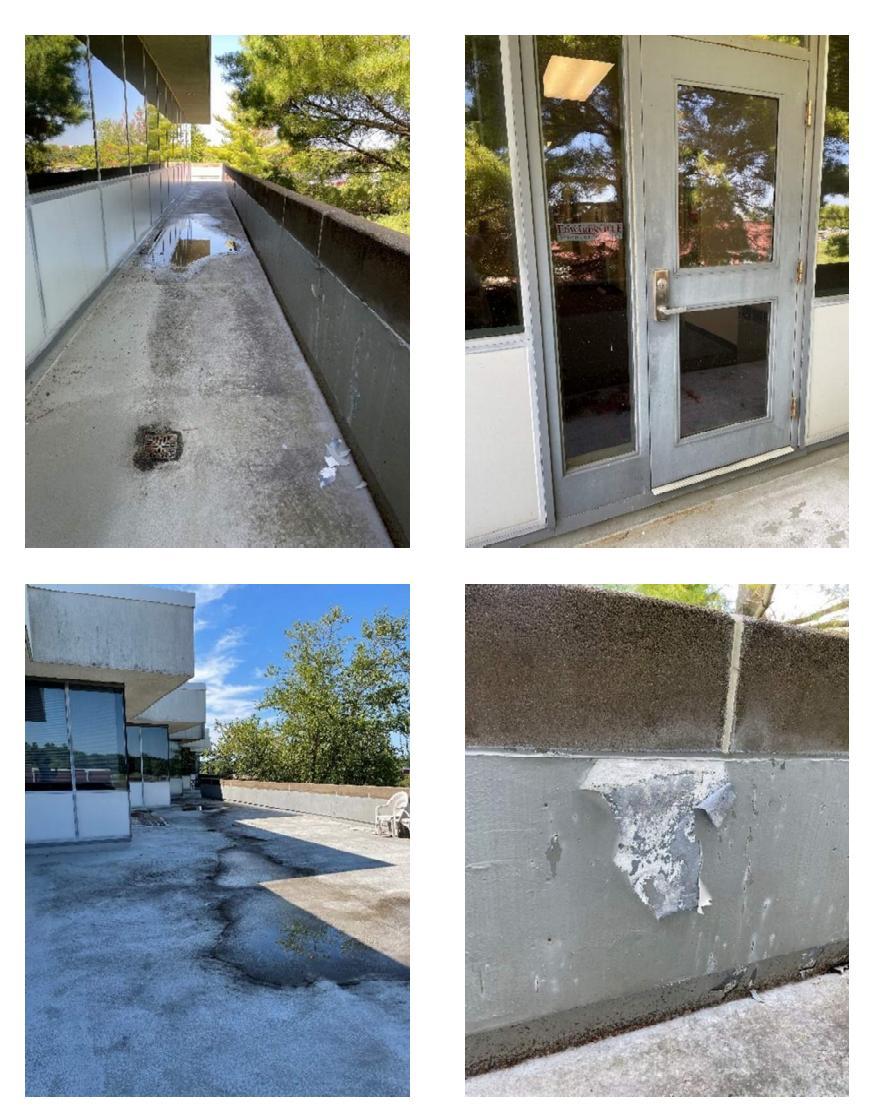
2.1.03.2.1 Figure 7: Typical Terrace Conditions

Walking surfaces at the terraces have exterior traffic-type coating that is in poor condition and quite discolored. Several areas of the terraces had pooling water and inadequate drainage despite internal drains in the terrace walk. The interior floor elevation is approximately nine inches above the terrace walk surface. There are no landings at the doors from the office suites. The doors are a variety of styles with varying stile and rail framing. Some door and frame finishes are aged and display chalking, oxidation, rust, and pitted hardware. Door hardware, bottom rail heights, and the lack of landings indicate these doors may not be considered in compliance with current accessibility codes and standards.

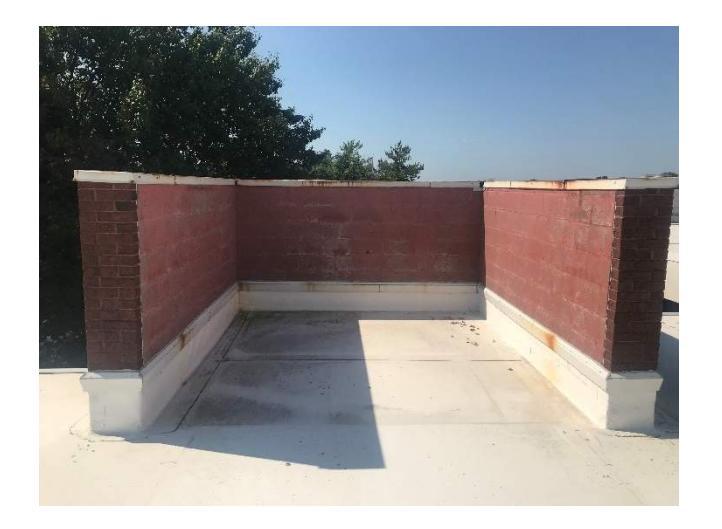
2.1.03.2.1 Figure 8: Typical Masonry Parapet Walls

The brick wall towers at the three upper level entrances extend above the roofline creating a three-sided projection capped with metal coping. The coping finishes have deteriorated, and large areas of the coping are rusting. Coping joints appear to be missing straps in some locations. Sealant at the masonry is aged, cracked, discolored, missing in some areas, and pulled away from adjacent surfaces in many areas.

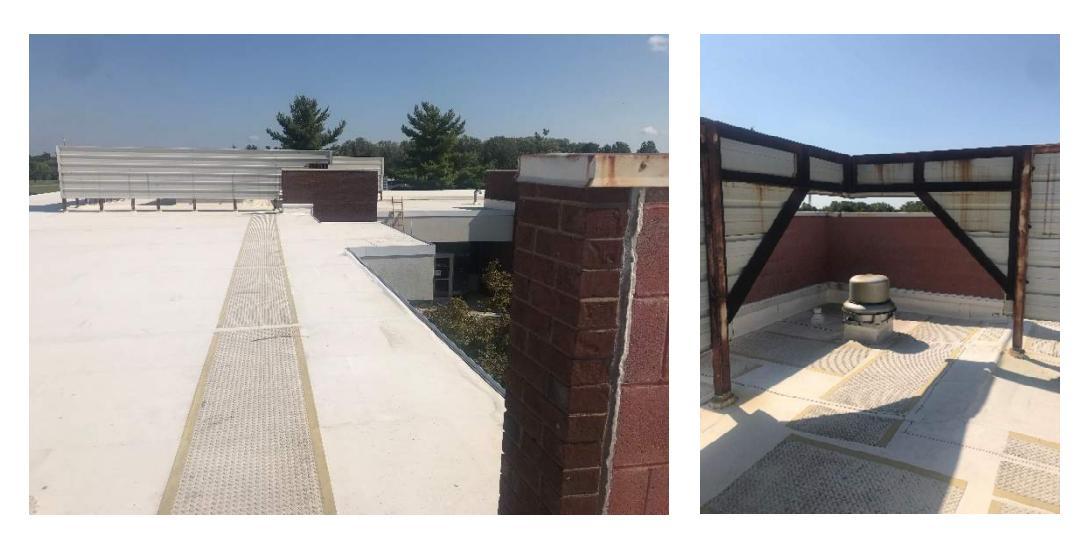
2.1.03.2.1 Figure 9: Typical Architectural Roof Components

The roof is accessed from the exterior of the building. There is no fixed roof ladder or roof scuttle. The roof is a no parapet, low-slope system with a white membrane, singular internal roof drains, and a versico edge fascia. Where the membrane meets the brick parapet walls there is an upturn of approximately 16 inches with termination bar, flashing, and sealant. Sealant in these areas is failing due to age. Flashing at the upturn is discolored and streaked from rusting fasteners. There are some areas where discoloration of the membrane indicates ponding, and areas not receiving direct sunlight have signs of mold and other surface growth. There is no discernable overflow system for roof drainage. Bulges in the membrane were observed, primarily at the perimeter of the roof. The roof membrane overlaps the expansion joint that runs through the building, no visual access to this joint is available. Roof penetrations are treated with standard boot accessories or built up curbs. Sealant at penetration assemblies is failing due to age.

Rooftop units are screened by steel tube framed ribbed sheet metal panel mechanical equipment screens. Framing steel finishes have deteriorated, and all surfaces are rusting. The metal panels are streaked from rusting framing and fasteners. Refer to the mechanical assessment for specifics on rooftop equipment.

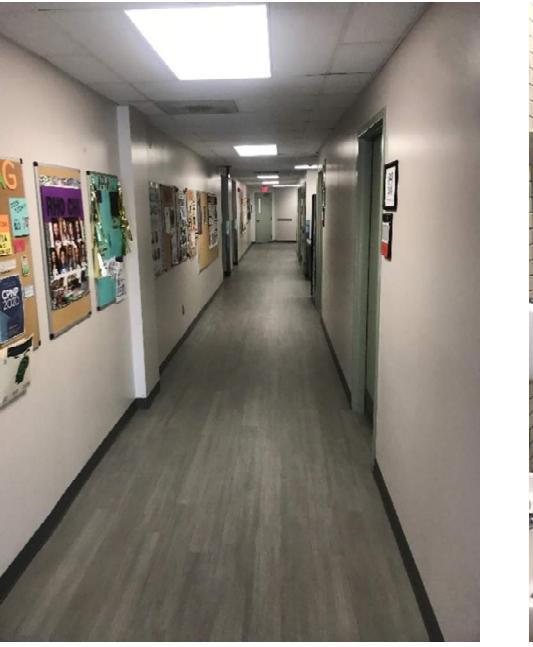
2.1.03.2.2 Figure 2: Typical Lower Level Corridor and Toilet Room Finishes

installed resilient sheet product. Floor finish was in good condition with no observed installation issues. Corridor ceilings are suspended 2x4 acoustic ceiling tile with lay-in light fixtures and ceiling devices. This ceiling is in fair condition but showing signs of age such as sag, fading, and damaged tiles. This ceiling finish is typical throughout the lower level, with the exception of some remodeled spaces which have more recent installations. All interior partitions are gypsum board finished, except for the multi-fixture toilet rooms which are ceramic tile finished. Exterior walls are gypsum board finished in public areas, with painted concrete and cmu in the stair shaft. Door hardware such as the kickstops on the toilet room doors may not be considered in compliance with current accessibility codes and standards.

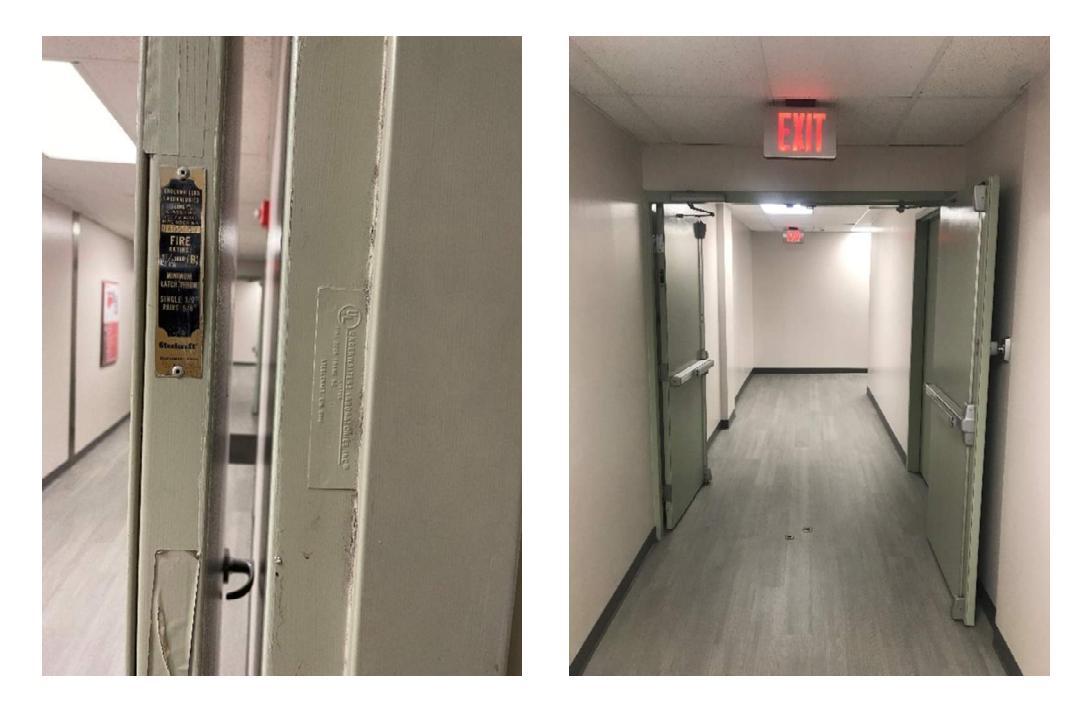
2.1.03.2.2 Figure 3: Lower Level Corridor Doors

Most corridor doors and frames appeared to be fire rated hollow metal, there were several instances where identifying labels have been painted over. A rated pair of double egress fire doors were observed at approximately the location of the building expansion joint, indicating a separation of fire areas within the building.

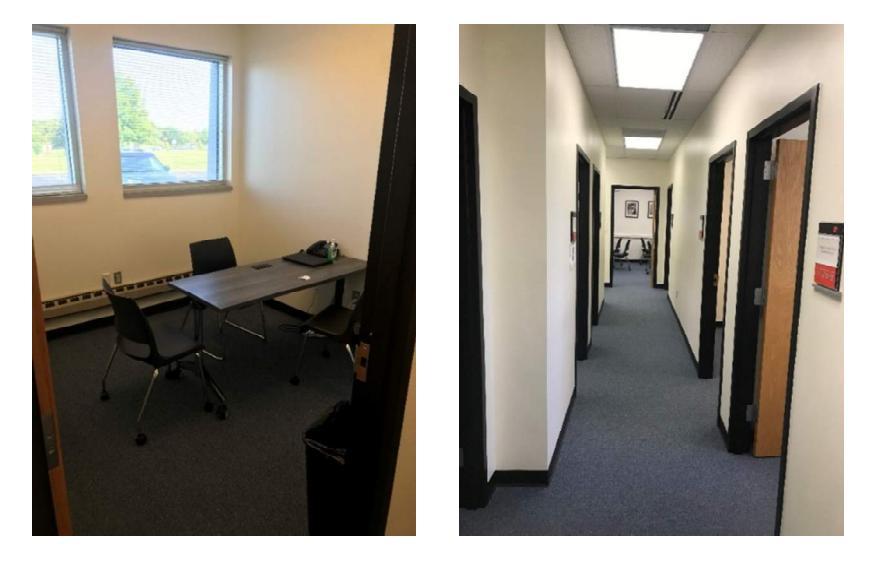
2.1.03.2.2 Figure 4: Typical Office Suite Finishes

Typical office suite finishes are carpet floor covering, vinyl wall base, painted gypsum board walls, and suspended acoustic tile ceilings. Doors within office suites are typically wood flush panel with hollow metal frames. Office suite finishes are generally in good condition and appear to have been upgraded and well maintained over the life of the building. There are some areas that are showing signs of age, such as the plastic laminate window stools delamination, and the sealant at exterior window frames shrinking and pulling away from adjacent surfaces.

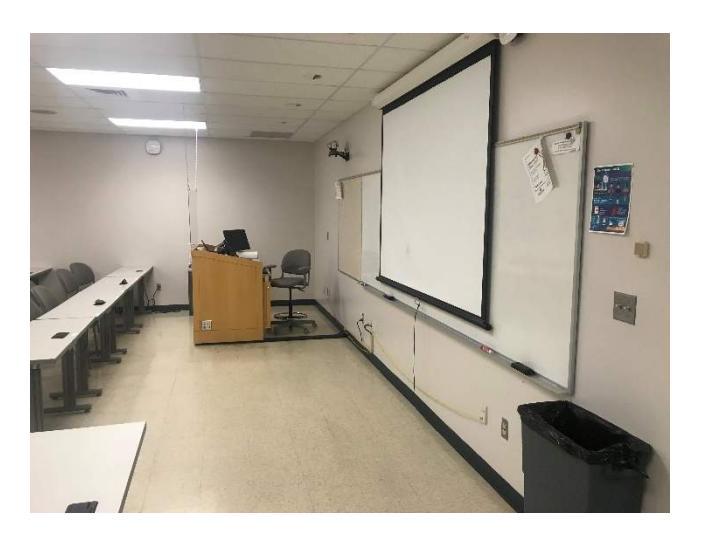
2.1.03.2.2 Figure 6: Typical Classroom

The Large Classrooms have heavily worn and discolored carpet floor finishes well beyond their life span. The remaining finishes are typical vinyl wall base, gypsum board walls, and suspended acoustic tile ceiling. Finishes in these areas show more wear and tear than office spaces, and window assemblies have similar issues with the laminate window stool and the sealant at the frames.

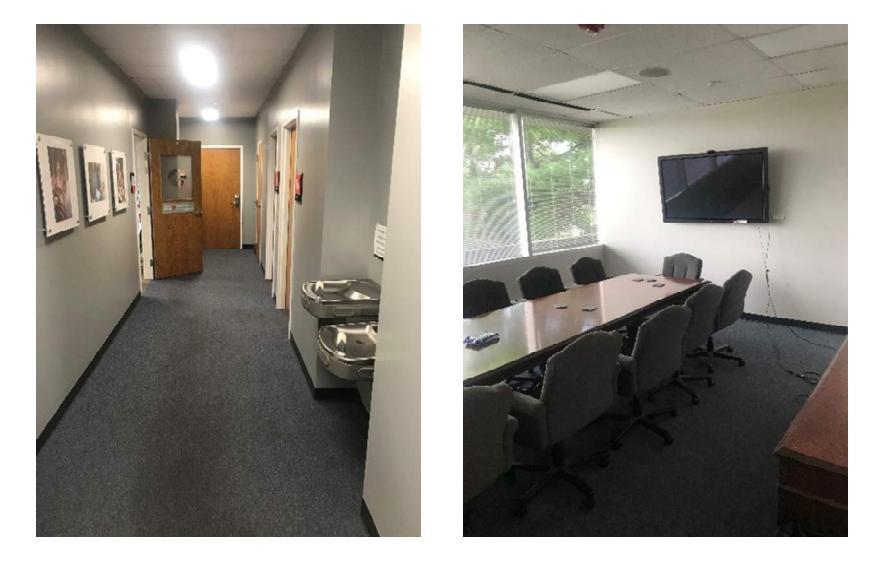
2.1.03.2.2 Figure 9: Typical Upper Level Finishes

Floor finishes in the upper level are predominately carpet with some areas of 12x12 vinyl tile in break rooms and storage/copy rooms, and ceramic tile or resilient flooring in toilet rooms. Carpet floor covering is in poor condition, discolored, stained, and heavily worn in high traffic areas, with some areas of bulging and wrinkling creating tripping hazards. With few exceptions, ceilings throughout the upper level are suspended acoustic tile. The ceiling finish on the upper level is in much poorer condition than the lower level. There are multiple instances of discoloration, staining, evidence of water leaks, and damaged or missing ceiling tiles and grid.

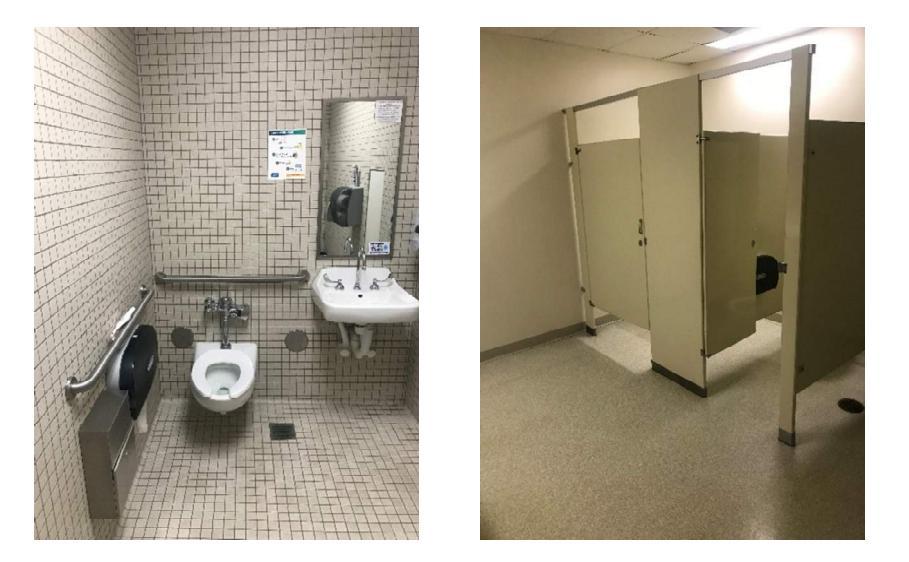
2.1.03.2.2 Figure 11: Typical Upper Level Toilet Rooms

In general, Bldg 200 toilet rooms have components and installations that may not be considered in compliance with current accessibility codes and standards. However, it did appear that most toilet rooms could be upgraded to current standards without major renovations. Toilet rooms finishes are dated, discolored, and showing high levels of wear and tear.

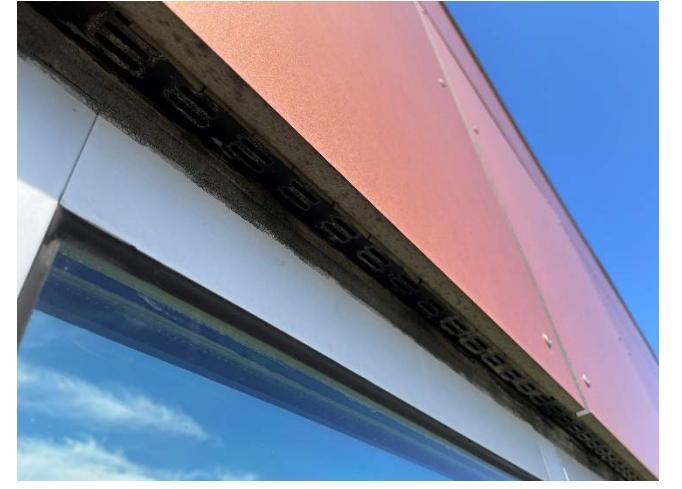
2.1.03.3.1 Figure 1: Panel Cladding Drainage at Window Head

At the northeast corner of the building the finish floor elevation is well below grade and the exterior wall reflects this with a concrete stem wall showing above grade to the sill height of the punched window openings. At the north end where the grade begins to drop this stem wall transitions to a cavity wall clad with the same large format cmu used at the parking lot entry wall and at the north wall next to the service drive. At the foundation wall this cmu has deteriorated and shifted displaying cracking and out-of-plane blocks. Above the stem wall is a laminated panel rainscreen cladding system that terminates with metal coping at the parapet. The panels are in good condition showing normal aging and minimal discoloration. There is observable delamination at the back side of the panels. The drainage channels in the cladding system appeared to be open and functioning, but some areas appeared to be directing water toward the window frame assemblies.

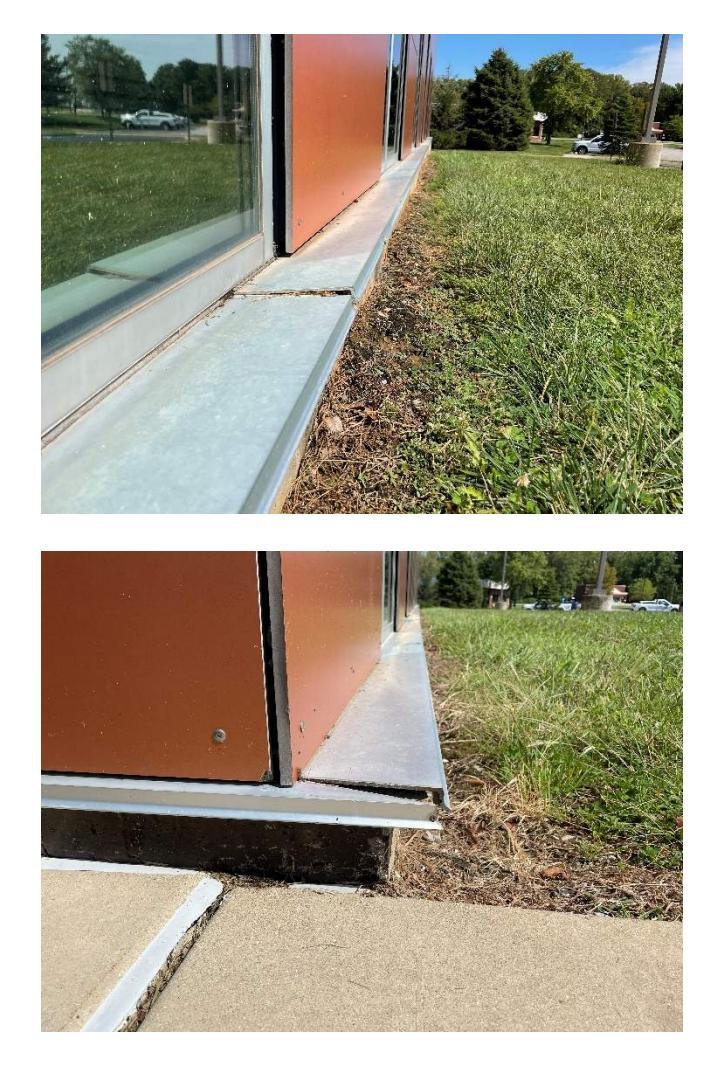
2.1.03.3.1 Figure 2: Sill Flashing at Panel Cladding and Windows

The metal sill flashing at the base of panels/top of stem wall is back pitched, directing water towards the window frame sills and base of panel wall. This flashing is butt-jointed and does not appear to have any counter-flashing or redundancy in the joint system. Sealant at these joints has failed and separated from adjacent surfaces or is missing. The joints are further exposed by warping and twisting of the sill flashing resulting in significant gaps. Residual water and wet organic matter from the lawn were observed under the panel cladding on top of the sill pan. At the metal framed windows perimeter sealant is aged beyond its lifespan, cracked, pulled away from adjacent surfaces. These conditions are prone to directing water into the exterior wall assemblies.

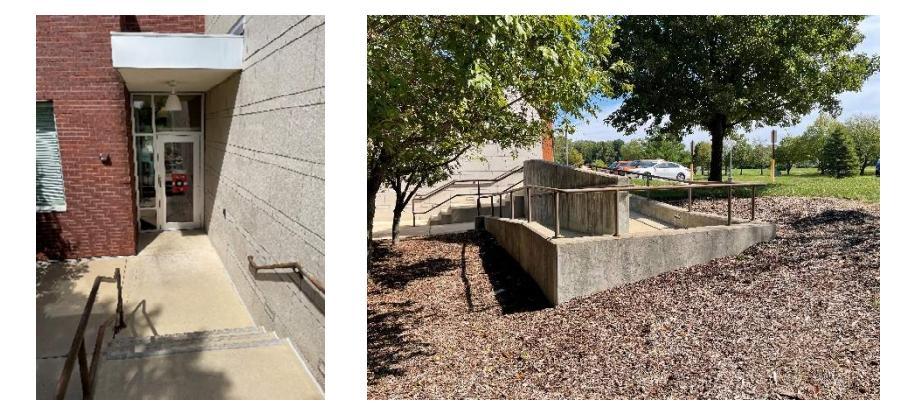
2.1.03.3.1 Figure 3: Building Entrance from Parking Lot

Where pedestrian access from the parking lot reaches the building there is a change in wall materials to the large format cmu at the wall adjacent to the storefront entrance door. Red brick veneer with a distressed texture begins at this inside corner and continues around the remainder of the building, apart from an area of the panel cladding next to the main entrance on the opposite side of the building. The change in elevation from the parking lot to the entrance door is addressed with a concrete ramp and stair system. Railings have deteriorated finishes and surface rust and pitting. Some railings may not be considered compliant with current codes and standards. Where the concrete walk meets the upper landing the walk appears to have sunk, enlarging the joint and creating an abrupt elevation change between the slabs that may not be considered an accessible route. At the lower landing and entrance approach the concrete walk

is in good condition but pulled away from the building creating significant joints between the walk and the building.

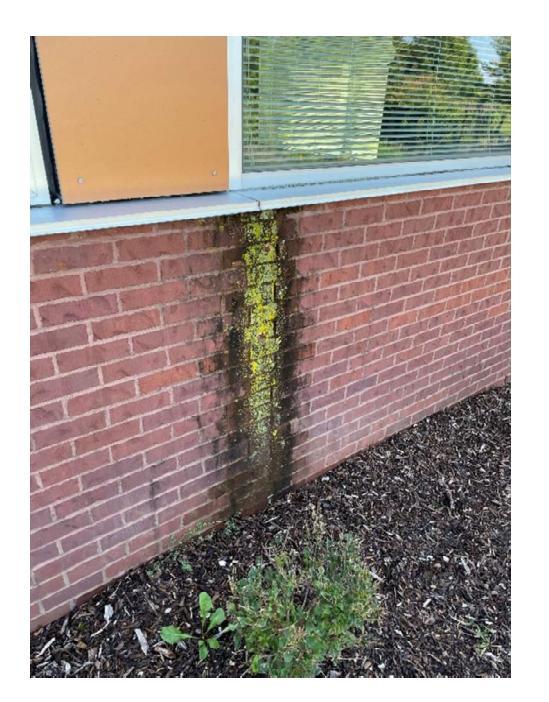
2.1.03.3.1 Figure 4: Surface Growth Below Failing Flashing

The brick veneer appears to be well constructed with appropriately located expansion joints, weeps, through wall flashings, and concave tooled mortar joints. However, the exterior masonry walls have significant water management issues and suffer from neglected maintenance of joints, flashing, and weep holes. Back pitched flashing, lack of redundancy in flashing, and deteriorated or missing sealant are allowing and/or directing water into these exterior wall assemblies. On the north sides of the building that do not receive much direct sunlight these compromised areas display discoloration, streaking, efflorescence, mold, lichen, and other surface growth. At the base of the exterior walls multiple areas were observed with mulch, dirt, and plantings covering or filling vents in the cavity wall, weeps, through-wall flashings, and drainage holes in metal framed glazed assemblies.

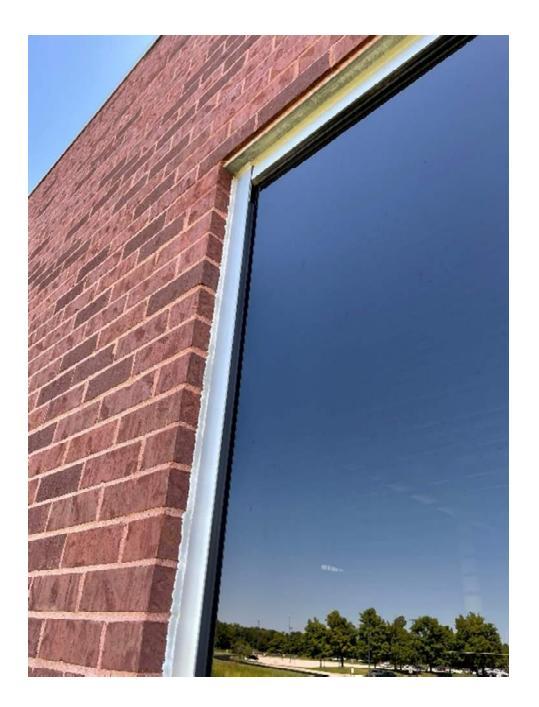
2.1.03.3.1 Figure 6: Window Opening at Building Addition

The addition to the building is clad in brick and mortar similar to the original build. Exterior walls of the addition do not display evidence of moisture infiltration to the extent the original build does. However, indications of moisture management issues were observed at the windows. Perimeter sealant of varying ages and levels of deterioration are cracked and pulled away from adjacent surfaces at both the window frames and the lintel. No weeps or through wall flashing was observed over opening lintels. Window frames have significant gaps at some joints, window gaskets are missing in some areas, and some sill pans are back pitched. It was noted that steel lintels at these openings appeared galvanized but not painted.

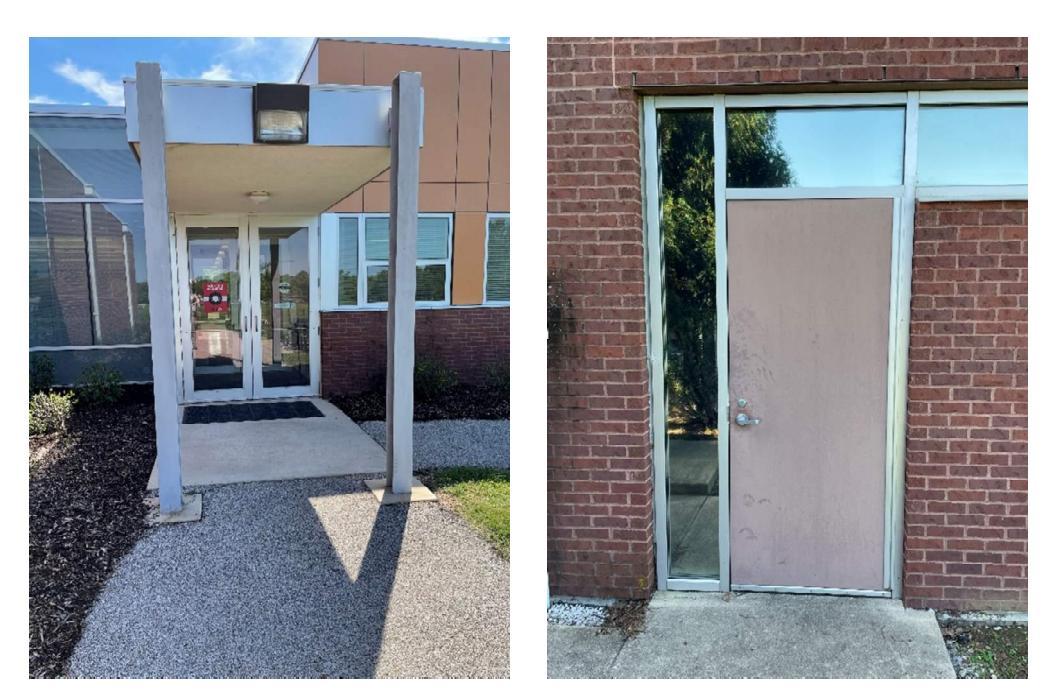
2.1.03.3.1 Figure 7: Typical Exterior Doors

Primary entrances are storefront doors and glazed vestibules. Storefront framing is in fair condition, displaying some oxidation and chalking normal for its age. Door actuators are provided at the primary entrances. Some walks, landings, and thresholds may not be considered compliant with current accessibility codes and standards. Hollow metal doors and frames at the service areas of the building are in good condition with some visible evidence of deteriorated finishes, pitting and rust. Exterior door hardware has aged finishes with varying degrees of discoloration and pitting surfaces.

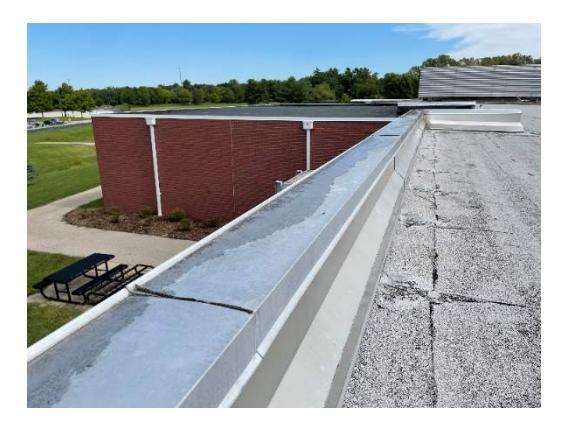
2.1.03.3.1 Figure 8: Standing Water on Parapet Coping

Access to the roof of building 220 is by a fixed internal roof ladder and roof scuttle. The roof of the original build is a low-slope, low parapet, roll asphalt system in fair condition but near the end of its serviceable life. The asphalt membrane shows signs of age, loss of protective impregnated granular surface texture, and multiple repairs. The roof membrane turns up and under the metal-flashed backside of the parapet. The metal coping of original build is back pitched and collecting water at many locations, joints are butt joints with multiple instances of failed or missing sealant. Lack of redundancy in flashing and open coping joints correlate to areas of walls surface discoloration and surface growth as observed from ground level.

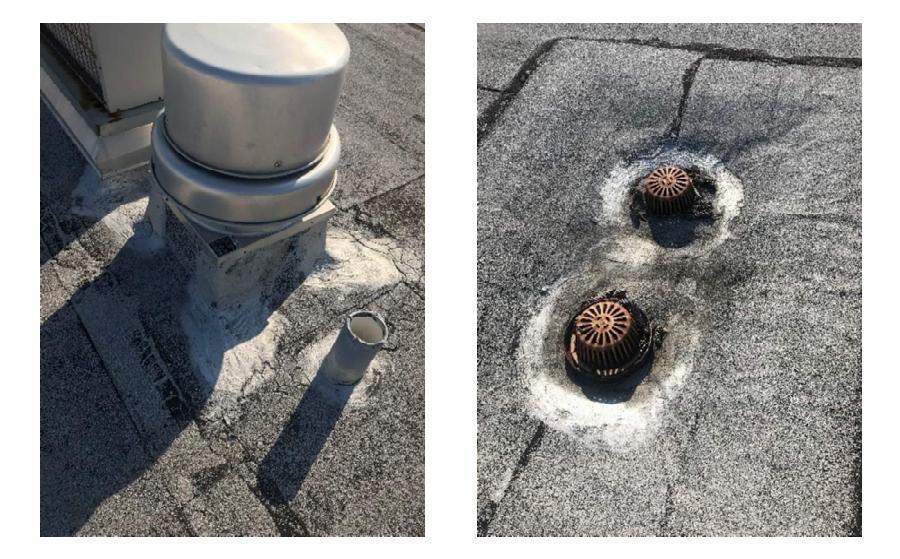
2.1.03.3.1 Figure 9: Typical Roof Penetrations

Both the surface and joint/edge sealers of the roll asphalt are cracked, alligatored, and deteriorated. Internal roof drains on the original build are combination units with overflows. Penetrations and curbs are upturned and overlapped asphalt sheet applications with heavy sealant.

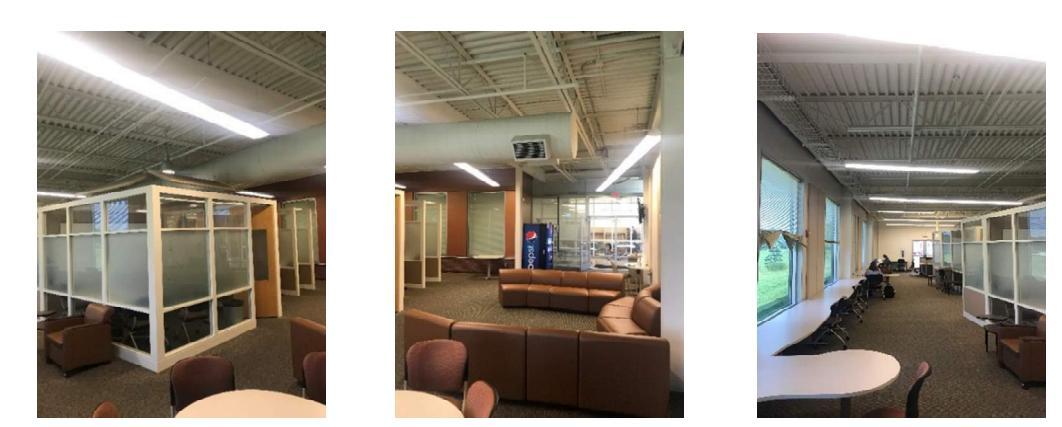
2.1.03.3.2 Figure 3: Student Learning Center Addition

The addition is a large open space with painted exposed steel framing and decking, gypsum board finished walls, carpet floor covering, and vinyl wall base. Termination of the gypsum board wall finish at the roof deck is poorly finished at several instances. There is a small equipment and storage room at the north exterior wall opposite the ground mounted mechanical unit. Portions of the original build exterior wall remain such as a brick wall base that transitions to the panel cladding system seen on the east building facade. The space is currently fitted out with modular workstations, small collaboration modules, and study carrels with power poles and overhead cable tray runs servicing the furnishings. Furnishings and carpet floor covering show wear and tear but are in good condition. Some paint finishes at the exposed roof deck and framing were observed to be discolored and peeling with rust at some areas indicating potential water intrusion at the roof.

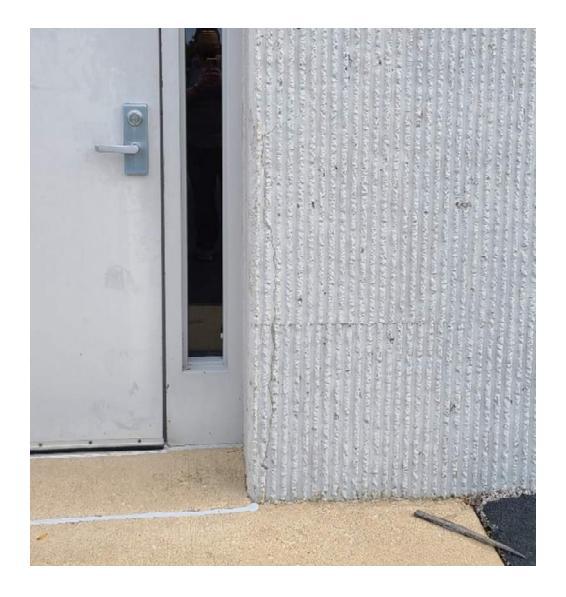
2.1.04.4.1 Figure 2: Building 200 Exterior Concrete Wall Cracking

- Cracking at exterior battered concrete walls:
 - Corners of windows and doors (typical):
 - See 5.1.03.4.1 Figure 1: Building 200 Exterior Concrete Wall Cracking

- See 5.1.03.4.1 Figure 2: Building 200 Exterior Concrete Wall Cracking
 - Along the top side of the wall along the form-liner finish:
 - See 5.1.03.4.1 Figure 3: Building 200 Exterior Wall Face Cracking (Looking Down)

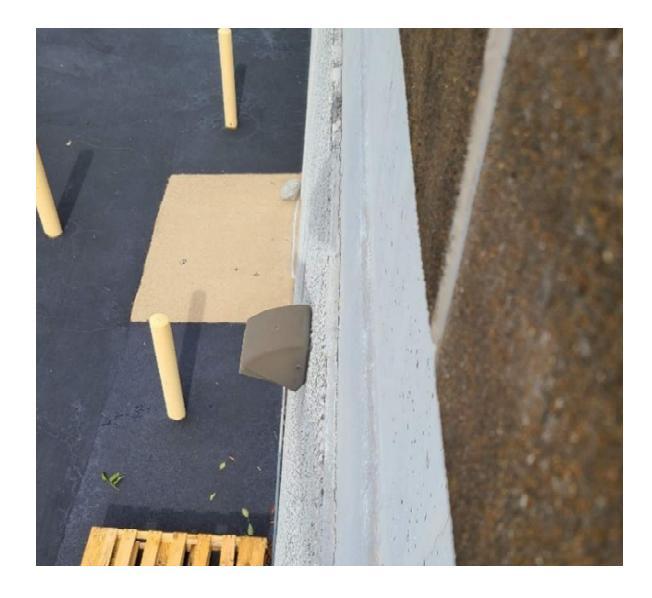
2.1.04.4.1 Figure 4: Building 200 Exterior Fall Protection Wall Cracking

- Along the fall protection wall at typical intervals:
 - See 5.1.03.4.1 Figure 4: Building 200 Exterior Fall Protection Wall Cracking
- Spalling at exterior battered concrete walls:
