# ASBESTOS MANAGEMENT PLAN REPORT

CDB - PROJECT NUMBER -- 910-010-093

NORTHERN ILLINOIS UNIVERSITY  
1425 WEST LINCOLN HIGHWAY  
WEST HEATING PLANT  
C.D.B. BUILDING #U1110  
NORTHERN ILLINOIS UNIVERSITY - DEKALB CAMPUS  
DEKALB, DEKALB COUNTY, ILLINOIS 60115

BY:  
CARNOW, CONIBEAR & ASSOC., LTD.  
333 WEST WACKER DRIVE, SUITE 1400  
CHICAGO, ILLINOIS 60606  
(312)782-4486

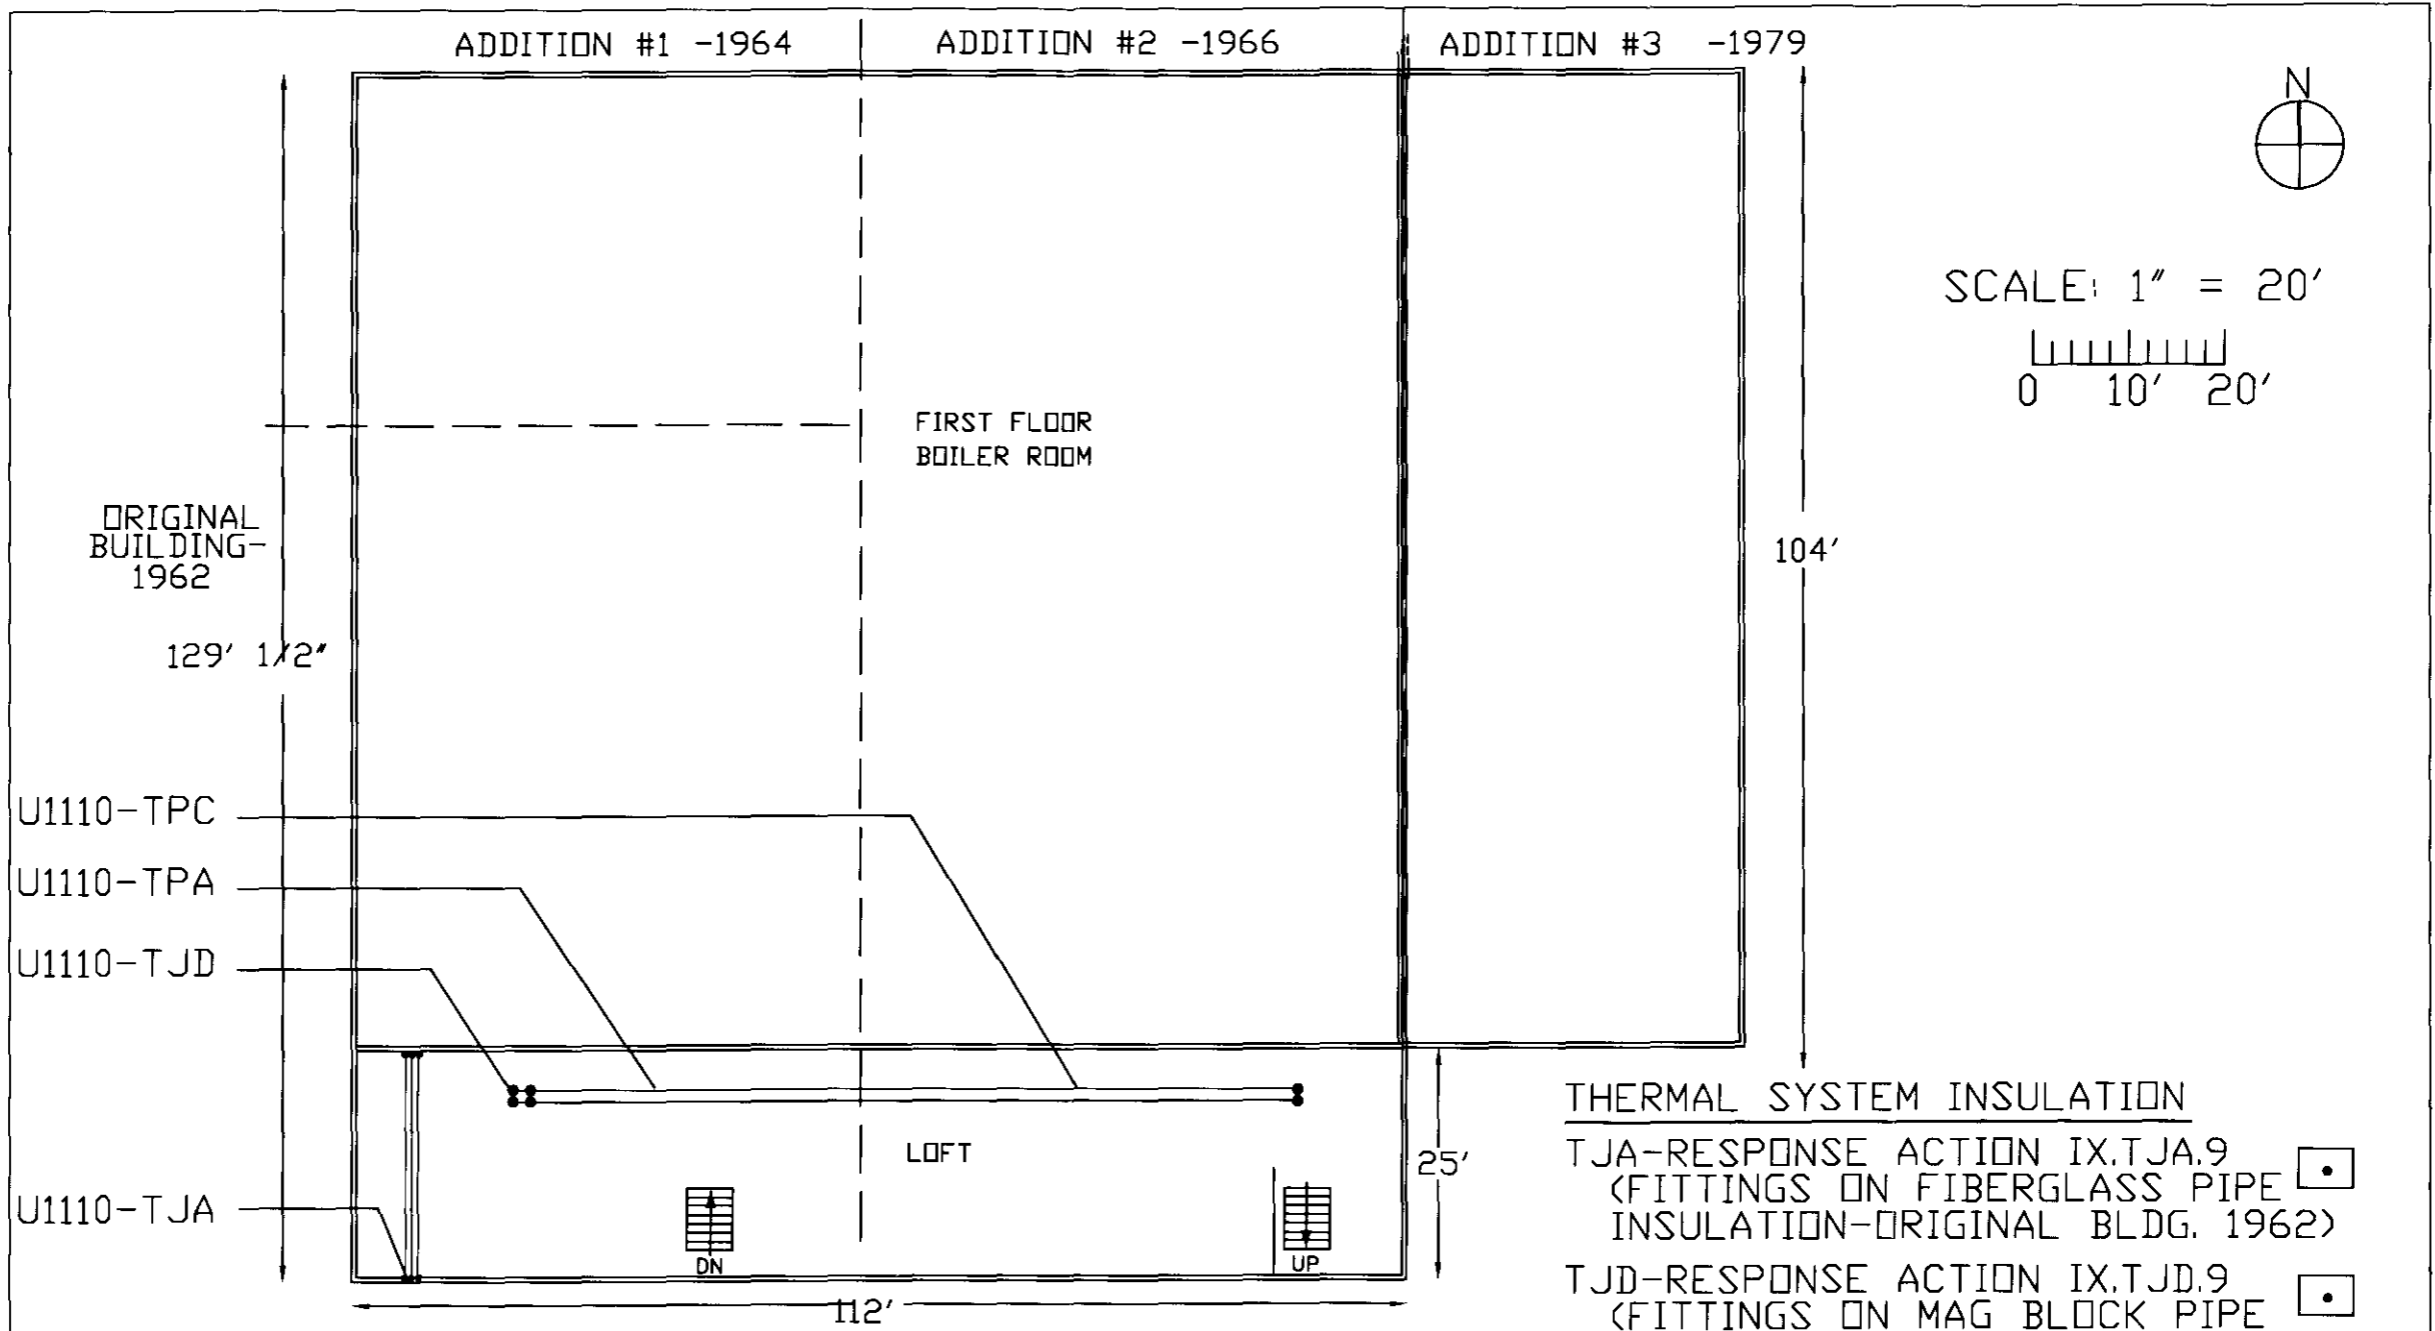
**THERMAL SYSTEM INSULATION**  
 TPC-RESPONSE ACTION IX.TPC.8 (MAG BLOCK PIPE INSULATION -ADDITION #2-1966)

**THERMAL SYSTEM INSULATION**  
 TJA-RESPONSE ACTION IX.TJA.9 (FITTINGS ON FIBERGLASS PIPE INSULATION-ORIGINAL BLDG. 1962)    
 TJD-RESPONSE ACTION IX.TJD.9 (FITTINGS ON MAG BLOCK PIPE INSULATION-ORIGINAL BLDG. 1962)    
 TPA-RESPONSE ACTION IX.TPA.9 (MAG BLOCK PIPE INSULATION -ORIGINAL BLDG. 1962)

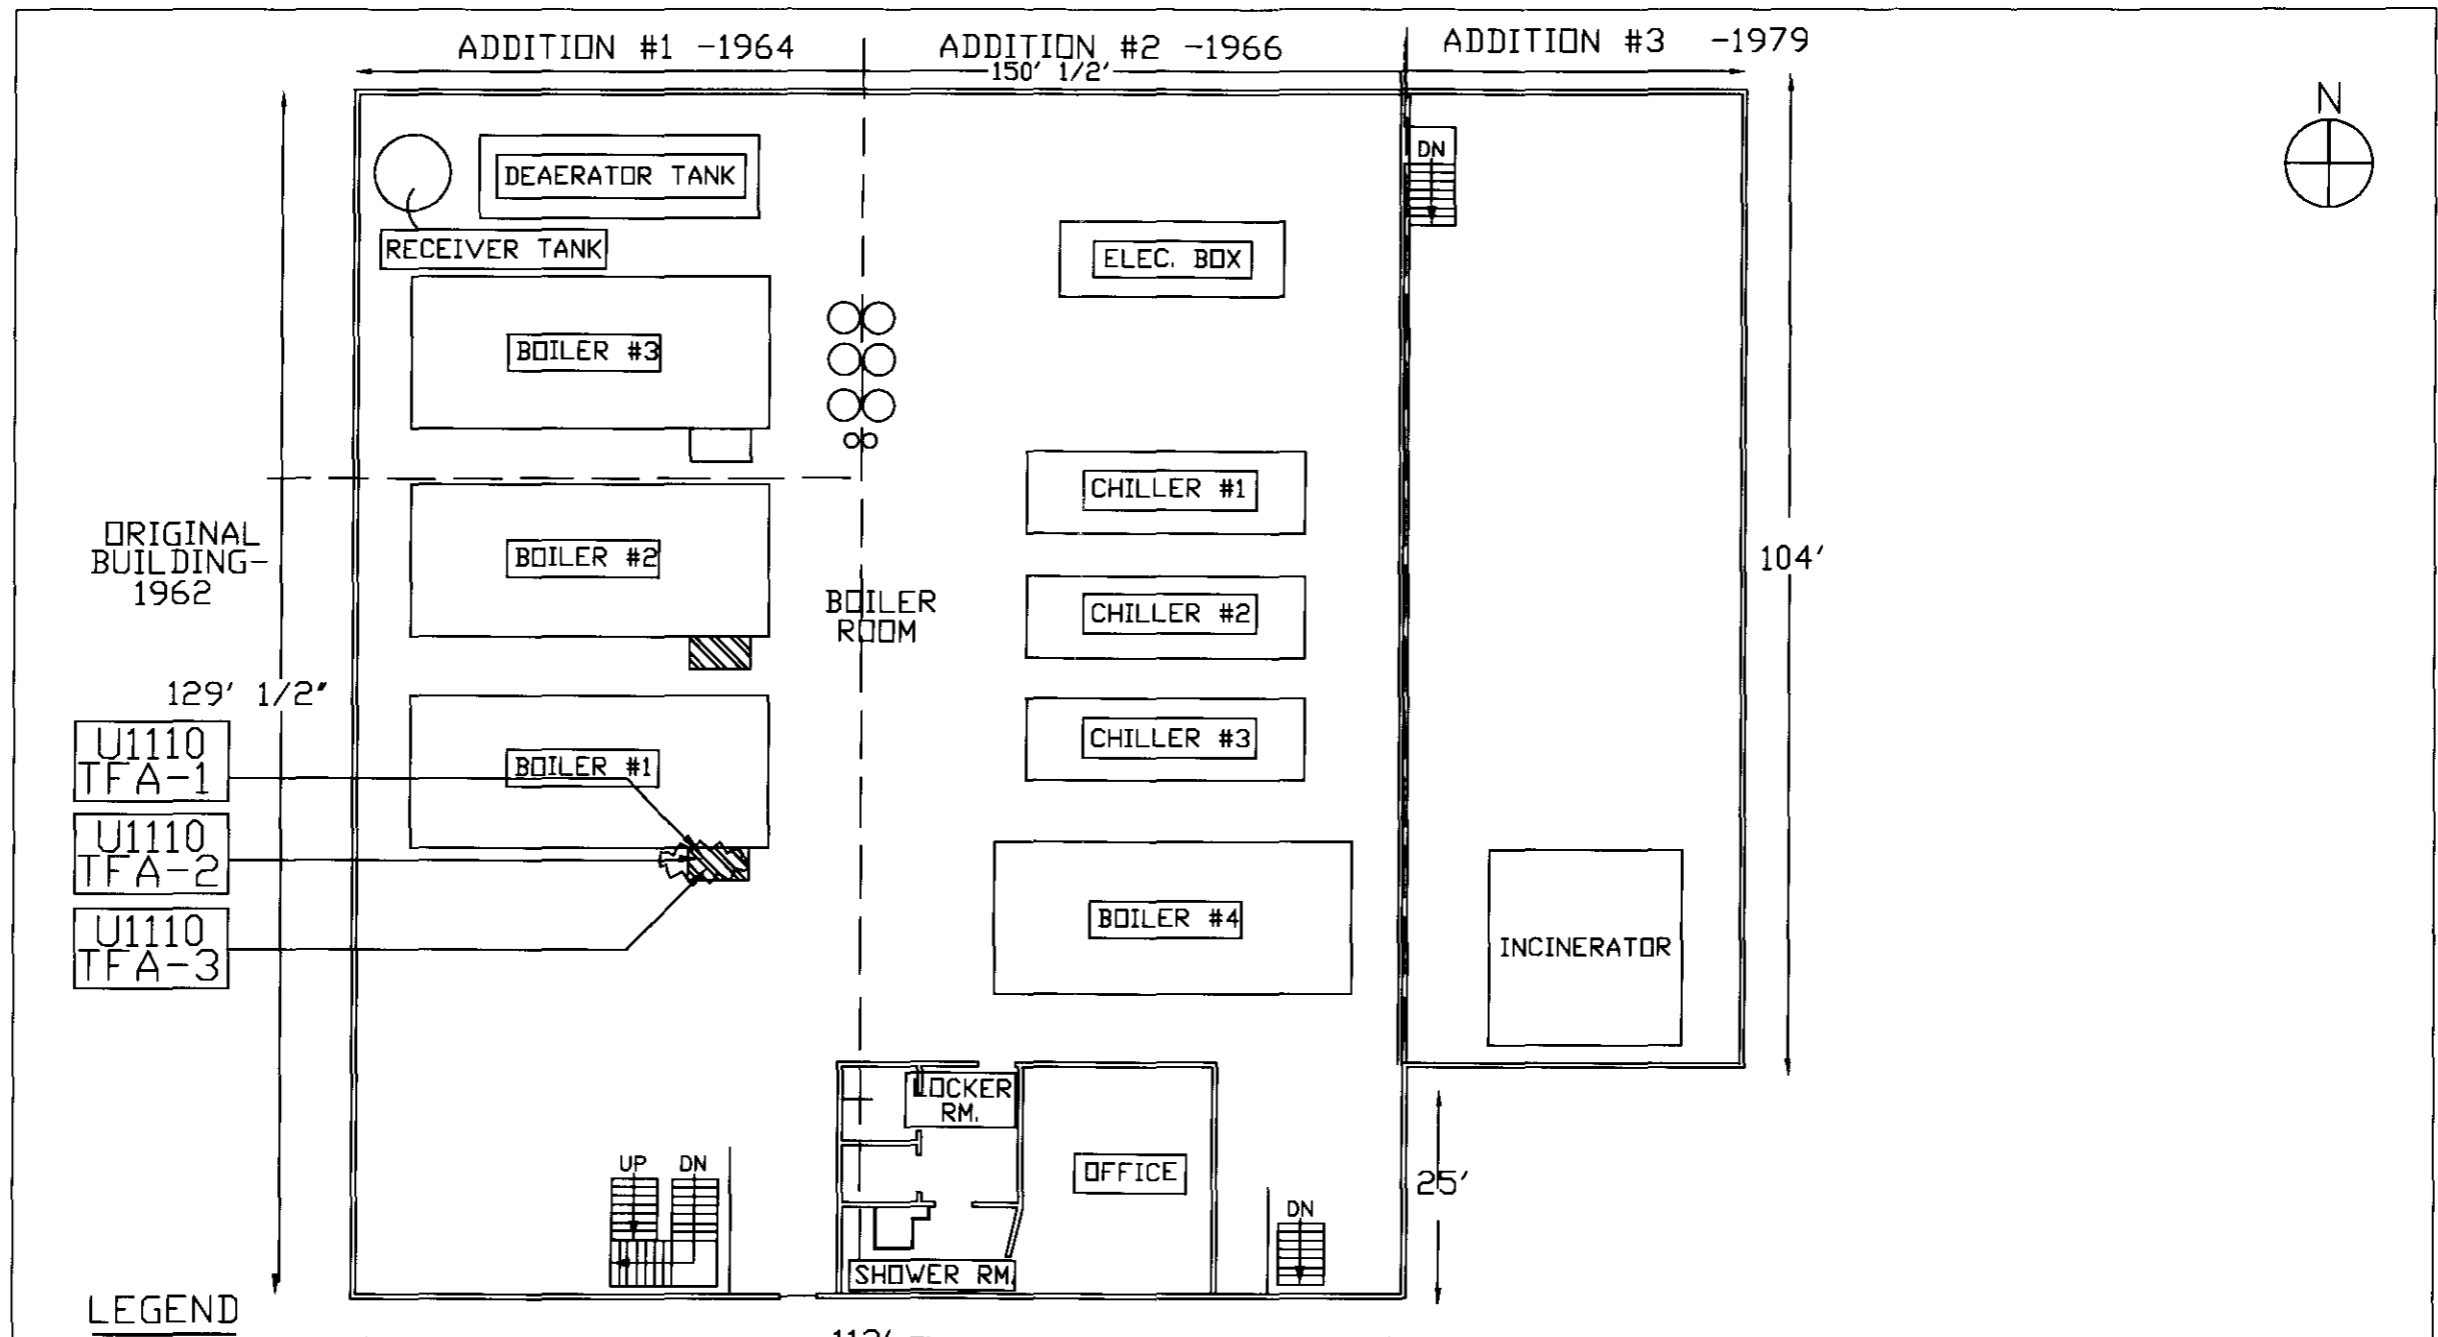
<p>CAPITAL DEVELOPMENT BOARD</p>	FIRST FLOOR	PROJ. NO. 910-010-093
		WEST HEATING PLANT NORTHERN ILLINOIS UNIVERSITY DEKALB, DEKALB COUNTY, ILLINOIS	DATE JANUARY 19, 2000
		CDB BUILDING # U1110	SHEET 1 PF 1 TFA

TFA - boiler stack insulation on boiler #1 and #2 (original building - 1962) and TFC - de-aerator stack insulation, are damaged and need to be repaired. There is approximately 10 square feet of debris on the floor around boiler #3 which needs to be cleaned up by an IDPH licensed asbestos worker.

HOMO AREA	DESCRIPTION	QUANTITY	ACM			NOTES
			ASSUMED	POS	NEG	
TFA	Boiler Stack Insulation on Boiler #1 and #2 (Original Building - 1962)	500 sf		3		Slight damage at the bottom of Boiler #1 stack is allowing asbestos debris to fall on the floor.
TFB	Boiler Stack Insulation on Boiler #3 (Addition #1 - 1964)	250 sf		3		Approximately 6 square feet of this insulation has fallen beside the boiler.
TFC	De-aerator Stack Insulation (Addition #1 - 1964)	350 sf		3		There is damage at the bottom of the stack above the electric panel which is leaking debris on top of the receiver. There is a 2 square feet significantly damaged area on the back side of this stack approximately 30' up.
TJA	Fittings on Fiberglass Pipe Insulation (Original Building - 1962)	24 fittings		2	1	Three (3) fittings are significantly damaged.
TJB	Fittings on Fiberglass Pipe Insulation (Addition #1 - 1964)	26 fittings		2	1	Approximately 4 square feet of the cover over this insulation has come off. Approximately 1 square foot of damage.

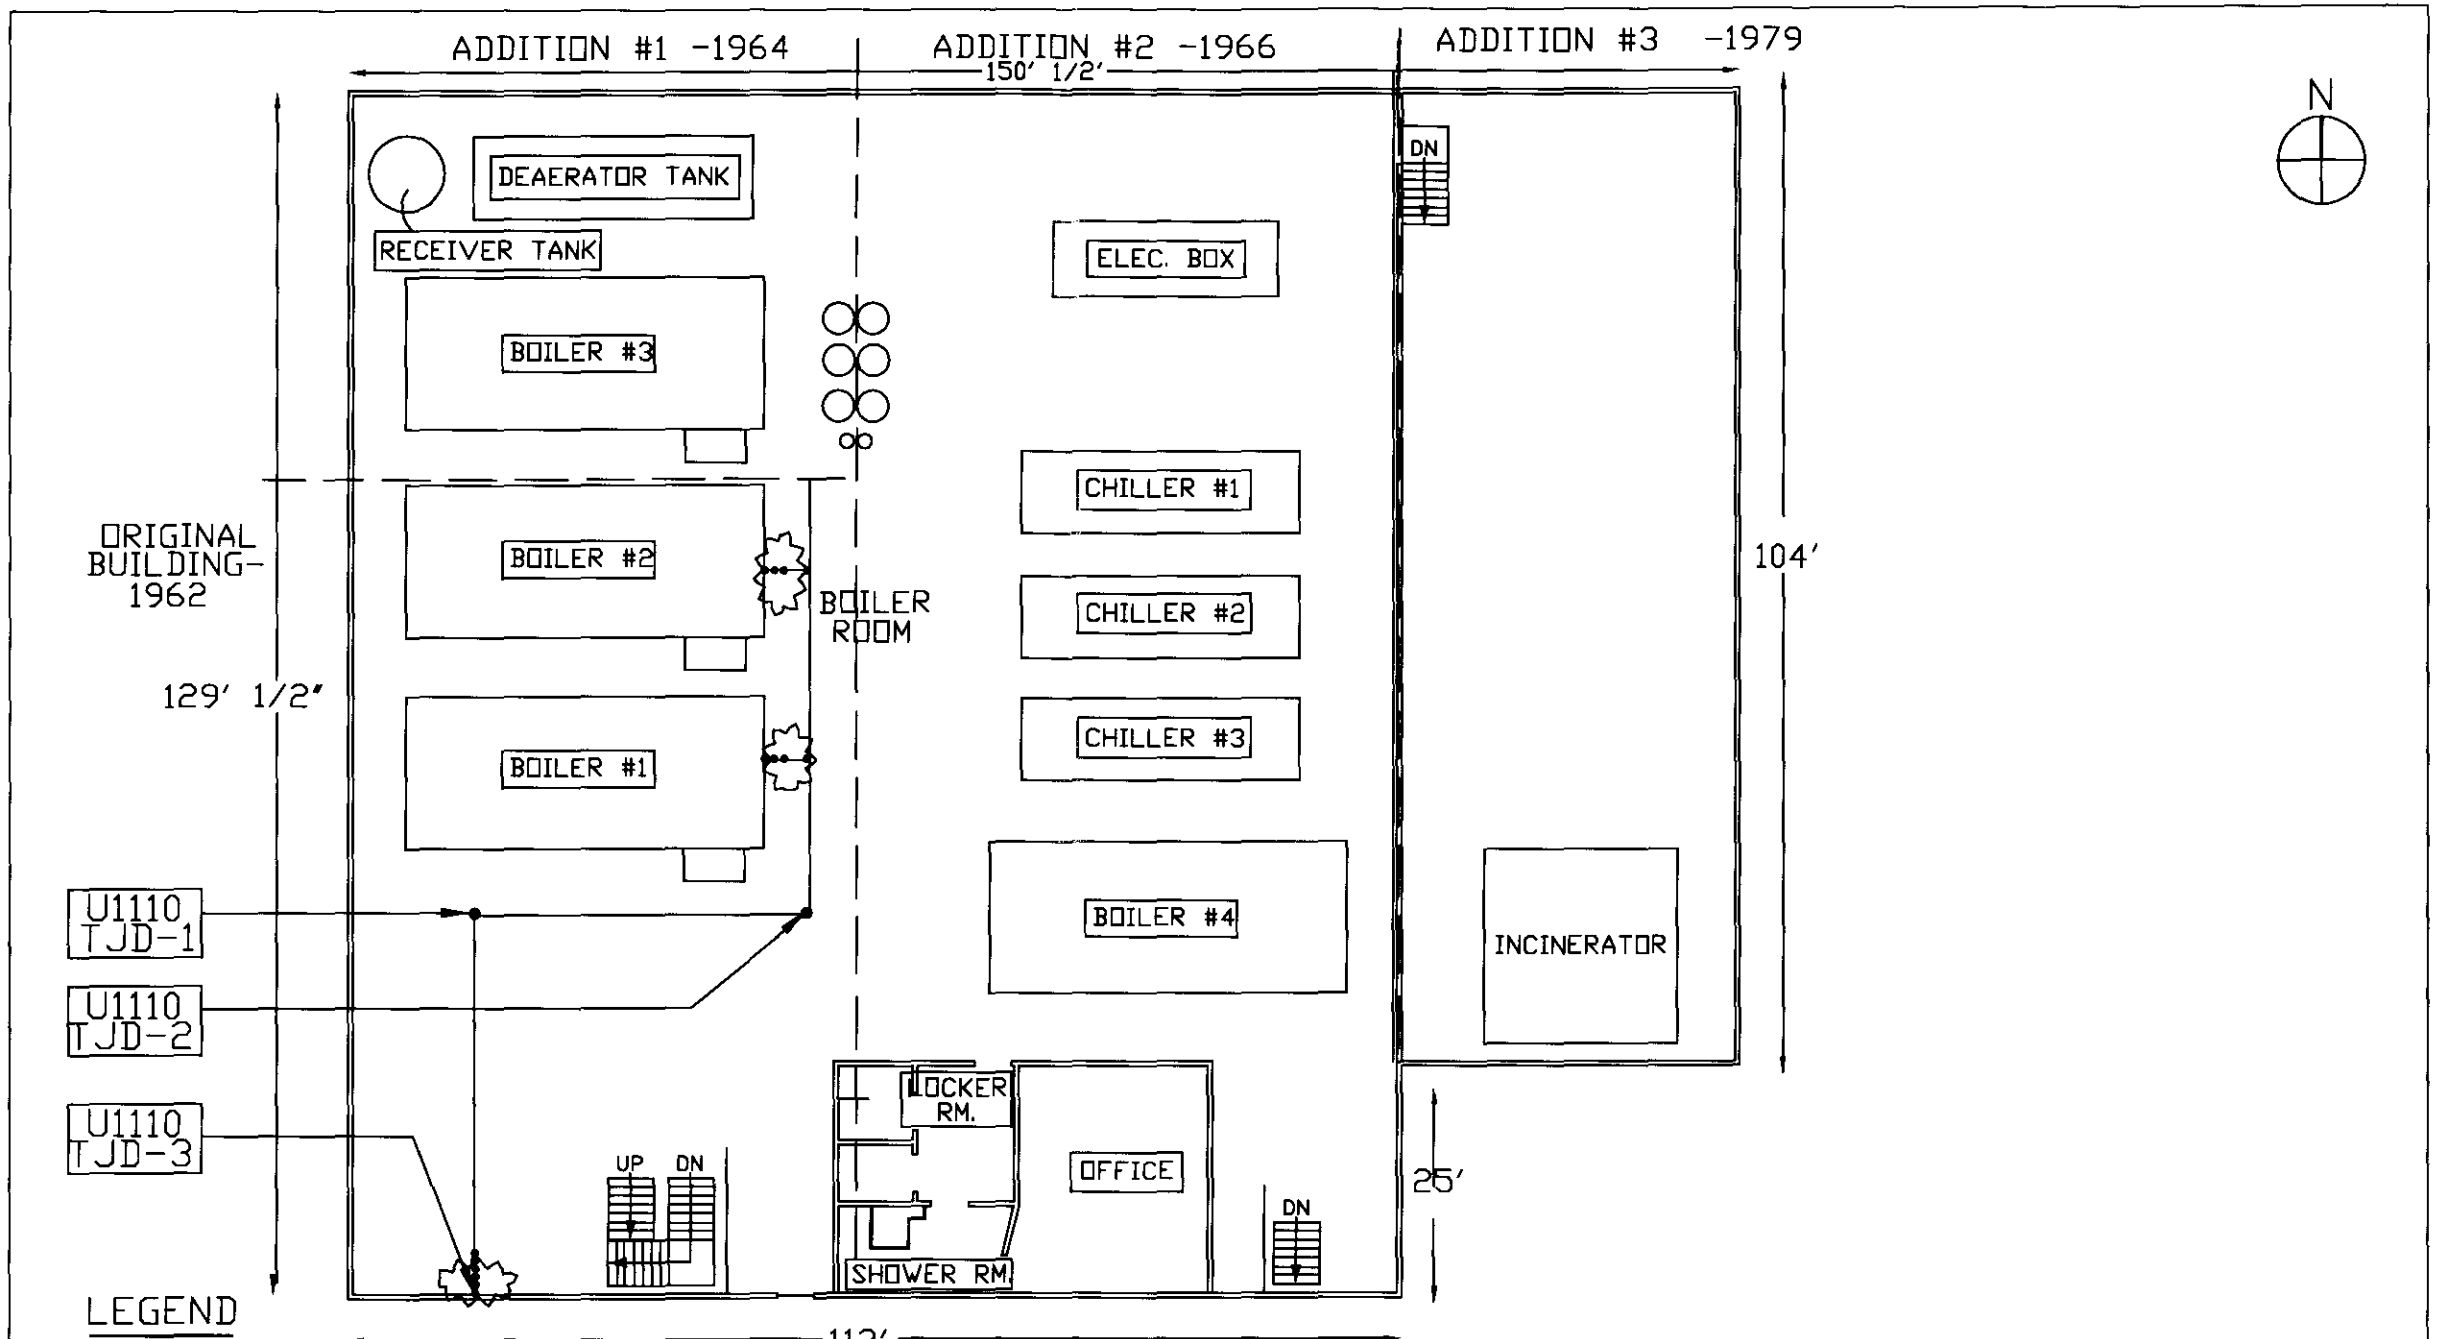
<p>CAPITAL DEVELOPMENT BOARD</p>	FIRST FLOOR	PROJ. NO. 910-010-093
		WEST HEATING PLANT NORTHERN ILLINOIS UNIVERSITY DEKALB, DEKALB COUNTY, ILLINOIS	DATE JANUARY 19, 2000
		CDB BUILDING # U1110	SHEET 2 OF 3 TJD

- INDICATES EXTENT OF HOMOGENEOUS AREA
- TJD-FITTINGS ON MAG BLOCK PIPE INSULATION (ORIGINAL BUILDING-1962)
- INDICATES LOCATION OF DAMAGE

If <1% damage, is salient present? Yes [X] No [ ]
If yes, describe A FITTING FROM THE FEED PUMP PIPING (UNDER THE DE-AERATOR) HAS FALLEN AND SHATTERED.

WATER DAMAGE Yes [ ] No [X] Description [ ]
PHYSICAL DAMAGE Yes [X] No [ ] Description A FITTING HAS FALLEN AND SHATTERED
AGE DETERIORATION Yes [ ] No [X] Description [ ]

EXPLANATION OF ASSESSMENT (REQUIRED) ONE FITTING IS CURRENTLY DAMAGED, AND SOME OF THE OTHERS ARE LOCATED AT ACCESSIBLE HEIGHTS.

DAMAGE PREVENTION MEASURES PICK UP DEBRIS FROM FALLEN FITTING. REPAIR DAMAGED FITTING. MAINTAIN THESE FITTINGS IN GOOD CONDITION. IF THEY BECOME DAMAGED, REPAIR THEM IMMEDIATELY.

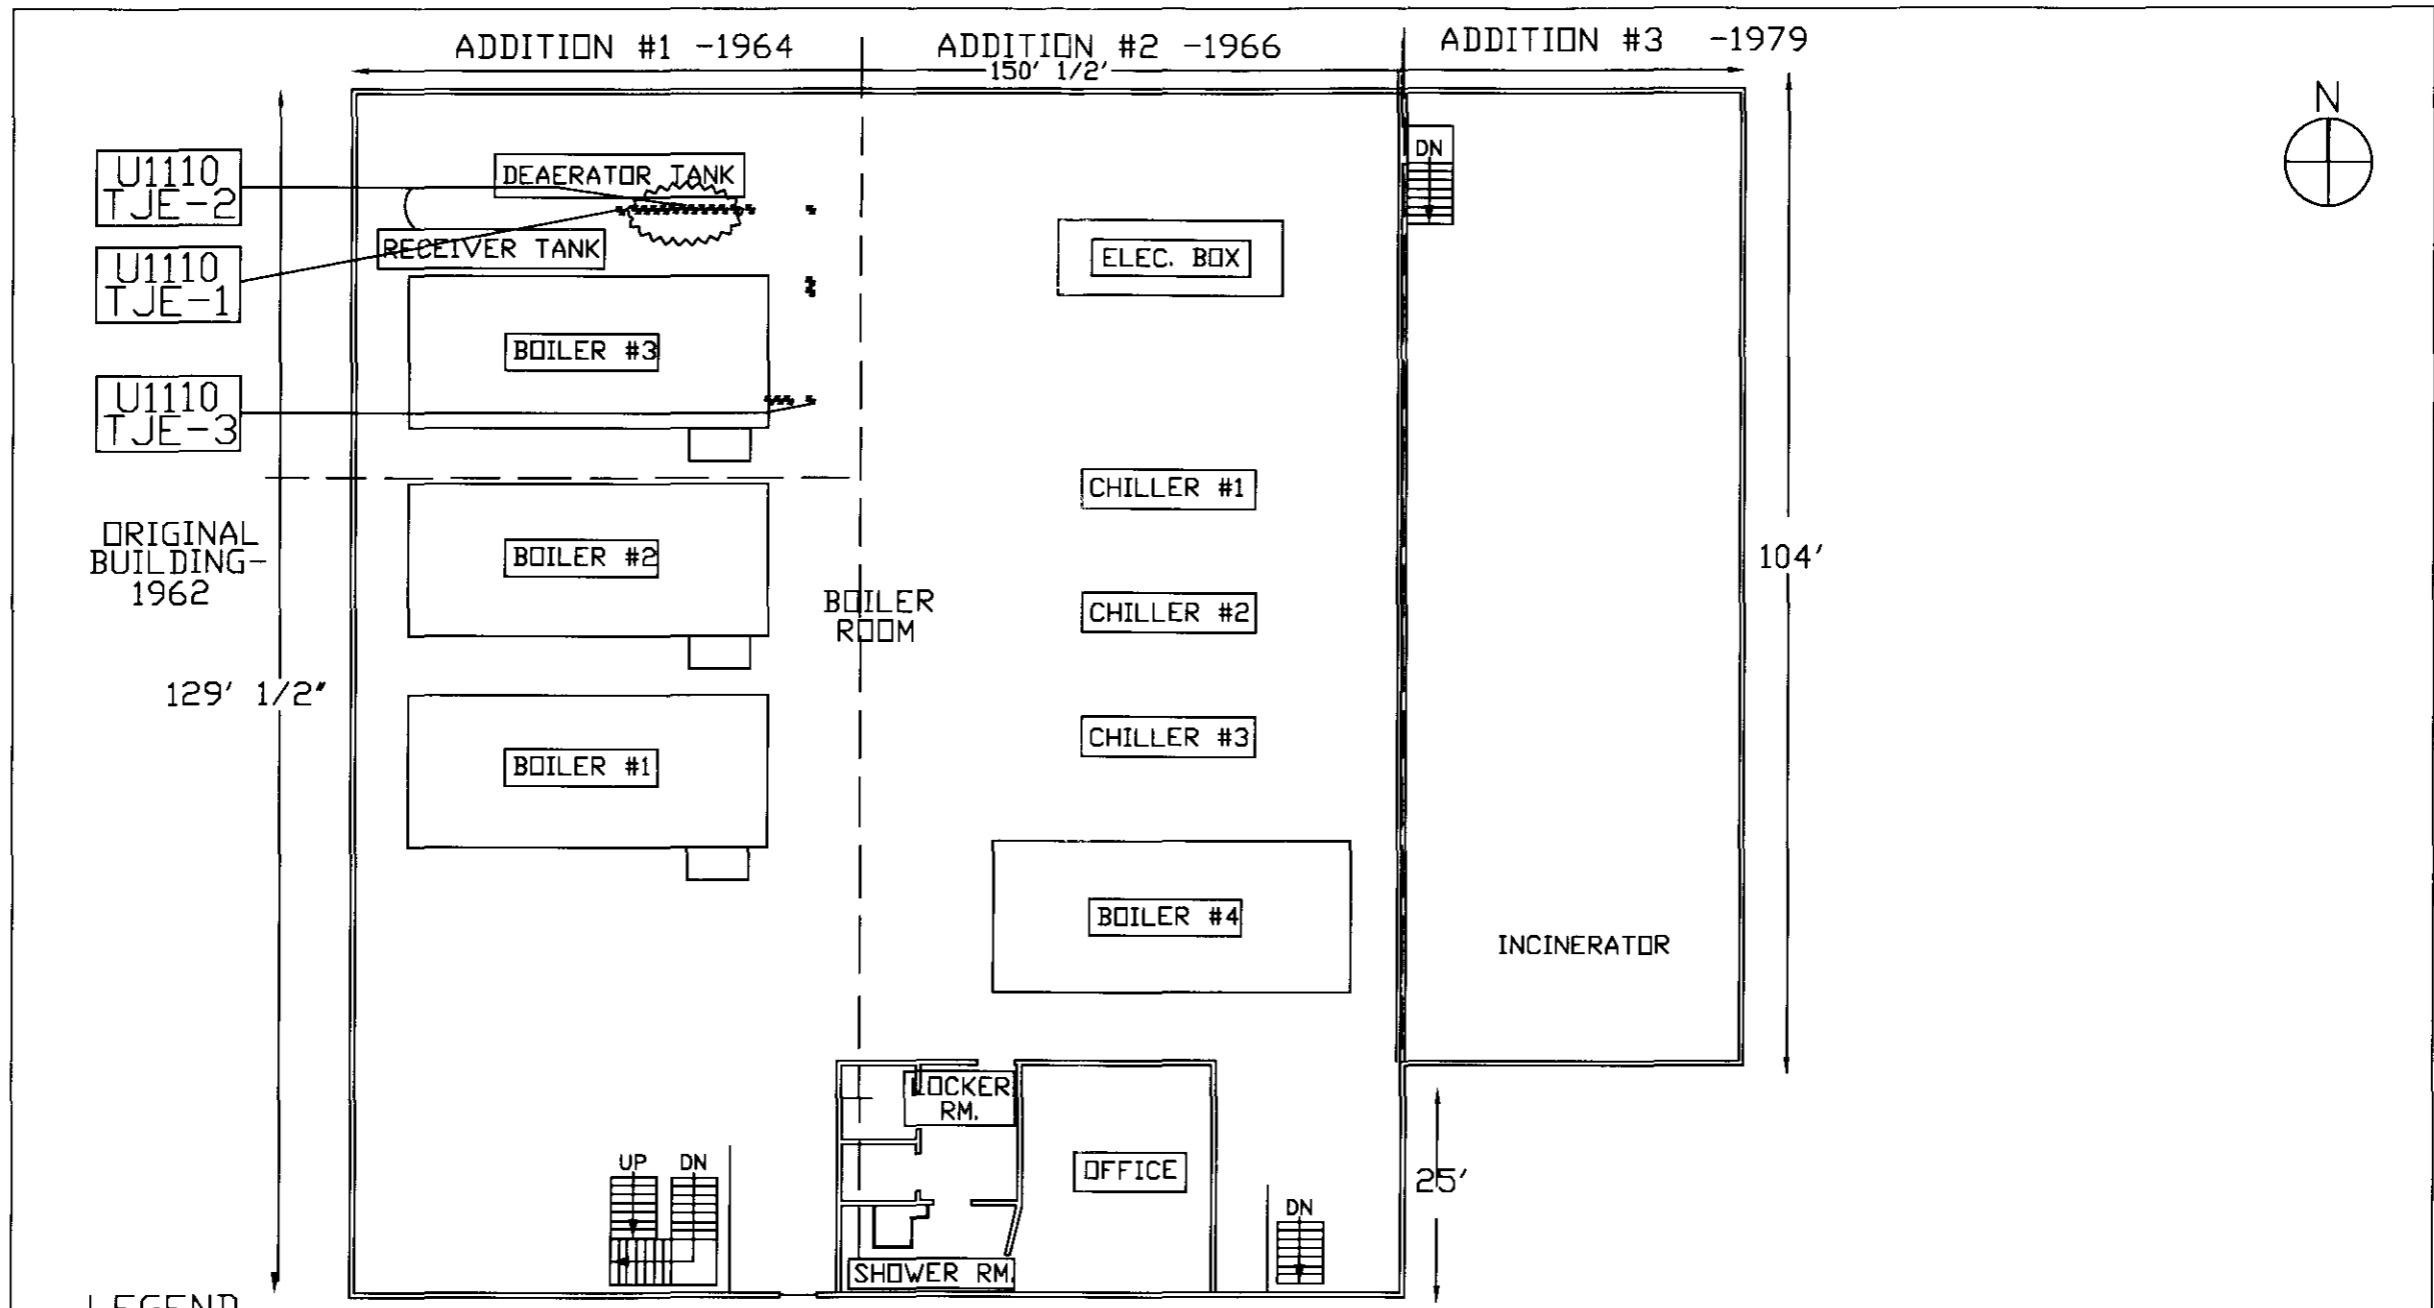
- INDICATES EXTENT OF HOMOGENEOUS AREA
- TJE-FITTINGS ON MAG-BLOCK PIPE INSULATION (ADDITION #1-1964)
- INDICATES LOCATION OF DAMAGE

POT. FOR DAMAGE MATERIAL IS CURRENTLY DAMAGED, MAKING FURTHER  
DAMAGE LIKELY.

A.3.a.(1) WHY ANY DISTURBANCE TO THIS DAMAGED, FRIABLE MATERIAL WILL CAUSE  
FIBERS TO BE RELEASED INTO THE AIR.

A.3.a.(2) PREVENTATIVE MEASURES DO NOT DISTURB IN A MANNER THAT WILL CREATE  
DUST SUCH AS DRILLING, CUTTING, SANDING, SAWING, ABRADING, OR  
PENETRATING IN ANY MANNER. CLEAN-UP DAMAGED FITTING.

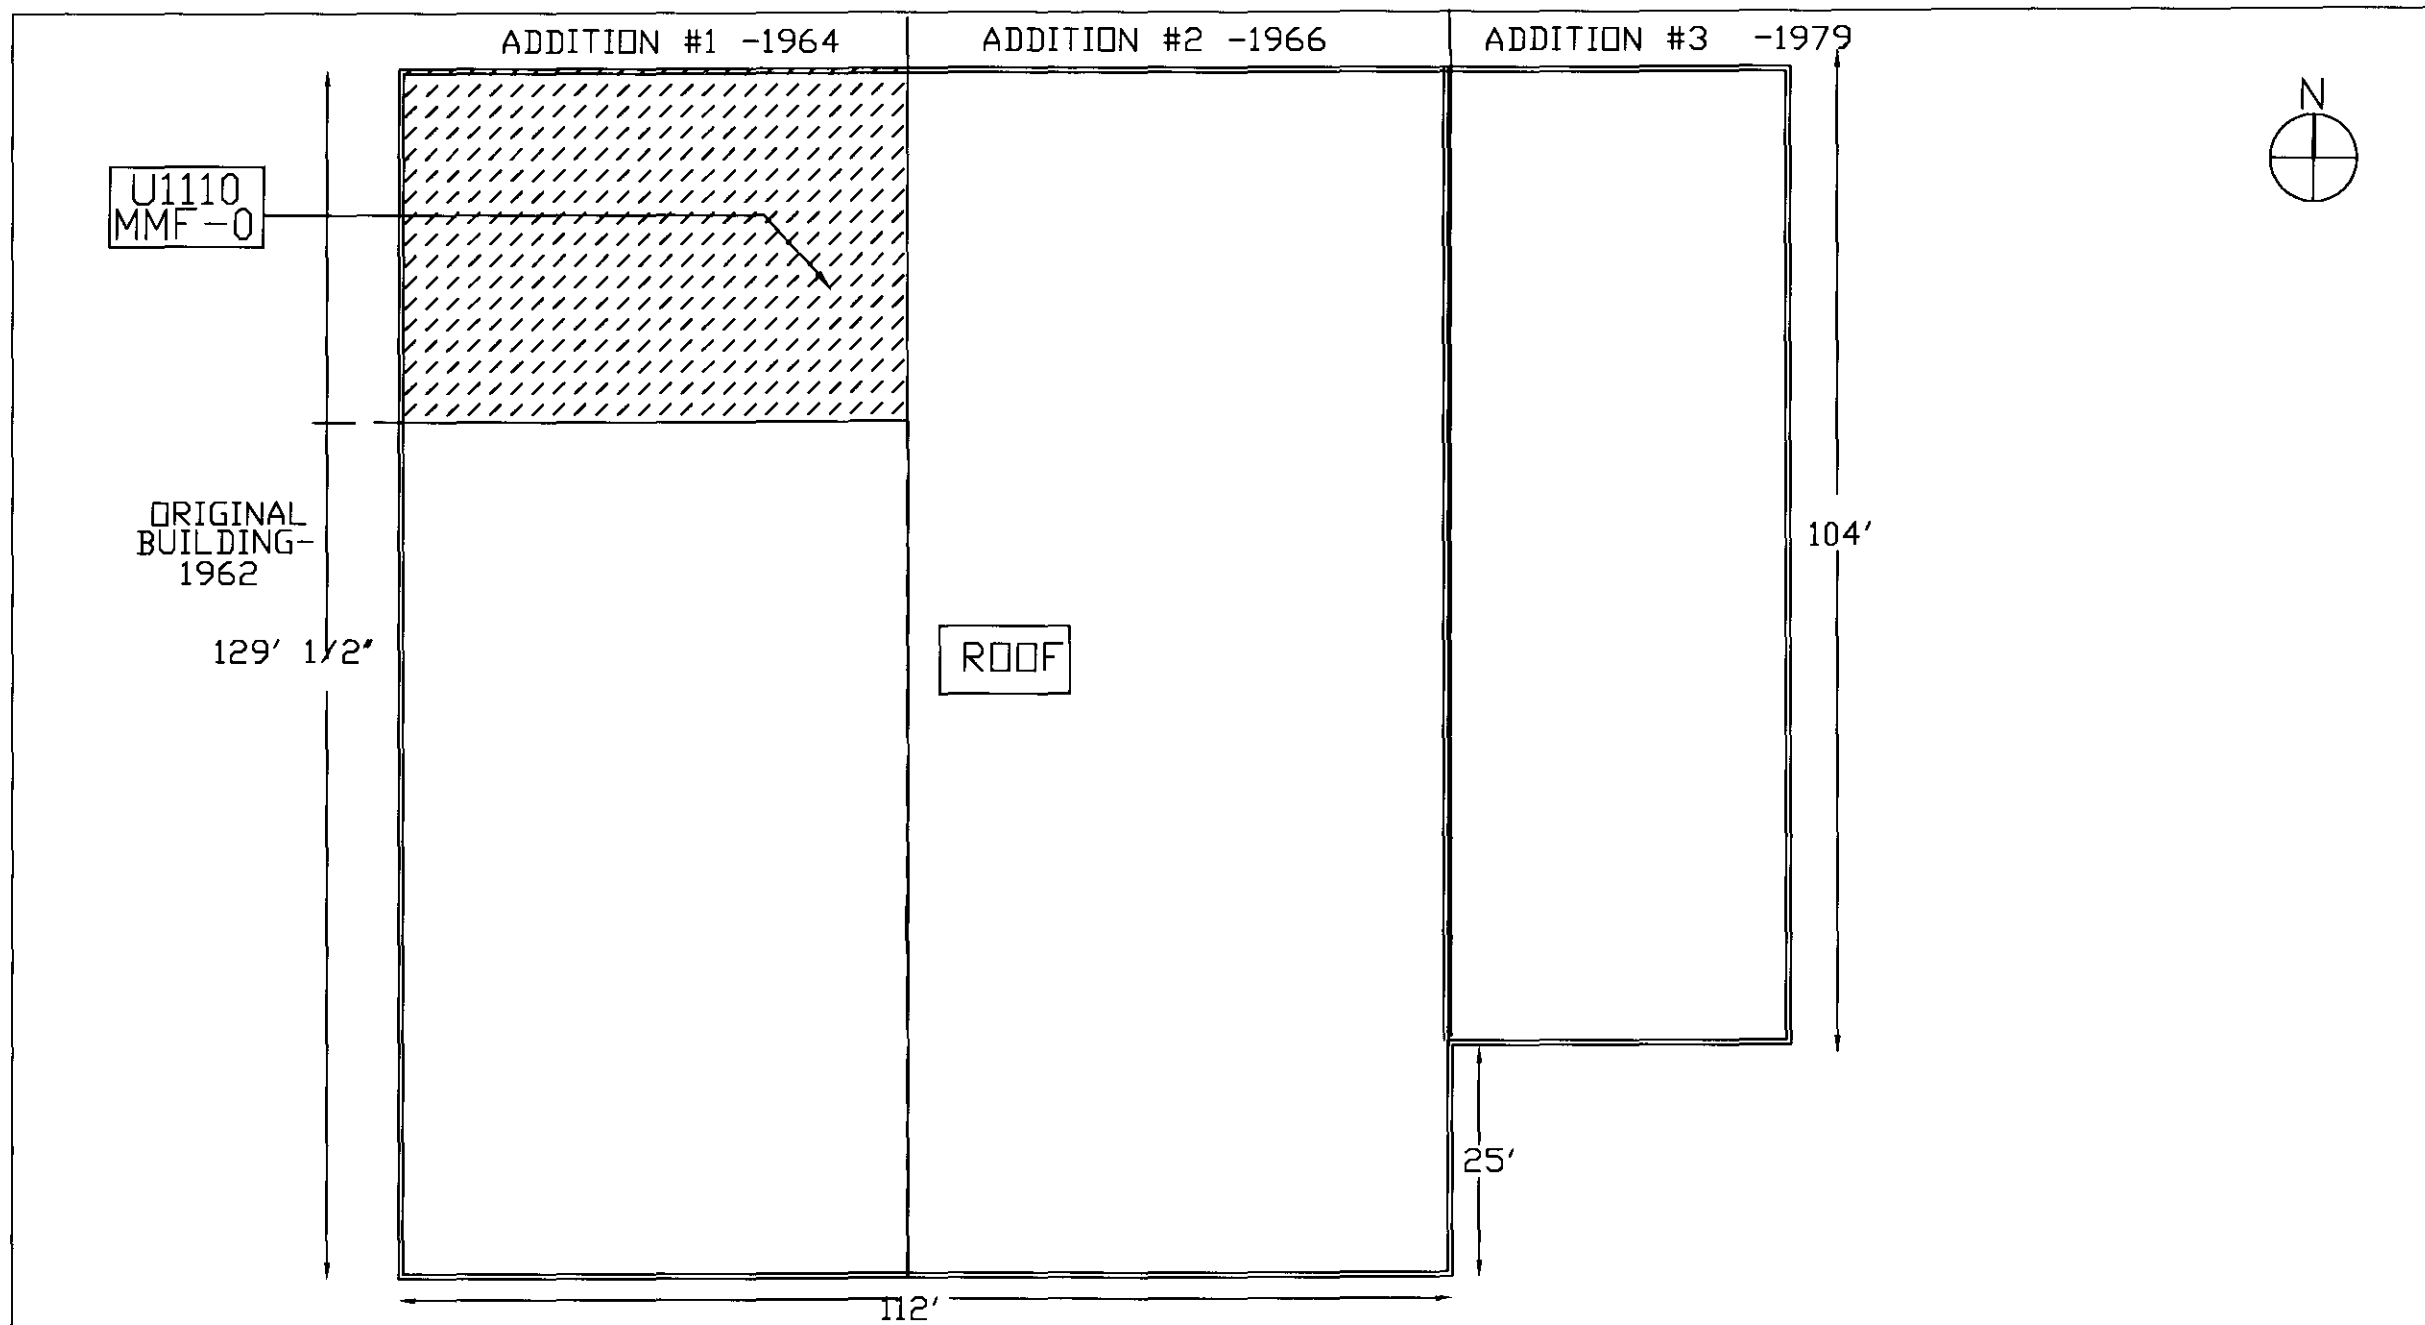
ROOF PLAN	PROJ. NO. 910-010-093
		WEST HEATING PLANT NORTHERN ILLINOIS UNIVERSITY DEKALB, DEKALB COUNTY, ILLINOIS	DATE JANUARY 19, 2000
		CDB BUILDING # U1110	SHEET 1 PF 1 MMF

POT. FOR DAMAGE THIS MATERIAL HAS A LOW POTENTIAL FOR DAMAGE DUE TO  
ITS NON-FRIABLE NATURE.

A.2.b. FRIABLE NO CONDITION GOOD  
DISTURBANCE LOW AIR FLOW HEAVY

1 BLDG. NAME WEST HEATING PLANT BLDG. NO. U1110  
HOMO AREA MMF DESCRIPT BUILT-UP ROOF (ADDITION #1 - 1964)  
RESPONSE ACTION 8 - CONTINUE O & M UNTIL MAJOR DEMOLITION OR  
RENOVATION REQUIRES REMOVAL UNDER NESHAPS, OR UNTIL HAZARD  
ASSESSMENT FACTORS CHANGE.

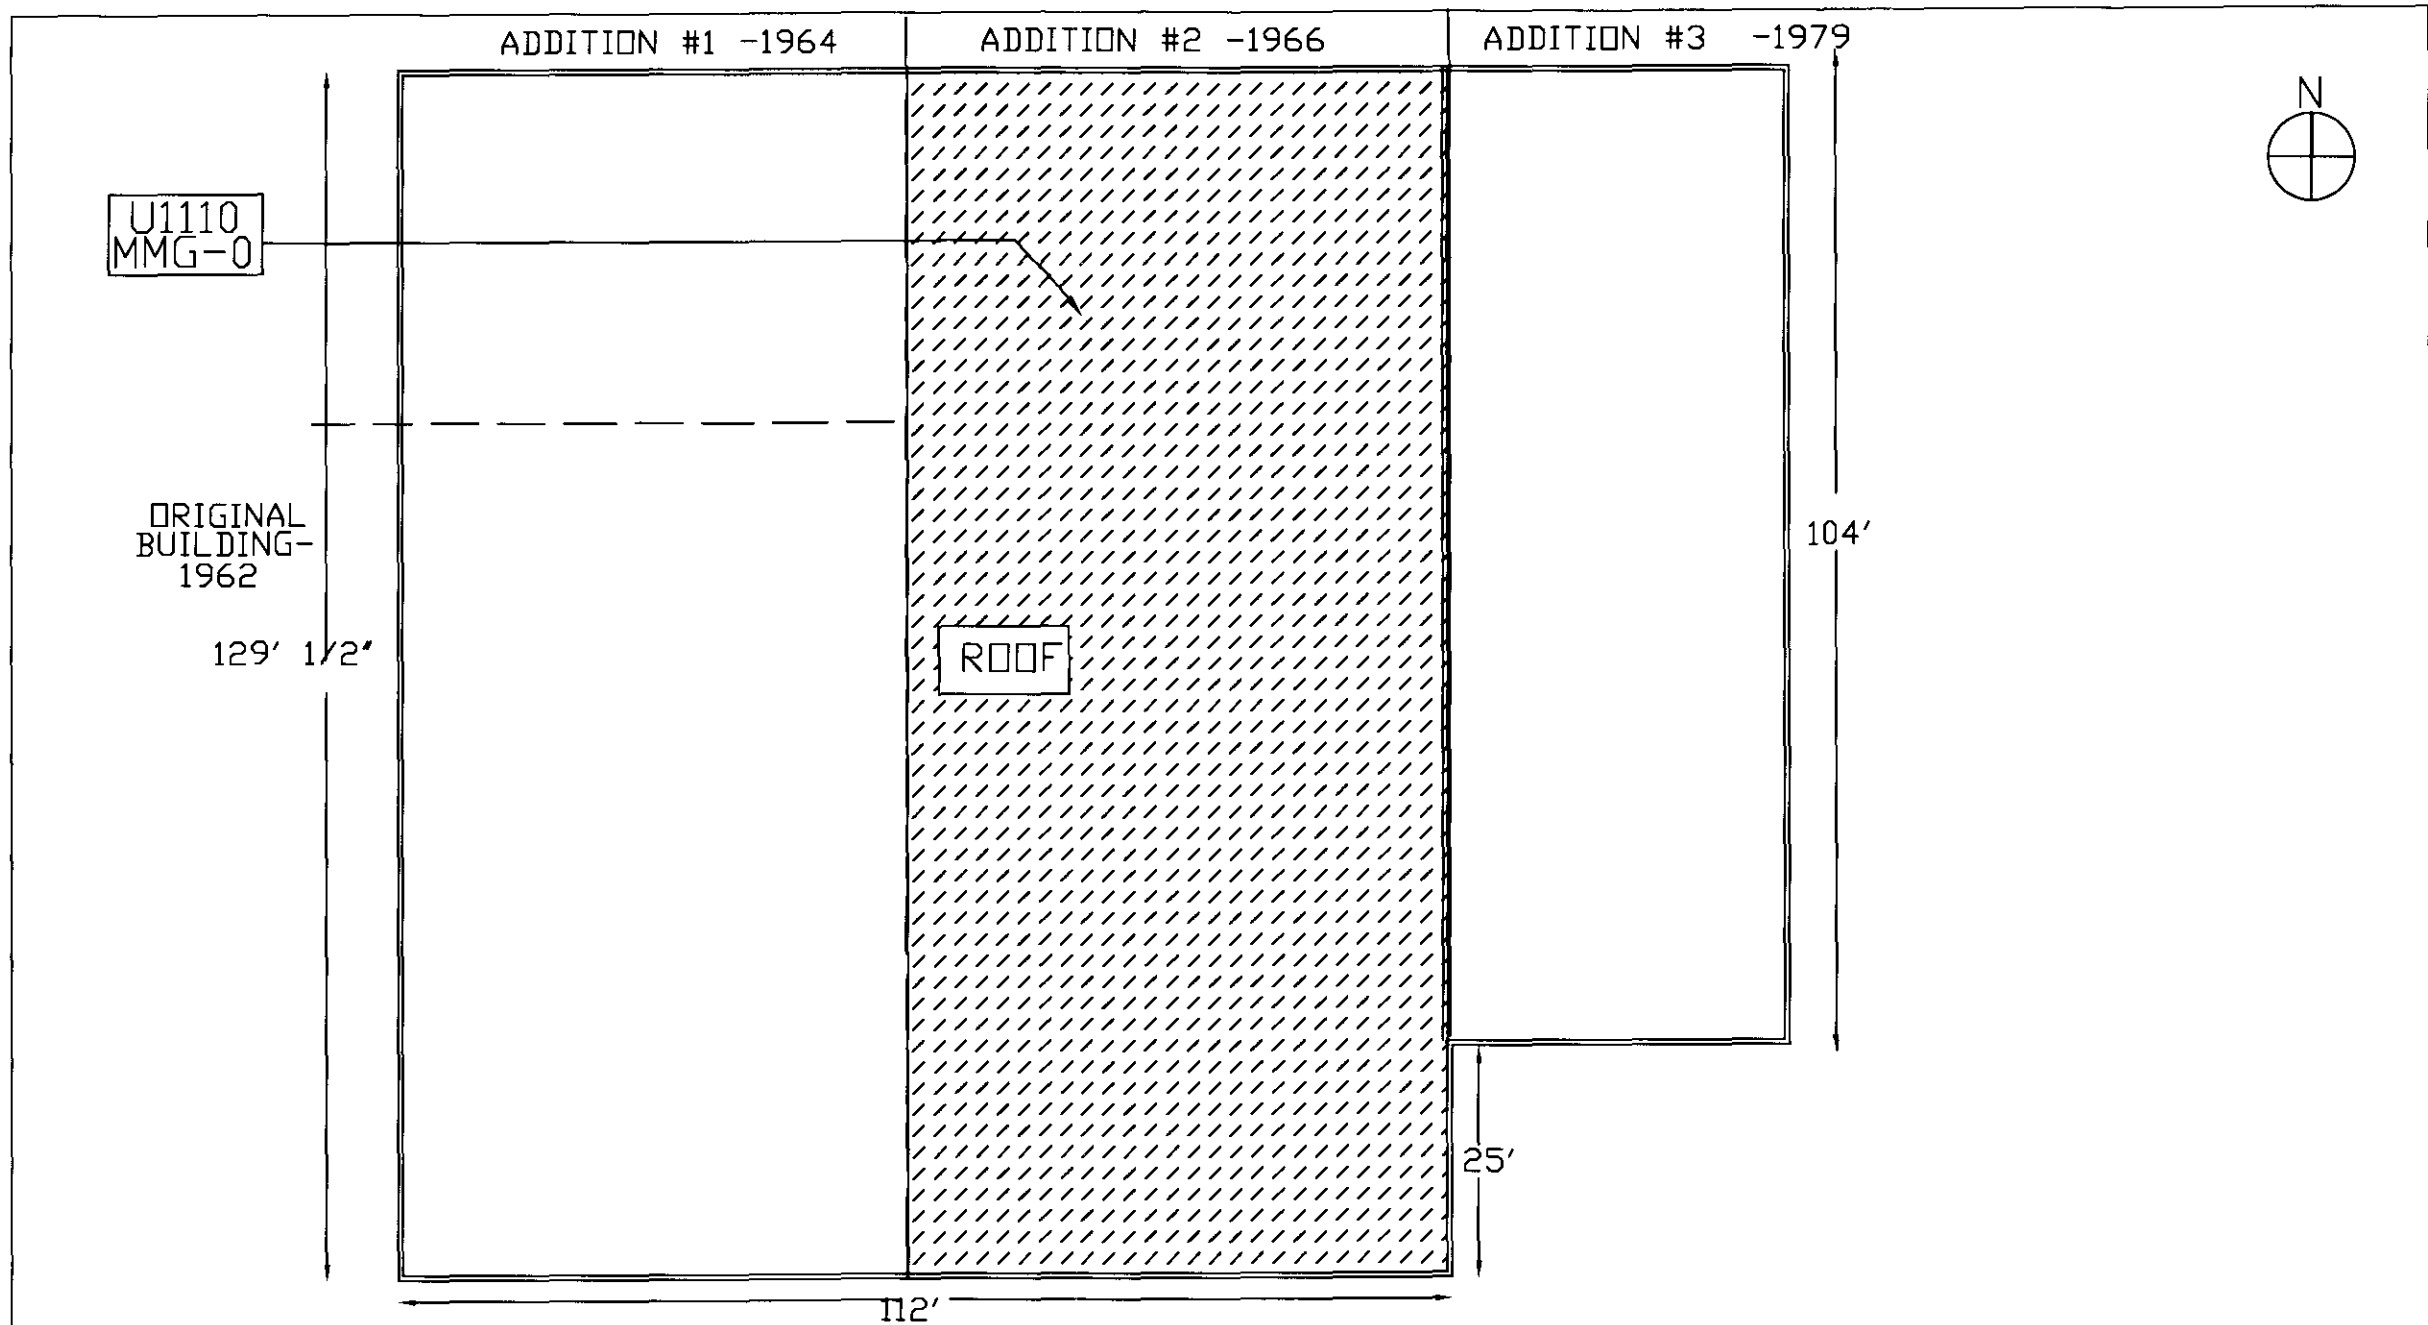
<p>CAPITAL DEVELOPMENT BOARD</p>	ROOF PLAN	PROJ. NO. 910-010-093
		WEST HEATING PLANT NORTHERN ILLINOIS UNIVERSITY DEKALB, DEKALB COUNTY, ILLINOIS	DATE JANUARY 19, 2000
		CDB BUILDING # U1110	SHEET 1 PF 1 MMG

**POT. FOR DAMAGE** THIS MATERIAL HAS A LOW POTENTIAL FOR DAMAGE DUE TO  
ITS NON-FRIABLE NATURE.

A.2.b. **FRIABLE** NO **CONDITION** GOOD  
**DISTURBANCE** LOW **AIR FLOW** HEAVY

A.1 BLDG. NAME WEST HEATING PLANT BLDG. NO. U1110  
HOMO AREA MMG **DESCRIPT** BUILT-UP ROOF (ADDITION #2 - 1966)  
**RESPONSE ACTION** 8 - CONTINUE O & M UNTIL MAJOR DEMOLITION OR  
RENOVATION REQUIRES REMOVAL UNDER NESHAPS, OR UNTIL HAZARD  
ASSESSMENT FACTORS CHANGE.
