# ASBESTOS MANAGEMENT PLAN REPORT

CDB - PROJECT NUMBER -- 910-010-093

NORTHERN ILLINOIS UNIVERSITY  
1425 WEST LINCOLN HIGHWAY  
WEST HEATING PLANT  
C.D.B. BUILDING #U1110  
NORTHERN ILLINOIS UNIVERSITY - DEKALB CAMPUS  
DEKALB, DEKALB COUNTY, ILLINOIS 60115

BY:  
CARNOW, CONIBEAR & ASSOC., LTD.  
333 WEST WACKER DRIVE, SUITE 1400  
CHICAGO, ILLINOIS 60606  
(312)782-4486

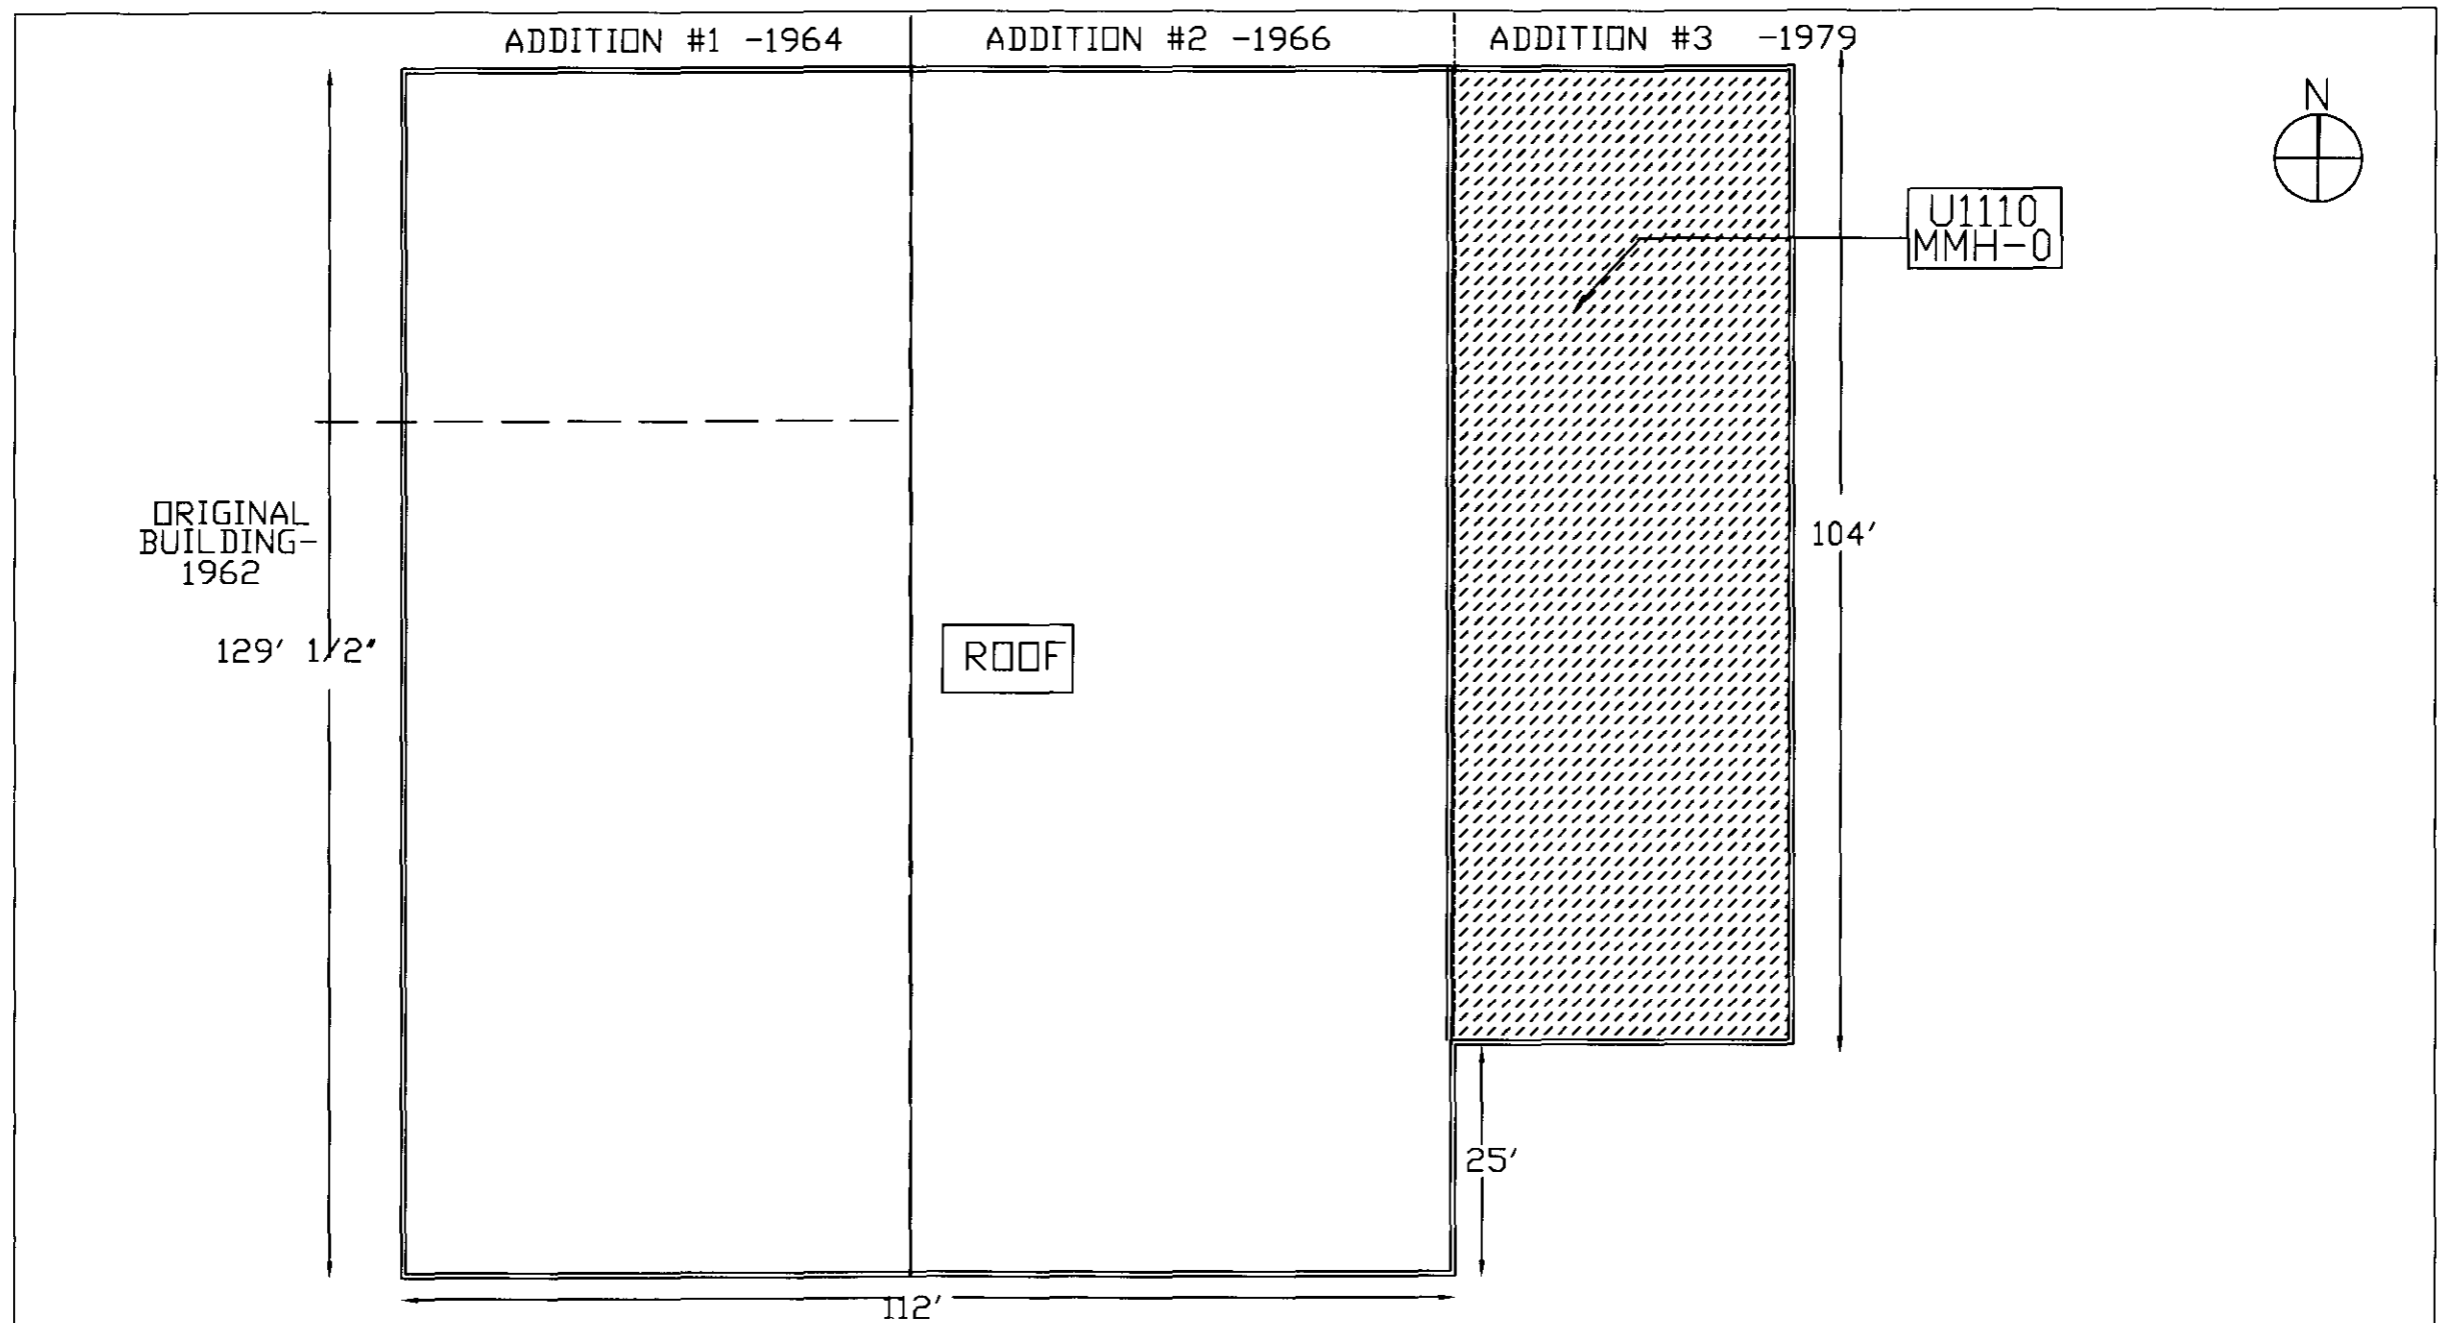
ROOF PLAN

POT. FOR DAMAGE THIS MATERIAL HAS A LOW POTENTIAL FOR DAMAGE DUE TO  
ITS NON-FRIABLE NATURE.

A.2.b. FRIABLE NO CONDITION GOOD  
DISTURBANCE LOW AIR FLOW HEAVY

.1 BLDG. NAME WEST HEATING PLANT BLDG. NO. U1110  
HOMO AREA MMH DESCRIPT BUILT-UP ROOF (ADDITION #3 - 1979)  
RESPONSE ACTION 8 - CONTINUE O & M UNTIL MAJOR DEMOLITION OR  
RENOVATION REQUIRES REMOVAL UNDER NESHAPS, OR UNTIL HAZARD  
ASSESSMENT FACTORS CHANGE.
