4.01 EXISTING CONDITIONS REPORTS

This Southern Illinois University Edwardsville (SIUE) Health Sciences Assessment Report considers the landscape within the property boundaries of SIUE Building 200 and Building 220, located on University Drive in Edwardsville, Madison County, IL. This assessment also takes into consideration provided campus standards and connections to the rest of the SIUE campus

This assessment addresses the exterior and interior architectural components of two existing buildings on the SIUE campus, known as Building 200 and Building 220. This report is based solely on visual observation of the buildings and does not involve any testing, removal or demolition of existing components, or other invasive methods to determine existing conditions.

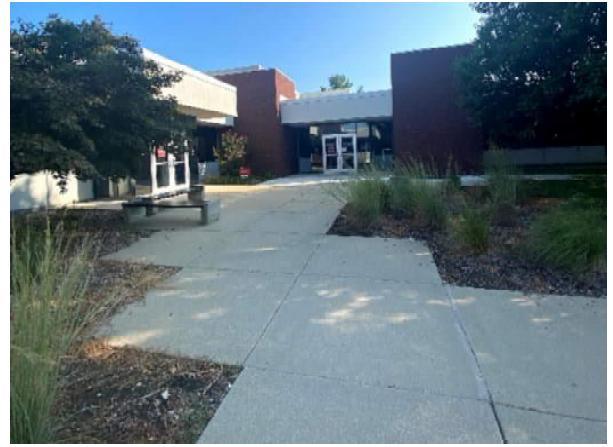
2.1.02.4.1 Figure 1: Entry Plaza

The paved entry plaza is spacious with multiple planting beds including ornamental and shade trees. Overall, the plant beds are underutilized and underpopulated with plant materials. The plaza pavement is concrete and in some locations the concrete has been repoured resulting in mismatched coloration of the pavement. There are four backless benches in the entry plaza.

Entry plaza view facing the main doors

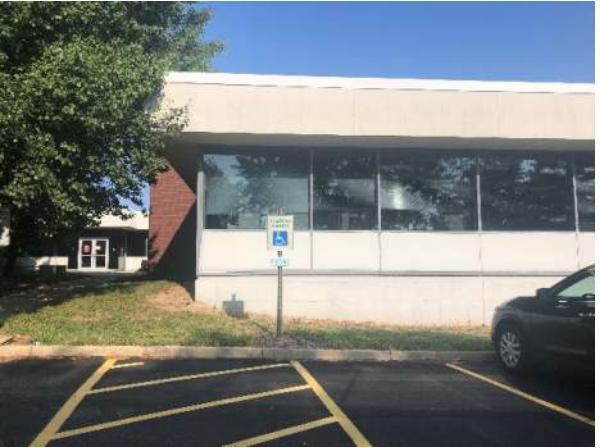
2.1.02.4 .2 Figure 1: ADA Parking Spot

There is ADA access from the parking lots to the entry of the building but in some spots, users have to walk behind vehicles to access the ADA entry. The paving material in these walk areas is concrete.

ADA parking spot with no immediate ADA accessible path

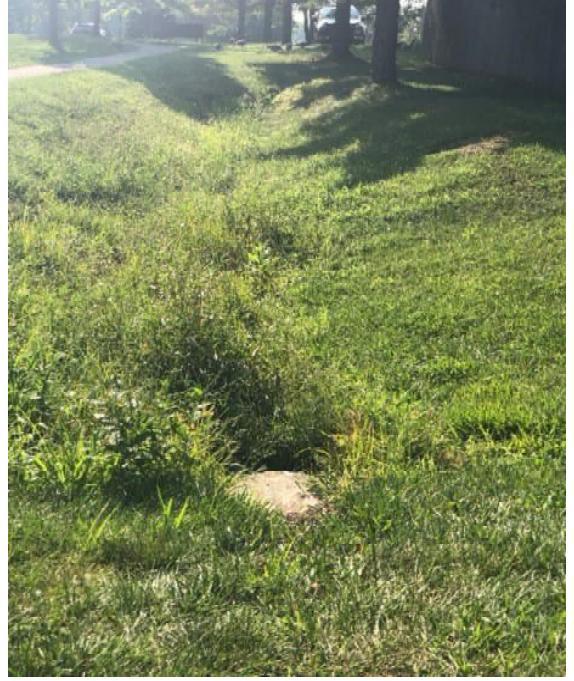
2.1.02.4.6 Figure 3: Bioswale

The majority of the planted areas on the site are turf, but where there are planting beds, the plants are primarily native. Within the memorial garden a mix of native prairie species are used. The areas where a swale is located is a mix of turf grasses in lieu of a specific bioretention plant mix.

The bioswale parallel to the building is planted with turf grass

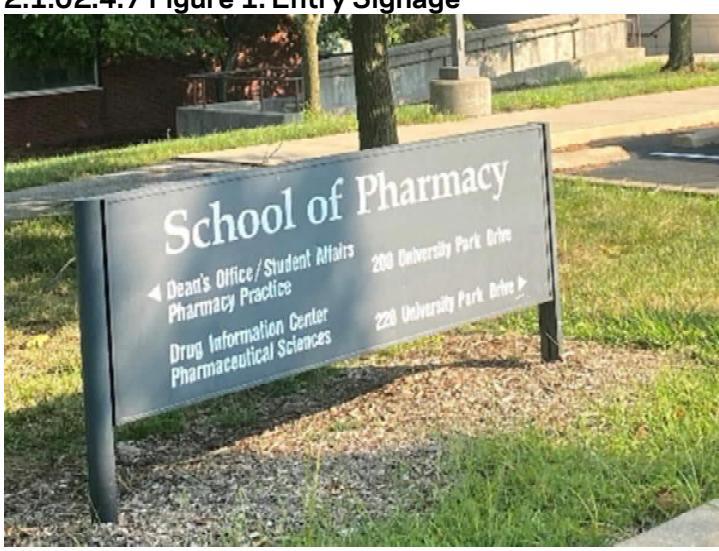
2.1.02.4.7 Figure 1: Entry Signage

The building entry signage does not match the indicated campus standard and is placed between the two buildings.

Signage shall be updated to meet the campuses current design standards as of fall 2021.

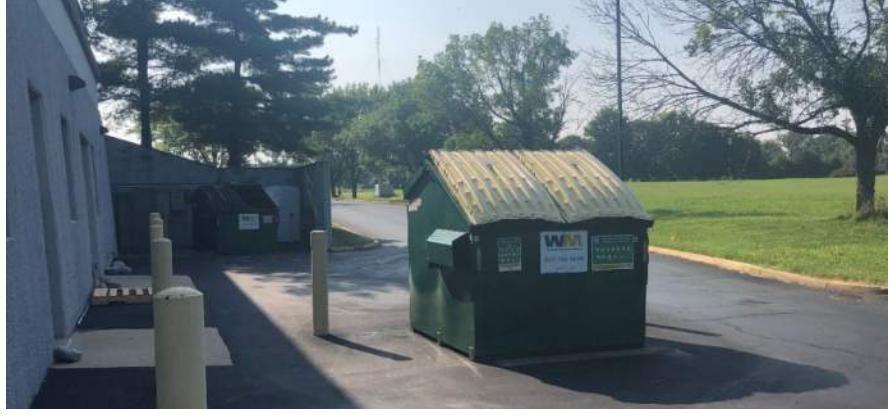
2.1.02.4.9 Figure 1: Loading Dock and Trash Dumpsters

To connect back to the main campus, a sidewalk leads from the north parking lot to the fan parking lot sidewalk system, refer to 5.1.01.4 Figure 1. To access the north parking lot, vehicular visitors must use the main entry drive. While accessing the north parking lot users, have to pass the service loading dock and dumpsters.

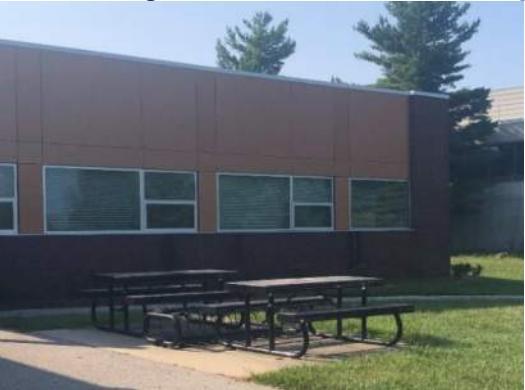
2.01.2.3 Figure 1: Picnic Tables and Bicycle Parking

Picnic tables on a patio with an unusable bicycle parking rack in between them

Bicycle racks need to be updated to meet the campuses current design standards as of fall 2021.Bike rack manufacturers are as follows:

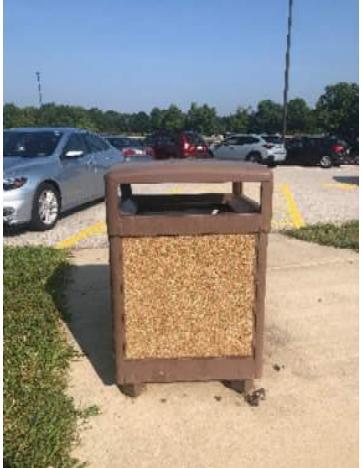
2.1.02.5.5 Figure 1: Trash Receptacle

Reference 5.1.01.4.5 regarding the picnic tables and commemorative bench. Reference 5.1.01.5.3 for bicycle parking and picnic tables. A single trash receptacle is located on the north sidewalk where the site connects to the campus parking. The trash receptacle does not match the campus standard.

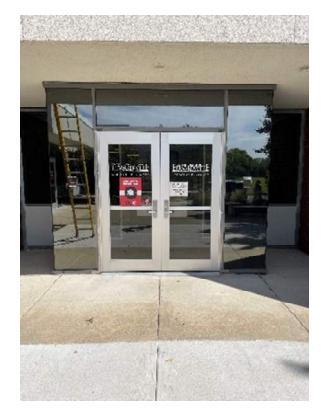
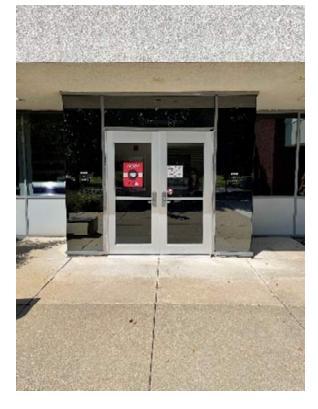
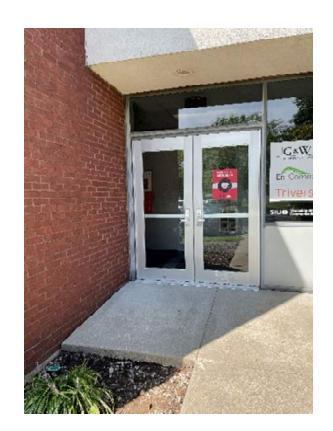
2.1.03.2.1 Figure 5: Upper Level Entrances

The upper level interior spaces are accessed from an entry plaza of concrete walks and landscaping. Entrances to the two larger spaces are glazed vestibules. Vestibules are butt-jointed single pane assemblies with aluminum storefront entry doors. Vestibules are in poor condition with gasketing and sealant missing or pulled away from the glazing and metal framing system. Solar control film at the interior is deteriorating and coming off the glazing. Retrofits on the doors display plates and screws crudely installed. Door and hardware finishes are pitted and discolored.

Concrete walks at the entry plaza are showing signs of shifting, there are multiple instances where the concrete has pulled away from the building and the sealant and/or wood filler strips are missing. Thresholds, door bottom rails, and door hardware may not be considered in compliance with current accessibility codes and standards.

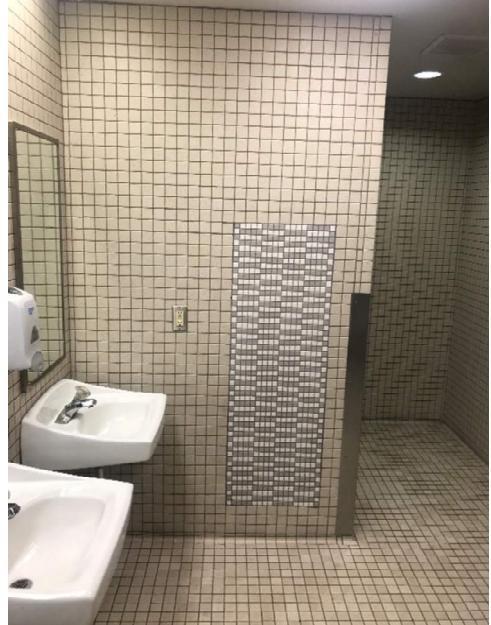
2.1.03.2.2 Figure 2: Typical Lower Level Corridor and Toilet Room Finishes

installed resilient sheet product. Floor finish was in good condition with no observed installation issues. Corridor ceilings are suspended 2x4 acoustic ceiling tile with lay-in light fixtures and ceiling devices. This ceiling is in fair condition but showing signs of age such as sag, fading, and damaged tiles. This ceiling finish is typical throughout the lower level, with the exception of some remodeled spaces which have more recent installations. All interior partitions are gypsum board finished, except for the multi-fixture toilet rooms which are ceramic tile finished. Exterior walls are gypsum board finished in public areas, with painted concrete and cmu in the stair shaft. Door hardware such as the kickstops on the toilet room doors may not be considered in compliance with current accessibility codes and standards.

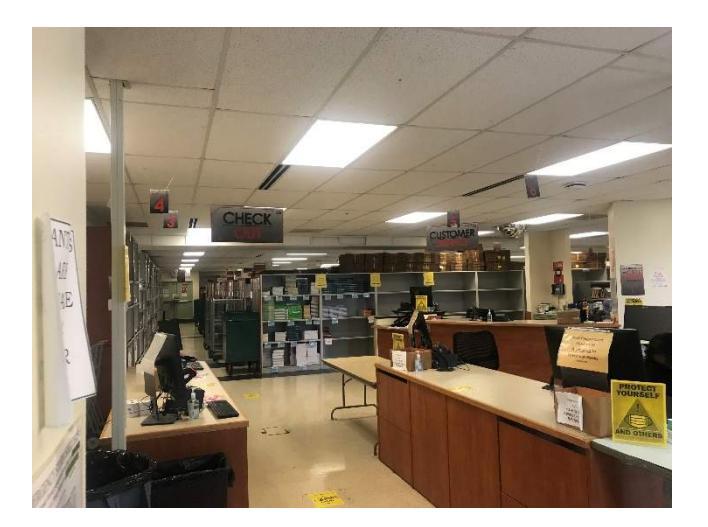
2.1.03.2.2 Figure 5: Textbook Services Space

The space currently utilized by textbook services is a large open room with shelving and transaction counters, a storage room, and a small office package. The floor finish is an aged 12x12 vinyl tile, vinyl wall base, painted gypsum board walls, and suspended 2x4 acoustic tile ceiling. Most light fixtures and lay-in, but some surface mounted fixtures have been added, apparently to align with the shelving layout. Several of these fixtures were observed as overlapping a lay-in slot diffuser. The storage room off the main area is unfinished except for a small office area with partially finished wall furring and insulation boards attached to the underside of the roof deck. A small office package shares a common wall with the storage room. A pair of hollow metal doors opens directly from the main floor to the exterior loading area.

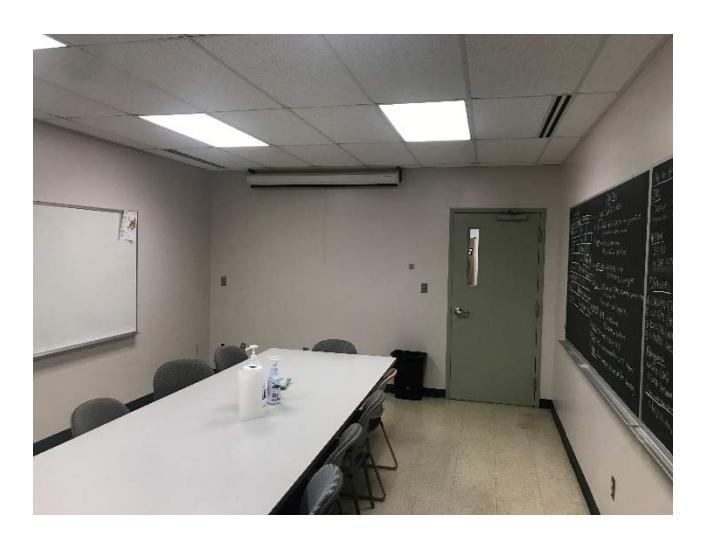
2.1.03.2.2 Figure 6: Typical Classroom

The Large Classrooms have heavily worn and discolored carpet floor finishes well beyond their life span. The remaining finishes are typical vinyl wall base, gypsum board walls, and suspended acoustic tile ceiling. Finishes in these areas show more wear and tear than office spaces, and window assemblies have similar issues with the laminate window stool and the sealant at the frames.

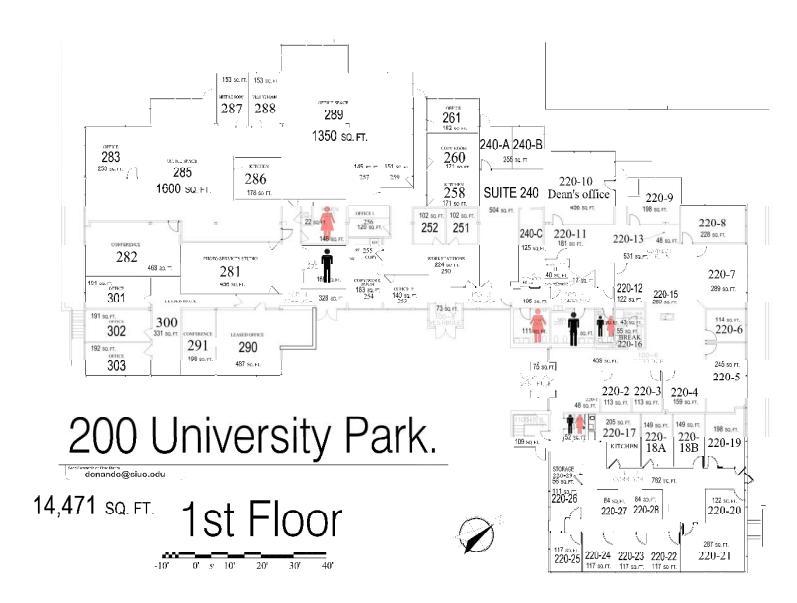
2.1.03.2.2 Figure 7: Upper Level Floor Plan

Floor finishes in the upper level are predominately carpet with some areas of 12x12 vinyl tile in break rooms and storage/copy rooms, and ceramic tile or resilient flooring in toilet rooms. Carpet floor covering is in poor condition, discolored, stained, and heavily worn in high traffic areas, with some areas of bulging and wrinkling creating tripping hazards. With few exceptions, ceilings throughout the upper level are suspended acoustic tile. The ceiling finish on the upper level is in much poorer condition than the lower level. There are multiple instances of discoloration, staining, evidence of water leaks, and damaged or missing ceiling tiles and grid.

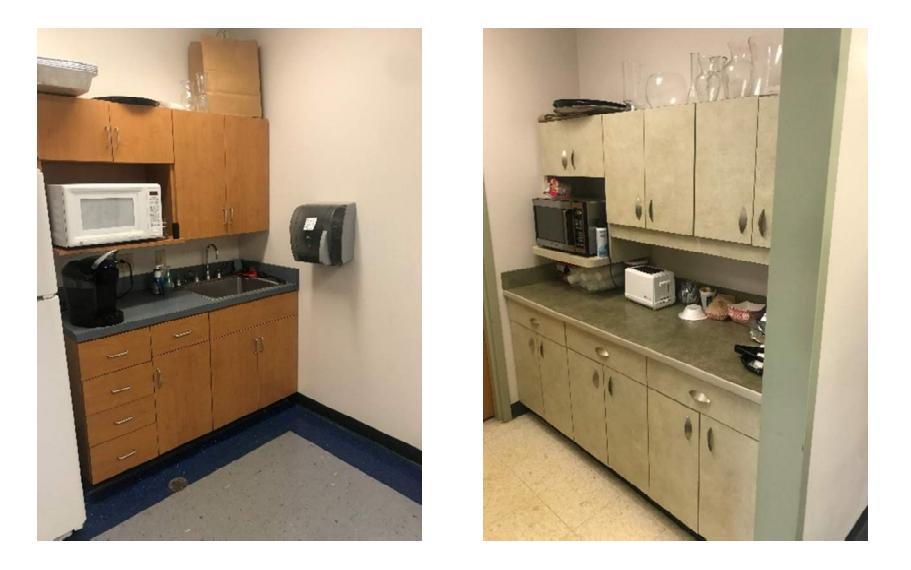
2.1.03.2.2 Figure 10: Typical Upper Level Breakroom

Support spaces such as break and copy rooms contain laminate casework that is dated but in fair condition and serviceable. Some breakroom casework
configurations and sinks may not be considered accessible by current codes and standards.

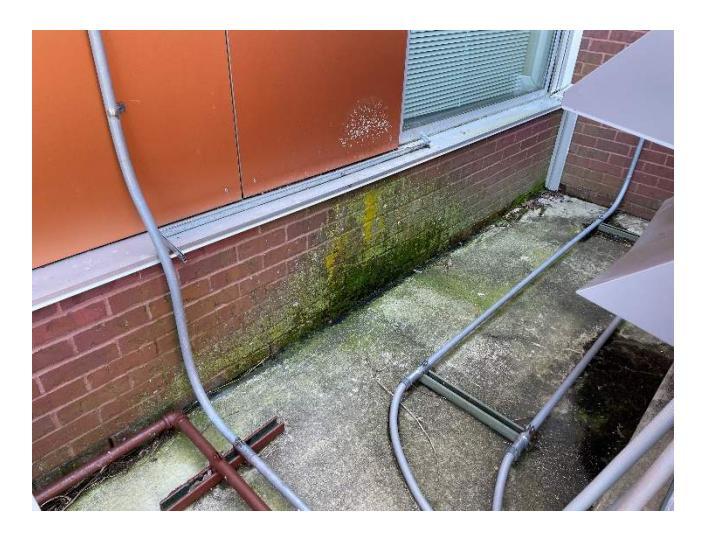
2.1.03.3.1 Figure 5: Surface Growth at Ground Mounted Mechanical Unit

The brick veneer appears to be well constructed with appropriately located expansion joints, weeps, through wall flashings, and concave tooled mortar joints. However, the exterior masonry walls have significant water management issues and suffer from neglected maintenance of joints, flashing, and weep holes. Back pitched flashing, lack of redundancy in flashing, and deteriorated or missing sealant are allowing and/or directing water into these exterior wall assemblies. On the north sides of the building that do not receive much direct sunlight these compromised areas display discoloration, streaking, efflorescence, mold, lichen, and other surface growth. At the base of the exterior walls multiple areas were observed with mulch, dirt, and plantings covering or filling vents in the cavity wall, weeps, through-wall flashings, and drainage holes in metal framed glazed assemblies.

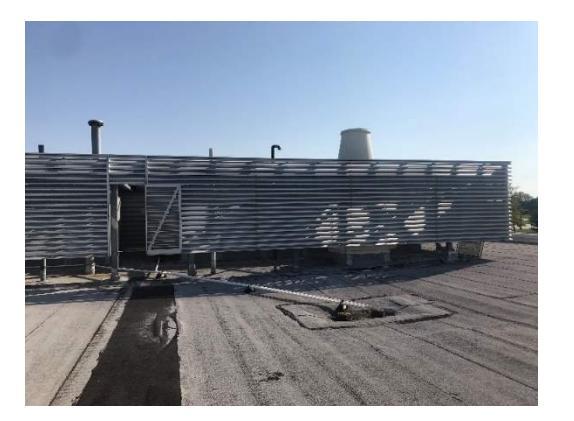
2.1.03.3.1 Figure 10: Mechanical Equipment Screen

Rooftop mechanical units over the original build are screened with a tube steel and metal louver panel system. Steel framing for the equipment screens appears galvanized, unpainted, and is in good condition.

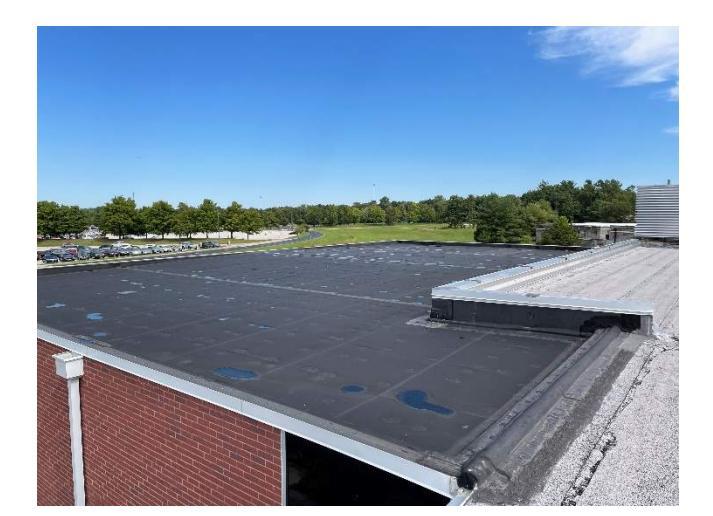
2.1.03.3.1 Figure 11: Roof at Building Addition

The roof of the addition is a low-slope, low parapet, black membrane roof system that meets the original build with an expansion joint. This roof drains to its north and south walls via through-wall scuppers, metal collector heads and leaders which connect to underground drain piping. The coping at the parapet is a metal fascia system that has the roof membrane overlapping the top horizontal surface and adhered to the metal fascia, leaving an exposed edge of the membrane at the roof perimeter.

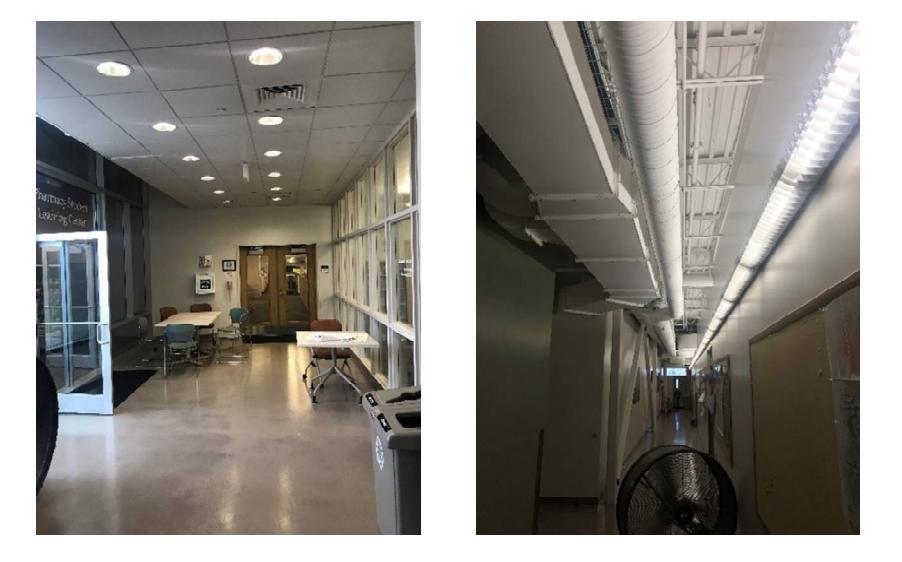
2.1.03.3.2 Figure 2: Interior Lobby and Corridor

The main entrance is a storefront framed vestibule that opens into a circulation node at the intersection of interior corridors and the lobby. Corridors are open to structure above with painted framing and ductwork, and suspended strip or pendant light fixtures. Ceiling finish over the lobby is a suspended acoustic perforated metal pan and grid assembly in good condition. Lobby and main corridor floors are finished with a large format resilient floor tile that is aged and displaying cracking and bulging in some locations, primarily at the perimeter of the lobby. The lobby shares a glazed hollow metal interior partition with a small study area that serves the pharmacy lab and storefront framed partition with the student learning center addition.

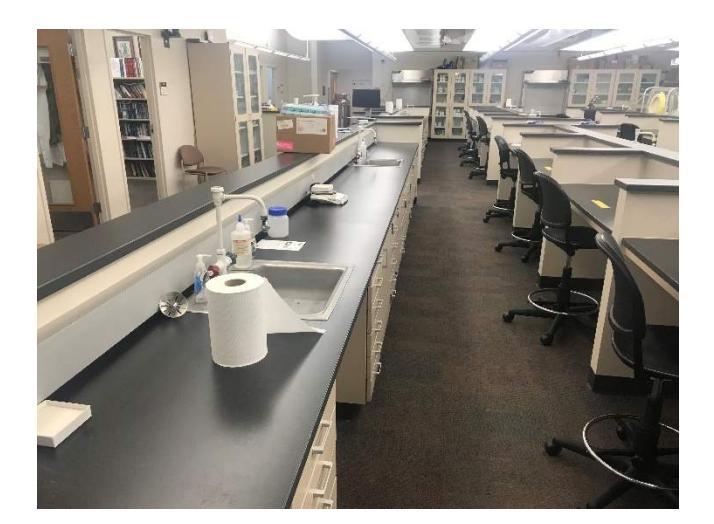
2.1.03.3.2 Figure 4: Large Laboratory Space

The large laboratory space is fit out with multiple counters, sinks, and casework. Sinks and plumbing fixtures show heavy wear and use. The lab is open to structure with painted framing and ductwork, suspended tectum acoustic panels and strip light fixtures over the workstations, painted gypsum board finished walls, vinyl wall base, and carpet tile floor covering. Finishes are in good condition overall with the floor covering displaying wear and tear in high traffic areas.

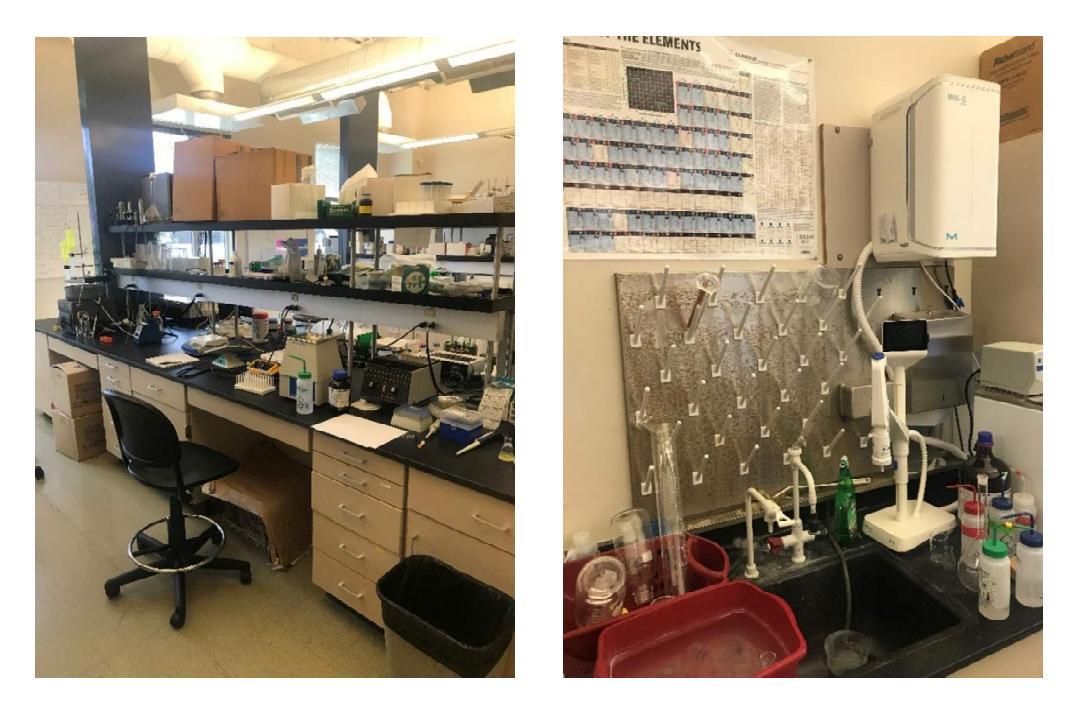
2.1.03.3.2 Figure 5: Research Laboratory Spaces

The four research labs are exposed to painted framing and ductwork above, have suspended strip light fixtures, painted gypsum board finishes partitions, and are fitted out with multiple counters, sinks, casework, and specialized equipment. See the Medical Equipment assessment for specifics regarding equipment. Floor finishes are 12x12 vinyl tile in poor condition displaying discoloration, cracking, missing corners, and heavy wear and tear. Casework, countertops, and plumbing fixtures exhibit heavy wear and use. Exterior windows have metal window stools.

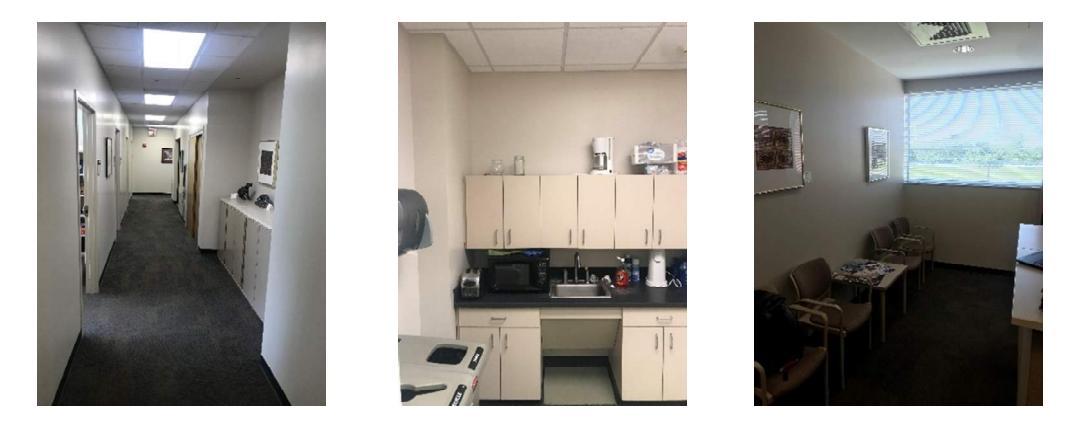
2.1.03.3.2 Figure 6: Typical Office Suite Finishes

Floor covering at the administrative office suite transitions to carpet tile, and typical office finishes of painted gypsum partitions, vinyl wall base, and suspended 2x2 acoustic tile ceilings with 2x4 lay-in light fixtures. Carpet tile is quite worn in high traffic areas. Exposed painted steel columns occur in some private offices, and exterior windows have the same metal stool as the remainder of the building. A small break room off the corridor has the 12x12 vinyl tile flooring and laminate casework including countertop and sink. The breakroom casework configuration and sink may not be considered accessible by current codes and standards.

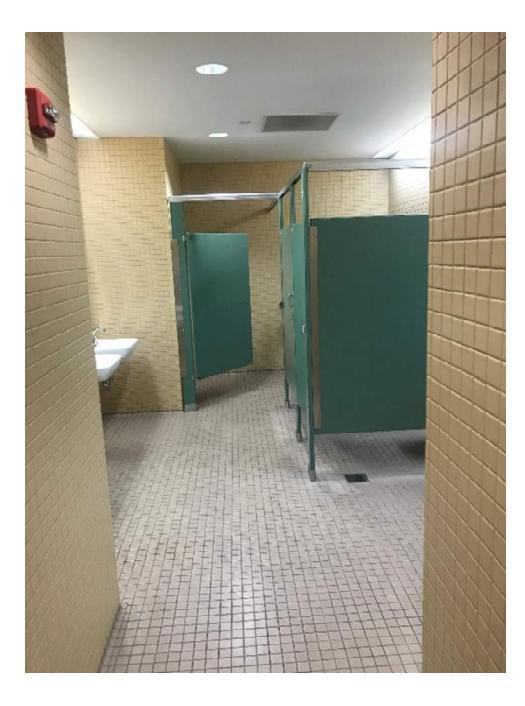
2.1.03.3.2 Figure 7: Toilet Room Door and Finishes

Toilet rooms are finished in small format ceramic tile on both floors and walls. Tile is in fair condition with grout that is discolored unevenly through high traffic and use areas. Toilet partitions and fixtures are in fair condition. Toilet rooms would likely require minor upgrades to comply with current accessibility codes and standards.

Typical interior doors are wood, either flush or with varying lite configurations, set in hollow metal frames. Interior door hardware such as the kickstops on the toilet room doors may not be considered accessible by current codes and standards.

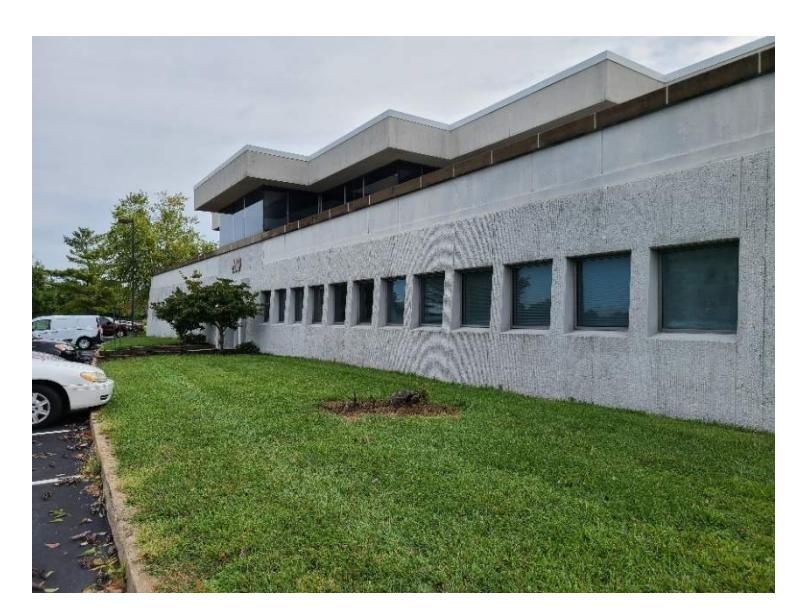
2.1.04.3.1.1 Figure 1: Building 200 West Face (Looking North)

The exterior of the lower level is constructed with load bearing, battered, CIP concrete walls with an architectural form-liner finish. Exterior faces of the walls are exposed on the north, west, and south face of the structure. Walls are 18" thick at the base and taper to 8" at the top (with a vertical interior face). An additional top wall segment serves as fall protection along the terrace and consists of a 5" thick CIP wall segment with a smooth finish and a precast cap stone. The top upper and lower portions of the wall are split by the CIP concrete floor at the upper level (see 5.1.03.3.1.1 Figure 1). The partially exposed east CIP concrete wall is typically 1-foot thick.

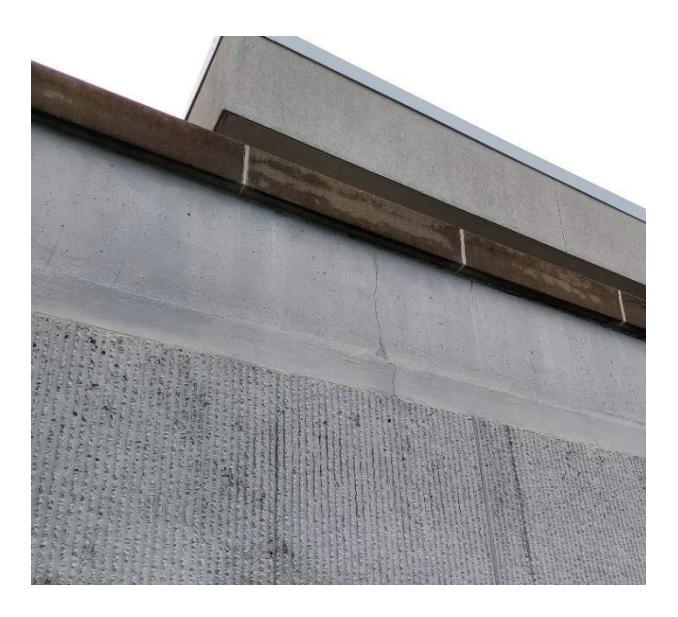
2.1.04.4.1 Figure 4: Building 200 Exterior Fall Protection Wall Cracking

- Along the fall protection wall at typical intervals:
 - See 5.1.03.4.1 Figure 4: Building 200 Exterior Fall Protection Wall Cracking
- Spalling at exterior battered concrete walls:

- DMA recommends applying a sealer to minimize water infiltration and future freeze-thaw damage.
- DMA recommends repairing spalled concrete surface.
- Approximately 2 square feet of spalled concrete surface on the west face of CIP concrete wall.
 - DMA recommends patching concrete at this location. This is a nonstructural issue. Restore surrounding form-liner finish.
- Approximately 15 linear feet of cracking and spalled concrete at the beam supporting the south side stair access to terrace.
 - DMA recommends repairing spalled concrete and cracking.
- Membrane wearing surface damage for vertical faces in both terraces.
 - DMA recommends repairing or replacing vertical surfaces of the fall protection barrier membrane.

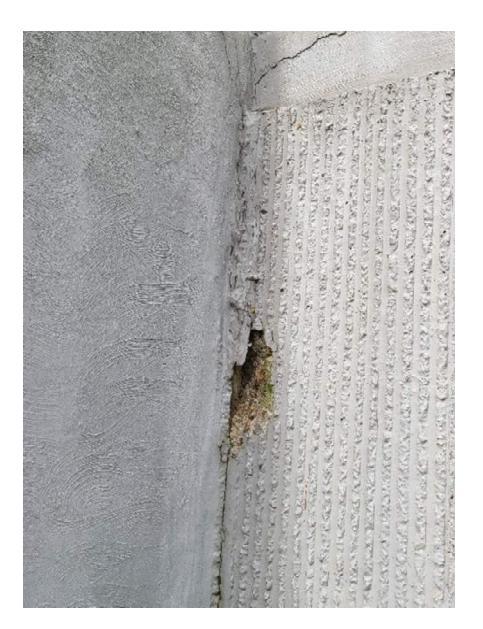
2.1.04.4.1 Figure 6: Building 200 Exterior Wall Spalling (North-East Face)

- At corners subject to potential chloride infiltration:
 - See 5.1.03.4.1 Figure 5: Building 200 Exterior Wall Cracking (North-East Face)
 - See 5.1.03.4.1 Figure 6: Building 200 Exterior Wall Spalling (North-East Face)

• Approximately 3000 linear feet of surface cracking on all exterior faces of CIP concrete walls. Concrete spalling was observed in the north-east corner of the structure at the north side stair access to terrace.

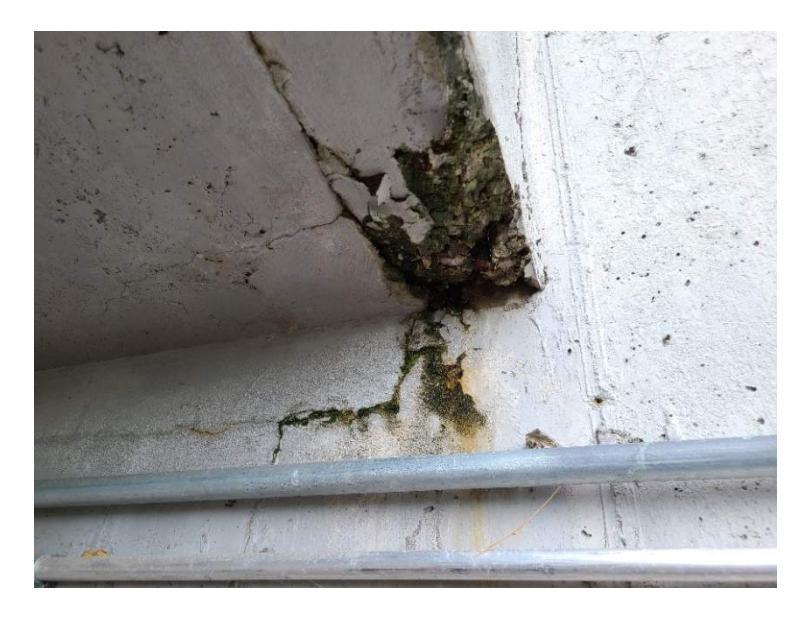
2.1.04.4.1 Figure 8: Building 200 Dock/Trash Cracking and Spalling

- At cast-in-place beam supporting stairs above (for terrace access) subject to chloride infiltration:
 - See 5.1.03.4.1 Figure 8: Building 200 Dock/Trash Cracking and Spalling

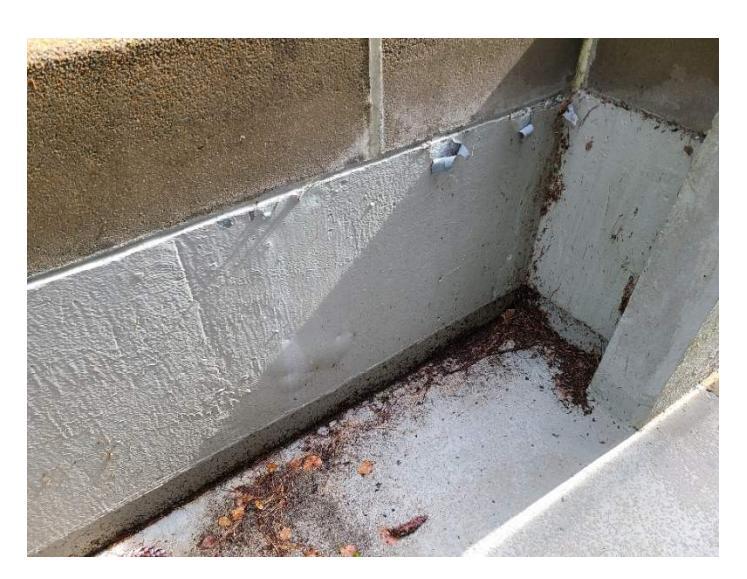
2.1.04.4.1 Figure 10: Building 200 Typical Membrane Damage

- At cast-in-place fall protection, damaged membrane surface causing potential water infiltration to concrete. Damage was typically limited to vertical surfaces:
 - See 5.1.03.4.1 Figure 9: Building 200 Typical Membrane Damage
 - See 5.1.03.4.1 Figure 10: Building 200 Typical Membrane Damage

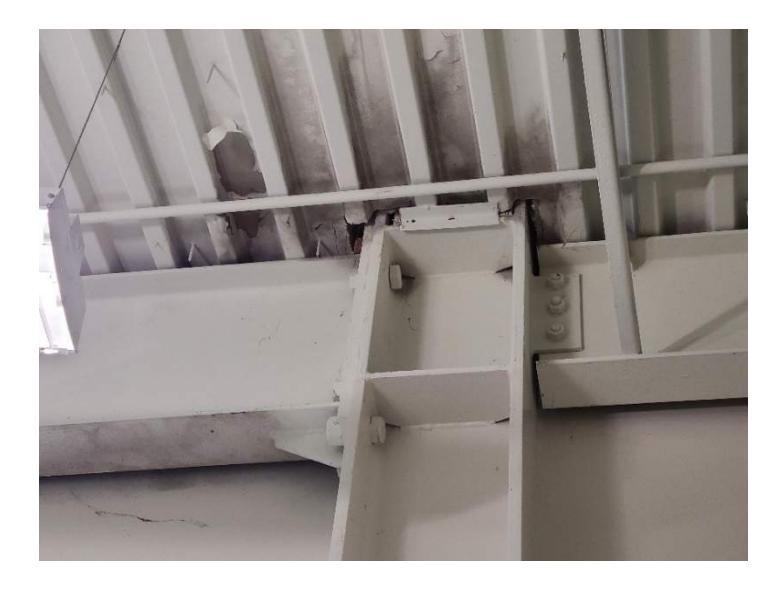
2.1.04.4.2 Figure 2: Building 220 Student Lounge Paint Flaking (Looking North)

- Joist bridging was observed to be cut in place:
 - In the north end of the Pharmacy Care Lab:
 - See 5.1.03.4.2 Figure 1: Building 220 Joist Bridging Cut
- Non-structural paint flaking was observed:
 - In the Student Lounge at the middle column on both the north and south sides:
 - See 5.1.03.4.2 Figure 2: Building 220 Student Lounge Paint Flaking (Looking North)
 - See 5.1.03.4.2 Figure 3: Building 220 Student Lounge Paint Flaking (Looking South)

- Approximately 60 square feet of flaking paint in the Student Lounge.
 - DMA recommends cleaning and removing flaking paint. Verify no rusting has occurred to structural steel and repaint as required.

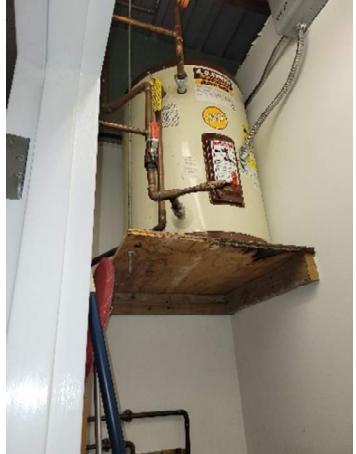
2.1.05.1 Figure 1: Electric Water Heater at Janitor

The existing domestic water service for Building 200 includes two separate service lines that enter the building at the southeast wall near Room 290 and the south wall near Storage 220-29. Neither service has backflow protection devices, and it was noted by the maintenance staff that the building originally had three domestic water service lines, but the third line was abandoned at some point. There are the remnants of an exterior water connection for irrigation that has been capped and the backflow removed. Domestic water meters are located in pits at the exterior of the building in the adjacent landscape areas. Typically, the plumbing code requires backflow prevention at the incoming domestic service, therefore the addition of backflow at this building will need to be considered. Domestic hot water at the restrooms and kitchen/break areas are provided via local electric tank type water heaters, hot water recirculation is not present. The water heaters were manufactured in 1992 and replacement should be considered.

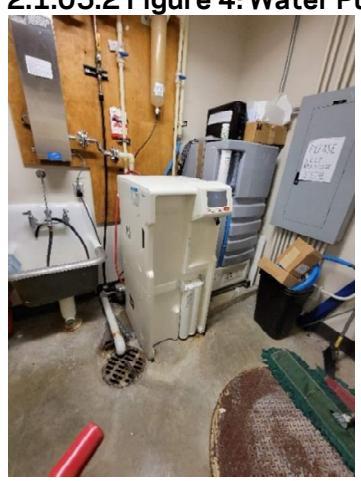
2.1.05.2 Figure 4: Water Purification System and Acid Tank

There is an ultra-violet water disinfection unit that provides water to a Millipore Elix 80 Electrodeionization (EDI) water purification unit and Millipore SDS Storage and Distribution System for distribution to the labs located in an internal mechanical room near Pharmaceutical Car Lab 1030. Also located in this room is a in floor acid waste tank. According to the maintenance staff there have been several issues with the Millipore Elix 90 EDI running properly.

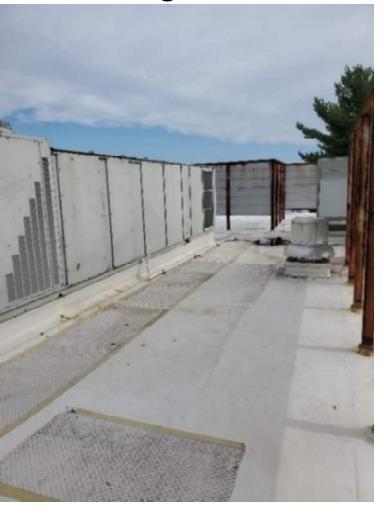
2.1.06.1 Figure 1: RTU-1

RTU-1 is an older unit with limited life remaining and appears to serve the north side of the building. RTU-2 appears to have been replaced in the last five years but is a smaller unit that likely serves only a small portion of the building. RTU-3 was installed in 2020, however according to discussions with facilities it has temperature control issues due to being purchased without adequate reheat. The compressor serving the pneumatic controls system is located in the small mechanical room 1109 on the lower level. Any renovation of the building will have to include a full controls upgrade that will eliminate the need for this compressor. The electronic thermostats observed in the building were Johnson Controls.

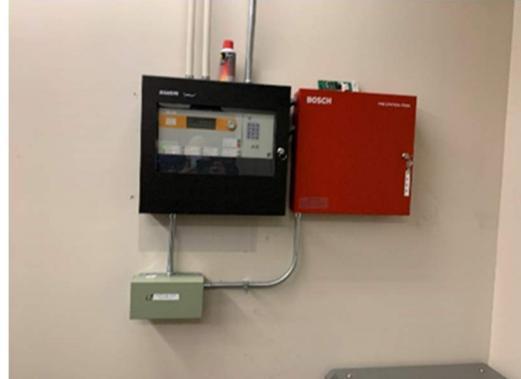
2.1.07.3 Figure 8: Fire Alarm Panel

The existing fire alarm system is Siemens Cerberus.

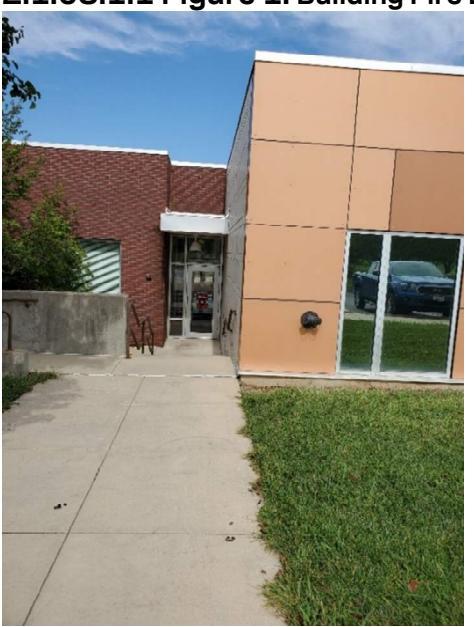
2.1.08.1.1 Figure 1: Building Fire Department Connection

A 6" combined fire and water services line splits off to a 6" fire water double check backflow preventer in the mechanical room. There is a fire department connection located adjacent to the main entrance on the south side of the building. Valves and zones on the system are monitored by the building fire alarm system. All fire protection equipment and piping appeared to be in good condition.

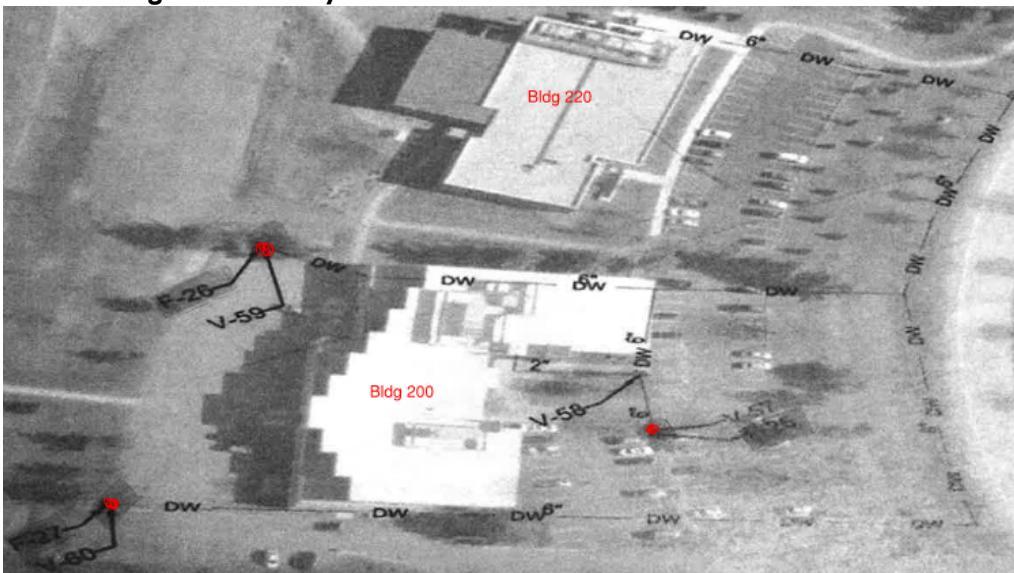
2.1.10.1 Figure 1: Fire Hydrant Locations

The bridging document team acquired the services of Ahern to complete flow and pressure testing on the three hydrants closest to the proposed project site. The measurements were taken at hydrants F-25, F-26, and F-27 that are served off a 6" water main that runs along the north side of University Park Drive.

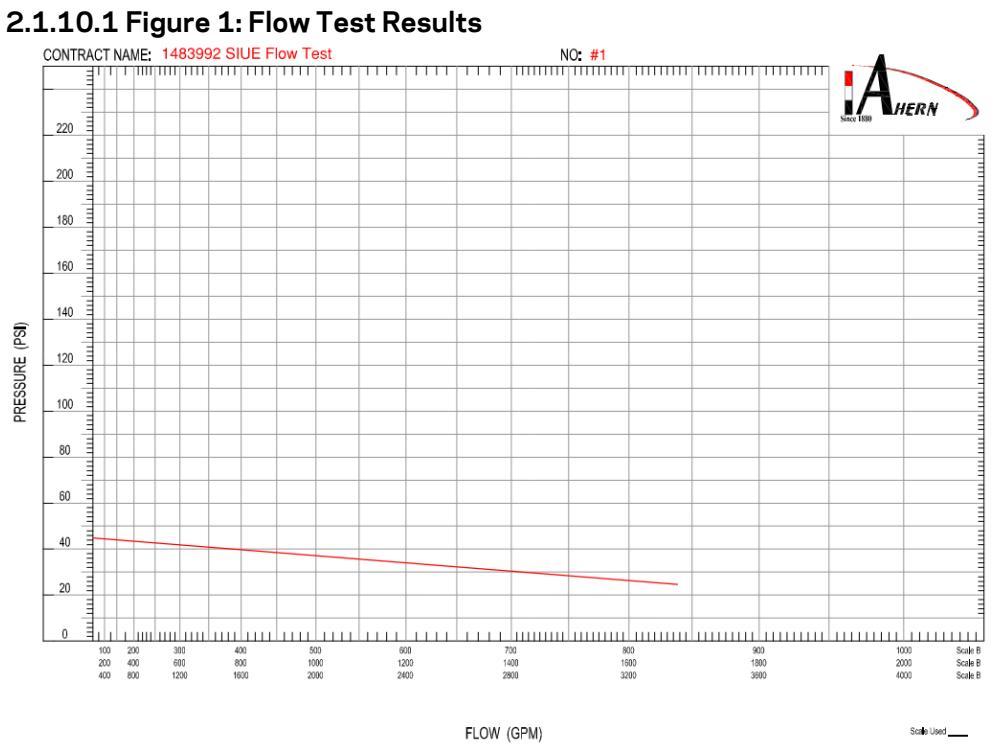
The tests were performed on October 21, 2021 and all three hydrants provided similar results as expected given their close proximity. Static pressures ranged from 45-50 psi and residual pressures ranged from 25-30 psi at a flow of 840 GPM. It was noted by Ahern that the pressure gauge briefly dropped near 0 psi and then recovered to pressure noted. This is something that is commonly seen when hydrants are at the end of a long dead-end run. Refer to attached full Ahern report for more details.

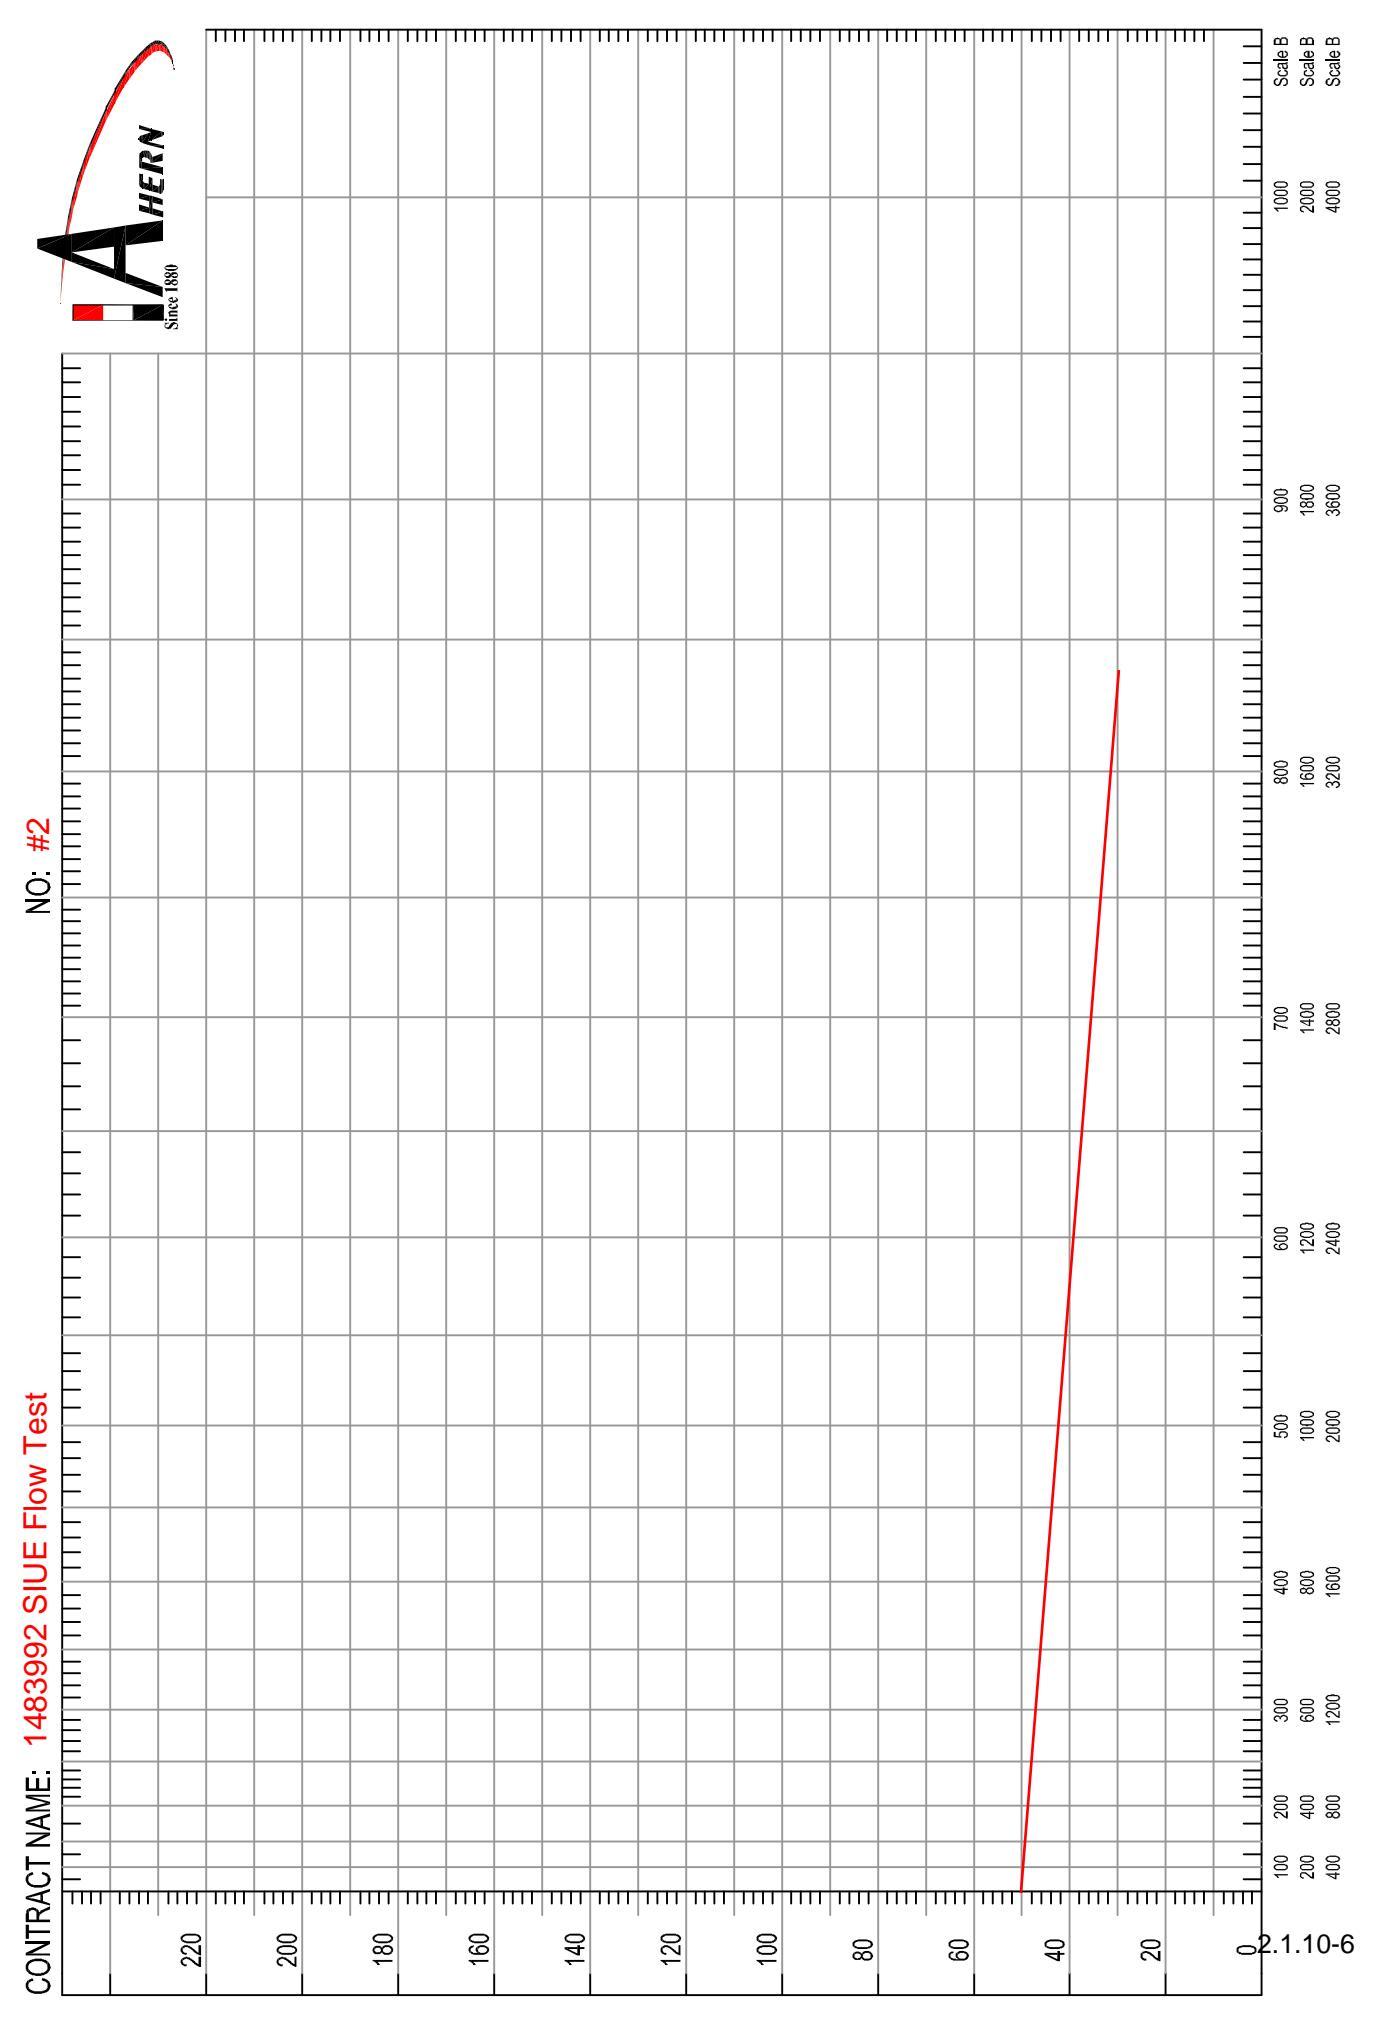
ADDRESS:	200 University Park Dr.		DATE:	October 21, 2021
PERFORMED BY:	P.J. & Randy w/ A	Ahern	TIME:	9:50 A.M.
OBSERVED BY:	Mike and Jeff w/ S	SIUE		
		See attached Site Plan for reference		
HYDRANT #(S):		Flow Hydrant #27		
		Gauge Hydrant #26

OBSERVATION NOTE: The Pressure Gauge on the Test Hydrant Briefly Dropped Near Zero Then Recovered to Pressure Noted Above.
