4.01 EXISTING CONDITIONS REPORTS

This Southern Illinois University Edwardsville (SIUE) Health Sciences Assessment Report considers the landscape within the property boundaries of SIUE Building 200 and Building 220, located on University Drive in Edwardsville, Madison County, IL. This assessment also takes into consideration provided campus standards and connections to the rest of the SIUE campus

This assessment addresses the exterior and interior architectural components of two existing buildings on the SIUE campus, known as Building 200 and Building 220. This report is based solely on visual observation of the buildings and does not involve any testing, removal or demolition of existing components, or other invasive methods to determine existing conditions.

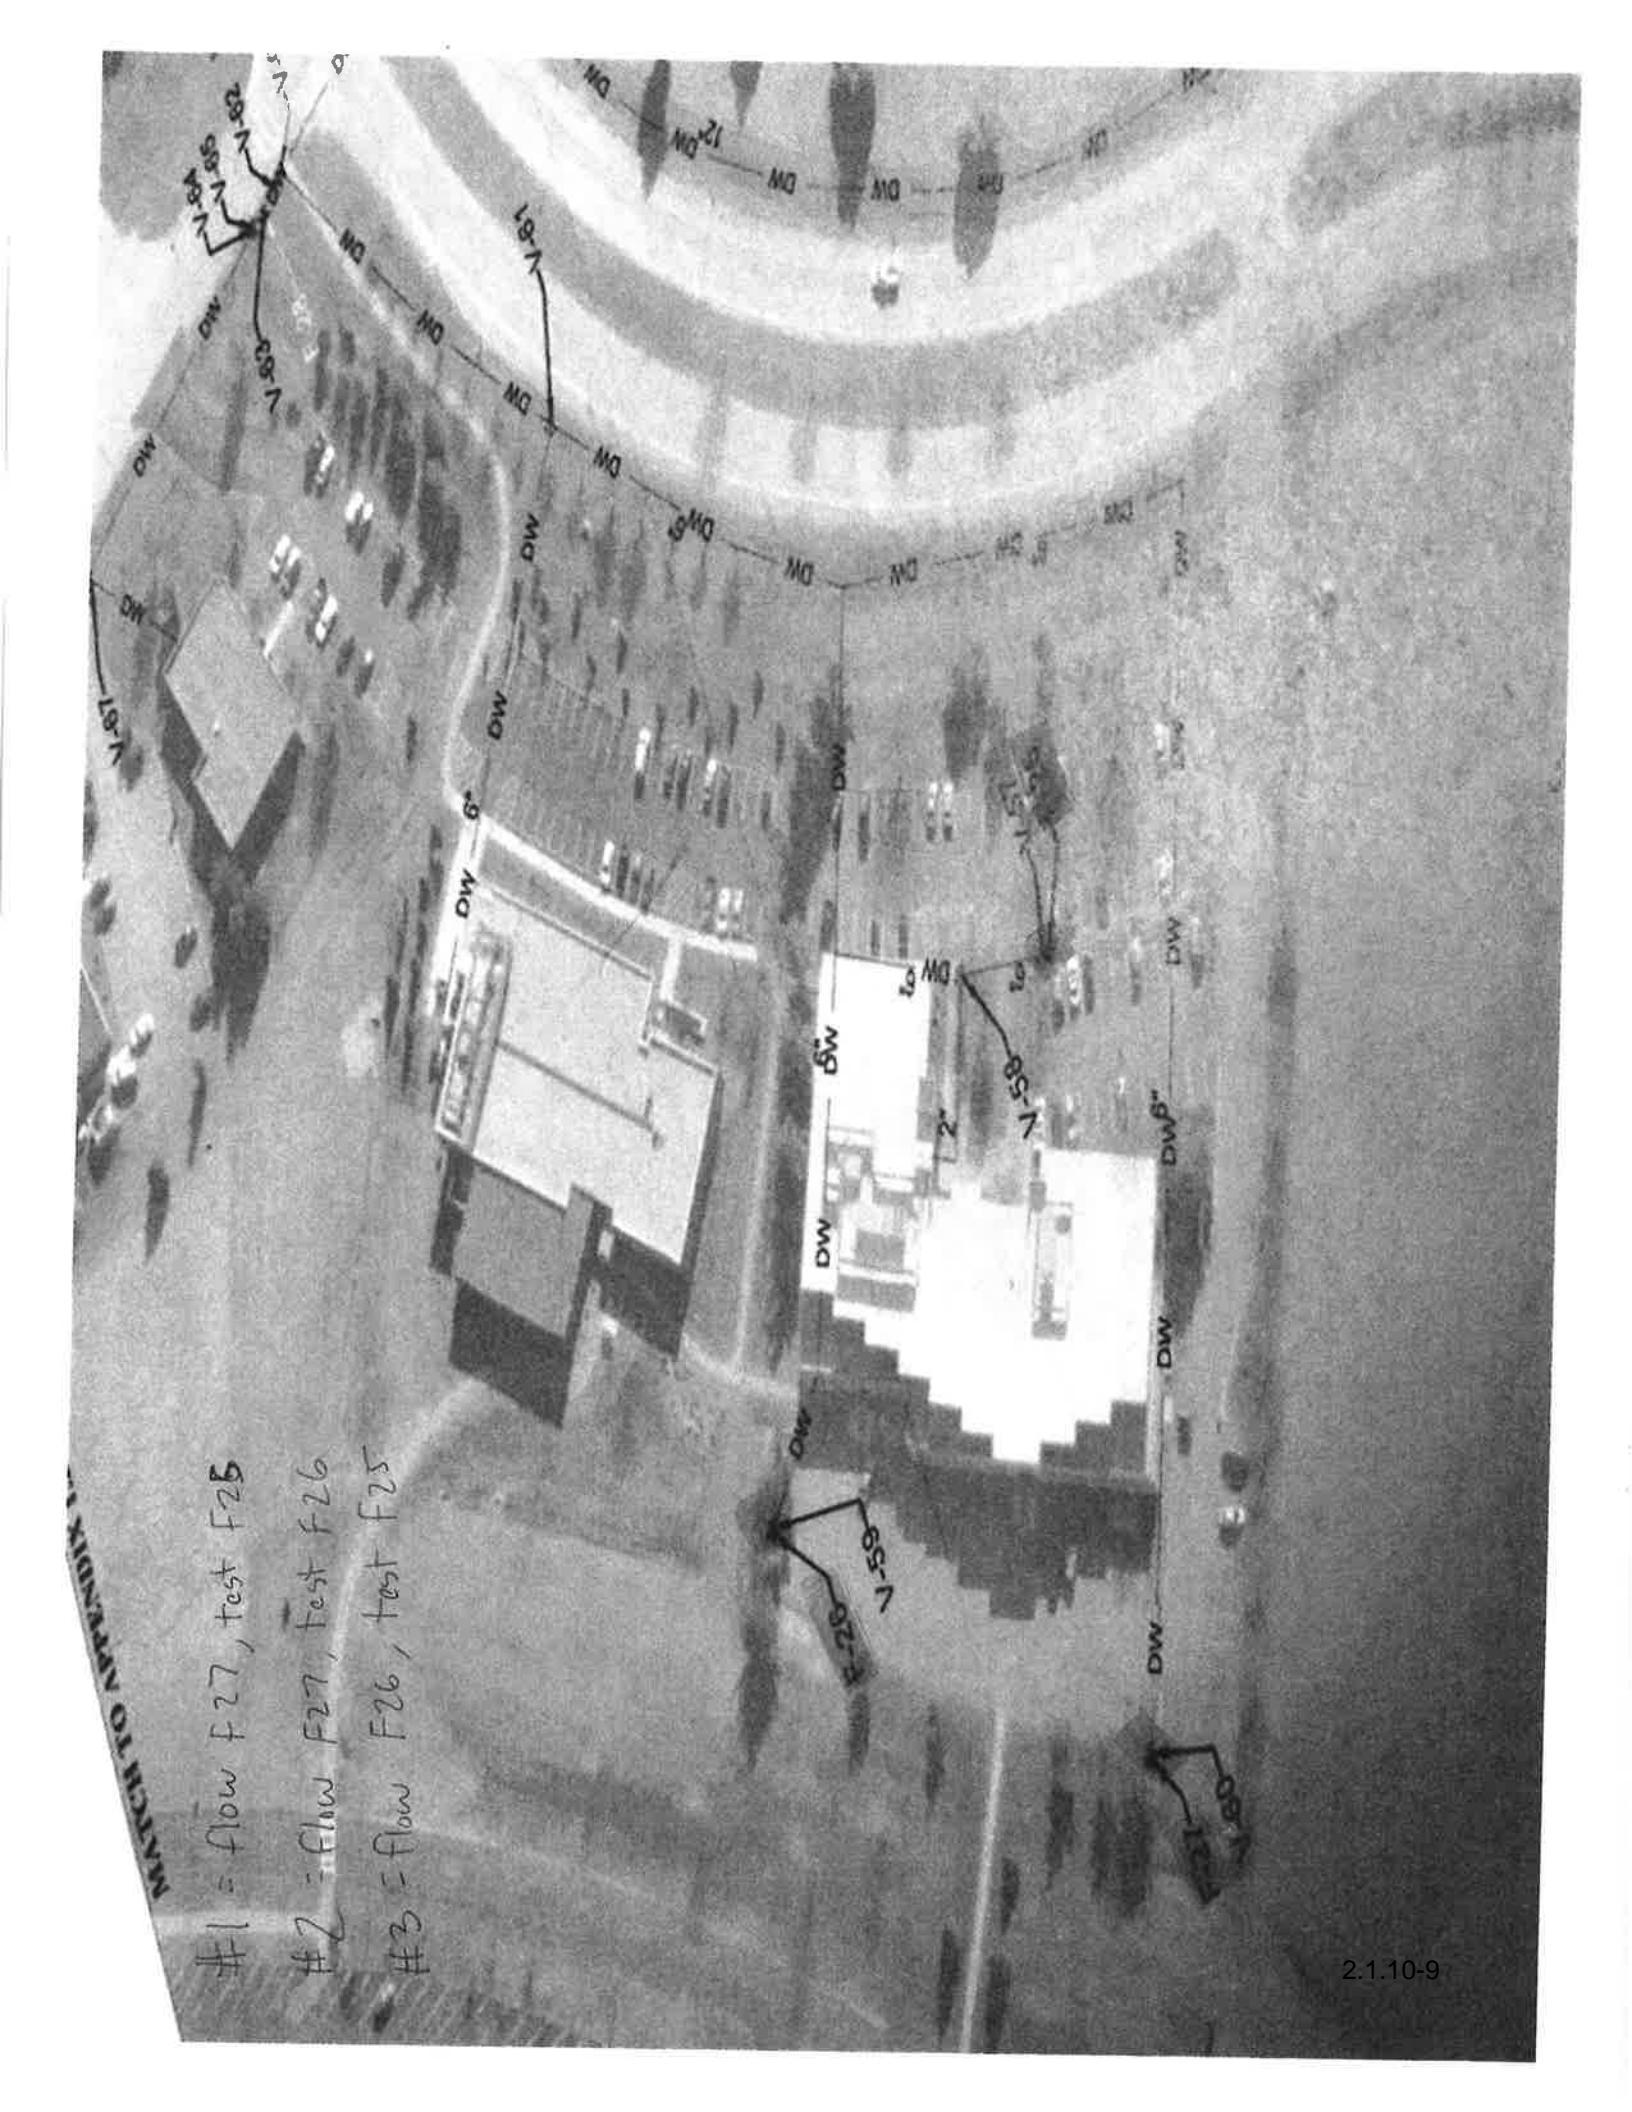
ADDRESS:	200 University Park Dr.		DATE:	October 21, 2021
PERFORMED BY:	P.J. & Randy w/ Ahern		TIME:	10:00 A.M.
OBSERVED BY:	Mike and Jeff w/ S	SIUE		
		See attached Site Plan for reference		
HYDRANT #(S):		Flow Hydrant #26		
		Gauge Hydrant #25

OBSERVATION NOTE: The Pressure Gauge on the Test Hydrant Briefly Dropped Near Zero Then Recovered to Pressure Noted Above.
